# Capital Improvement Program

Architecture & Engineering

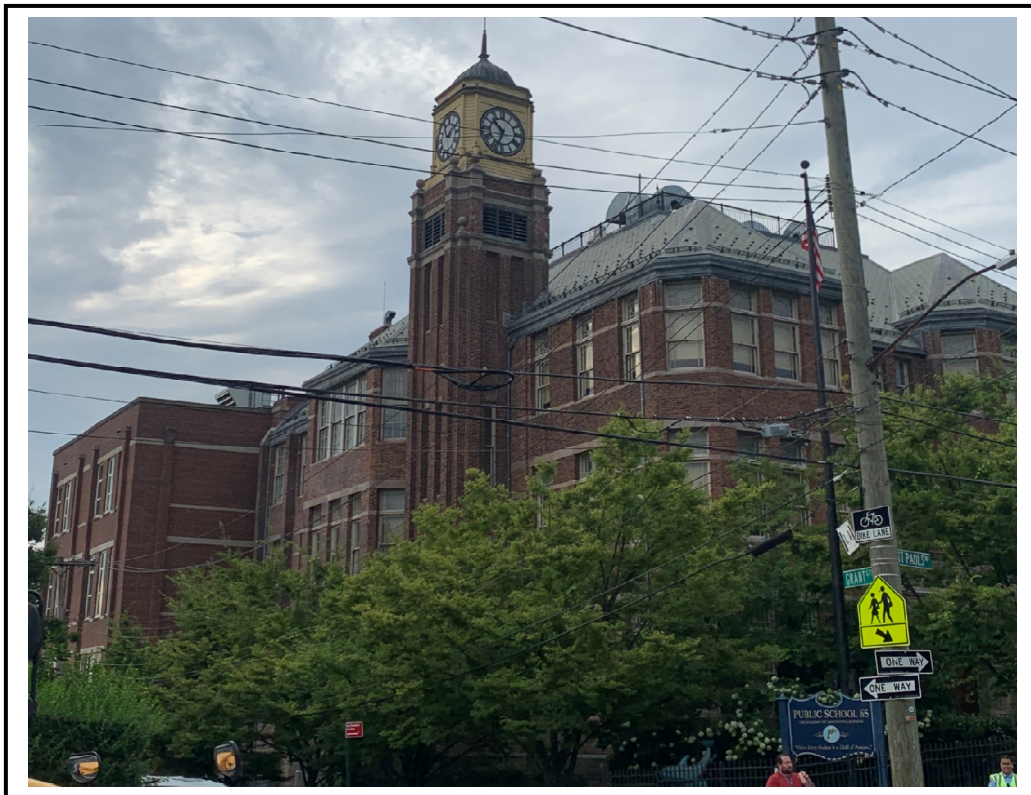
## Arthur D. Phillips School (Staten Island)

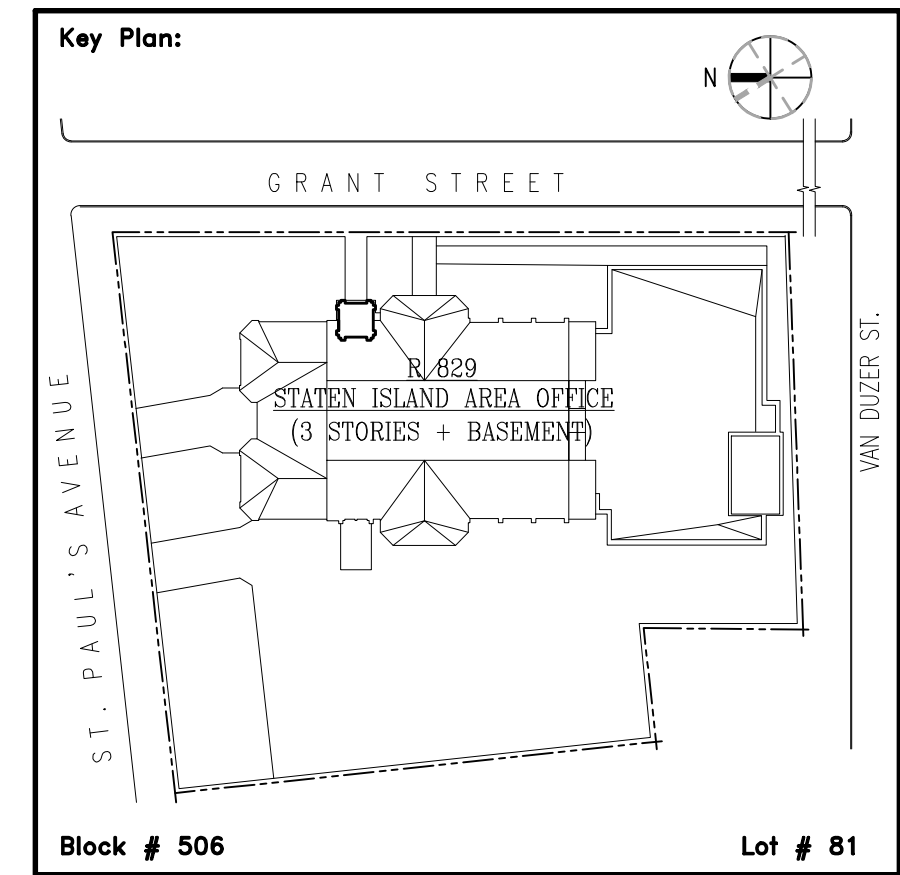
SCA Design Manager:	ASHRAF ELIAS, PE	
Project Architect/Engineer:	DAVID SAMMEL, RA	
Discipline Lead:	DAVID HUNSBERGER, RA	
Designer:	JUAN POLANCO	
Drawn by:	ALEXIS O'ROURKE	
Checked by:	DAVID SAMMEL, RA	
Design No or LLW No.:	Building ID:	Date:
D022292	R829	00/00/2023

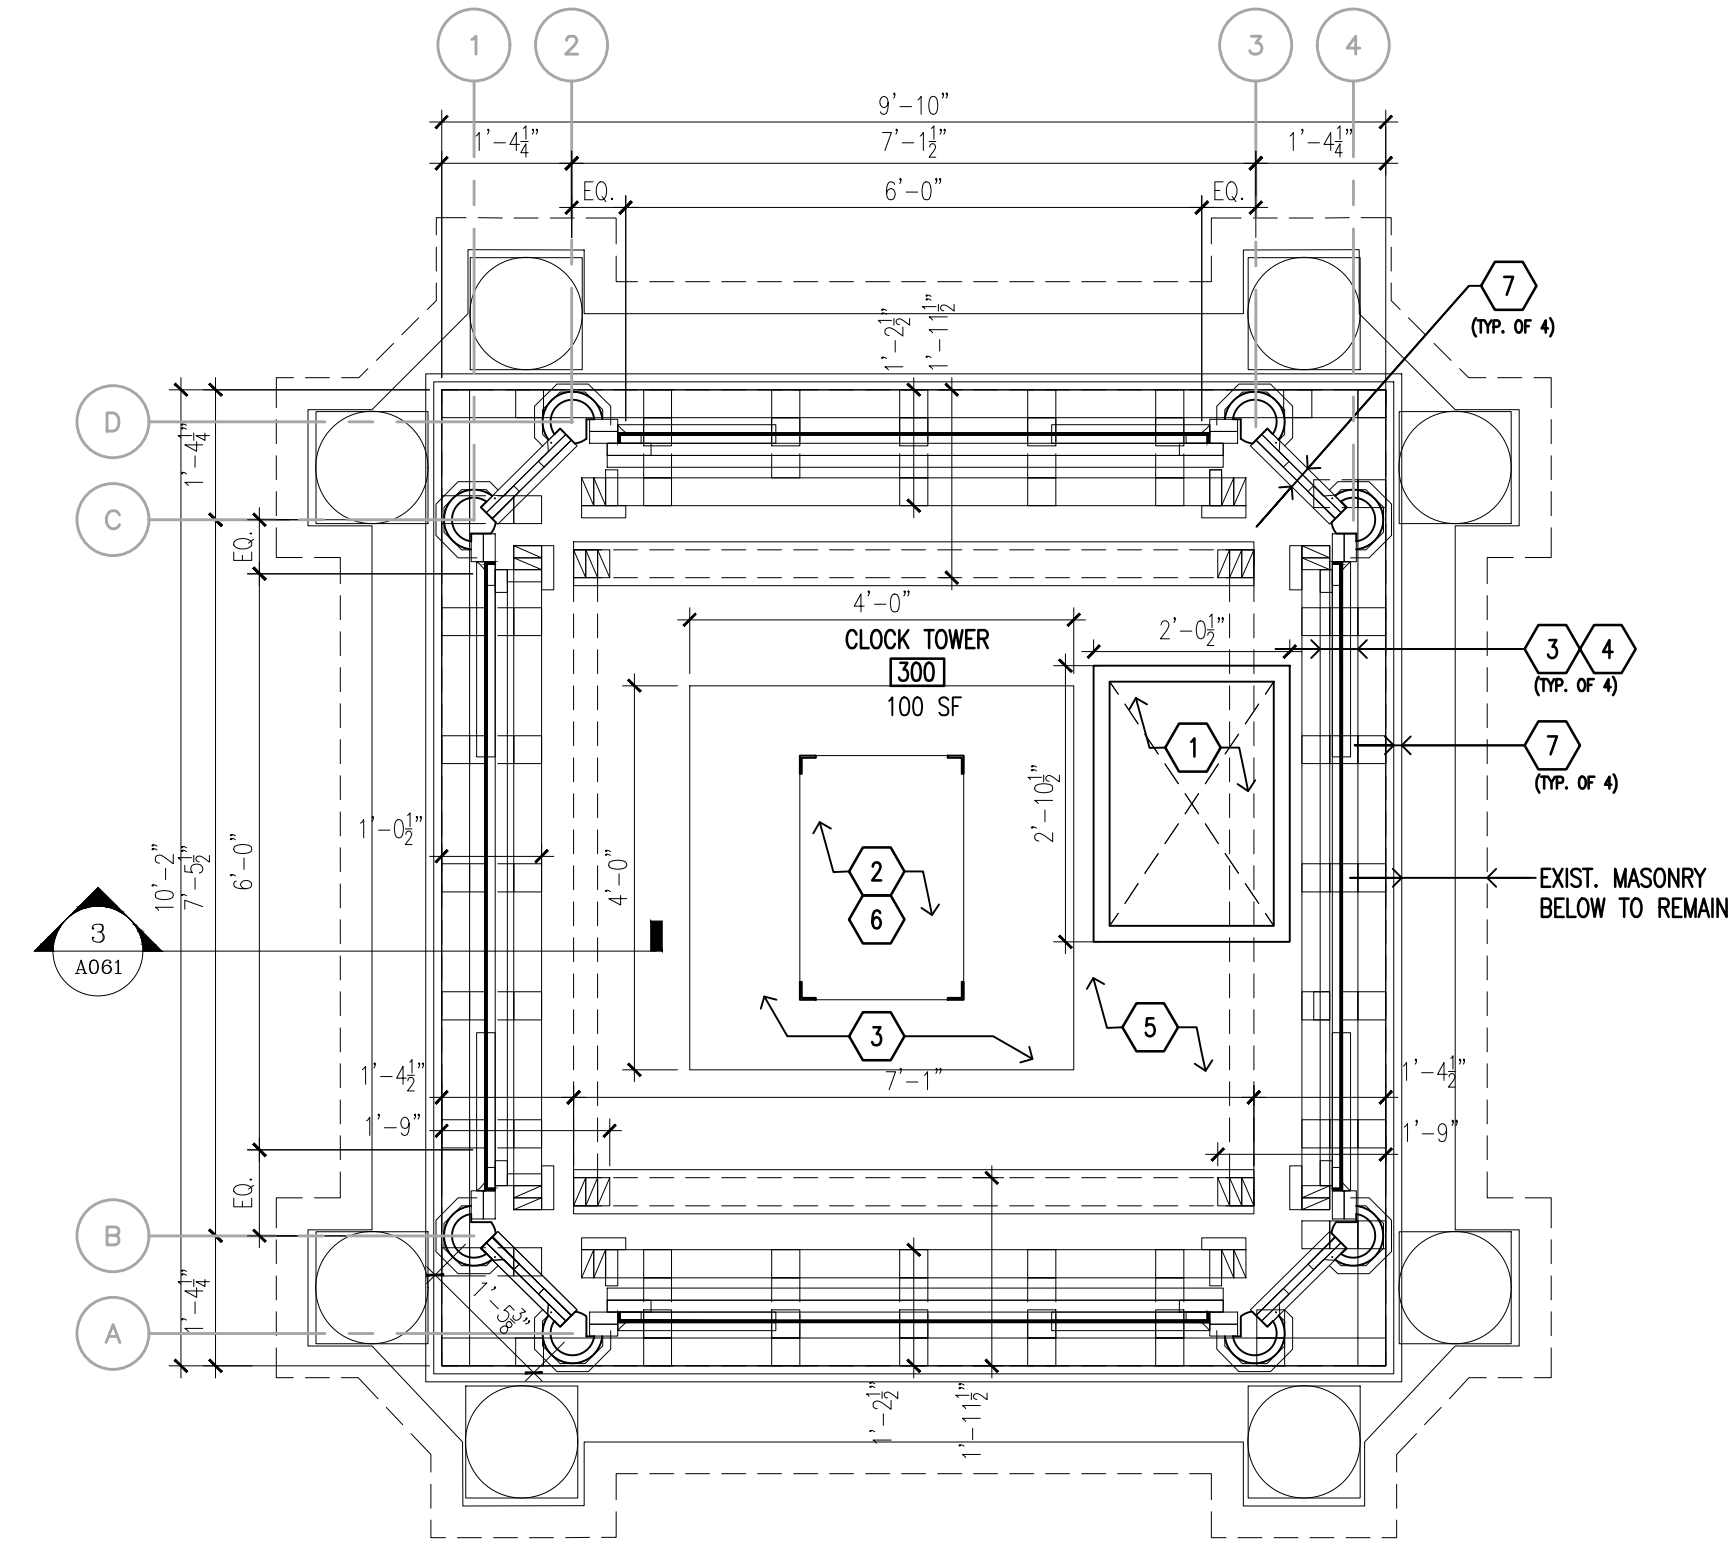
**2 3RD FLOOR CLOCK TOWER PLAN**  
SCALE: 1/2" = 1'-0"

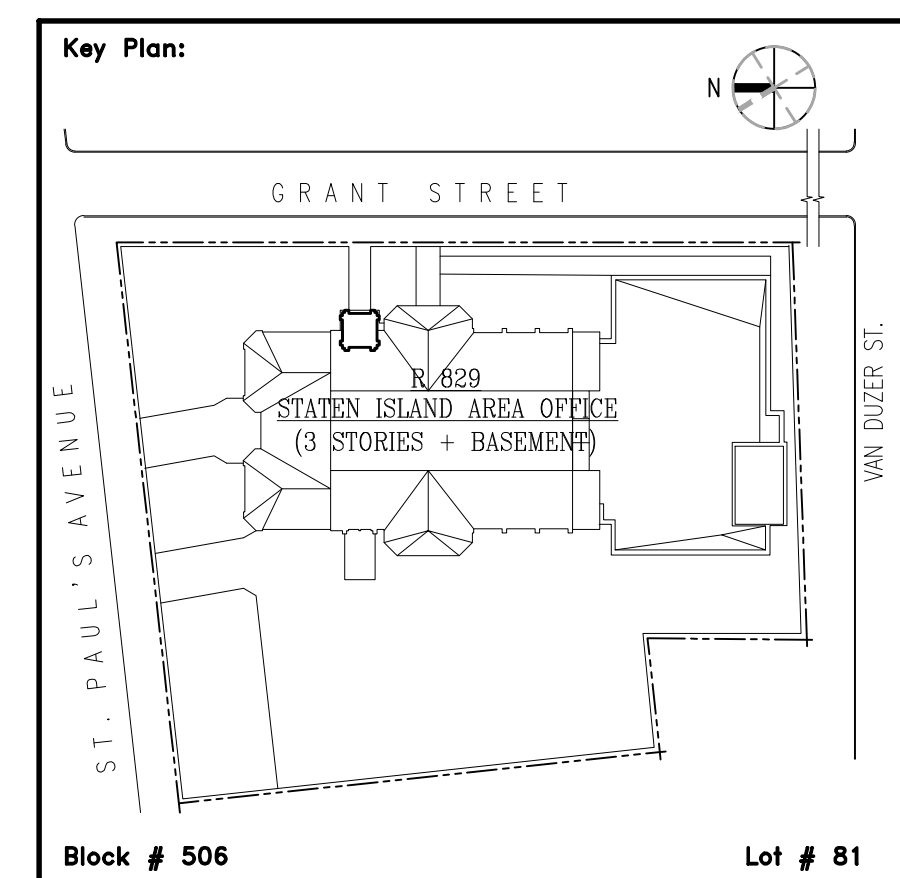
SCA Design Manager:	ASHRAF ELIAS, PE	
Project Architect/Engineer:	DAVID SAMMEL, RA	
Discipline Lead:	DAVID HUNSBERGER, RA	
Designer:	JUAN POLANCO	
Drawn by:	ALEXIS O'ROURKE	
Checked by:	DAVID SAMMEL, RA	
Design No or LLW No.:	Building ID:	Date:
D022292	R829	00/00/2023

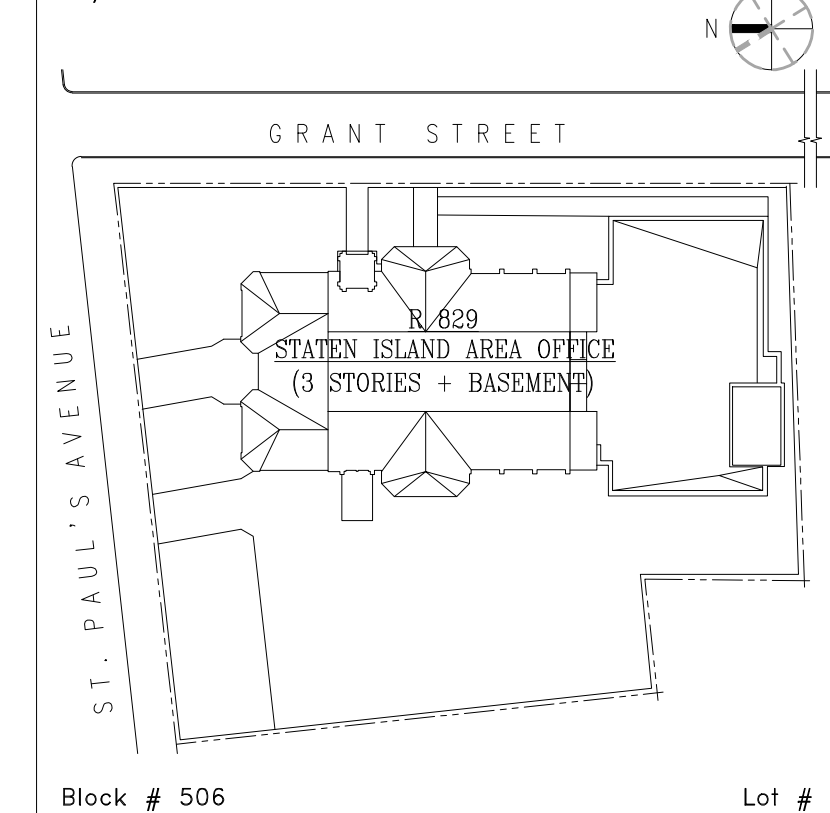
SCA Design Manager:	ASHRAF ELIAS, PE	
Project Architect/Engineer:	DAVID SAMMEL, RA	
Discipline Lead:	DAVID HUNSEBERGER, RA	
Designer:	JUAN POLANCO	
Drawn by:	ALEXIS O'ROURKE	
Checked by:	DAVID SAMMEL, RA	
Design No or LLW No.:	Building ID:	Date:
D022292	R829	00/00/2023

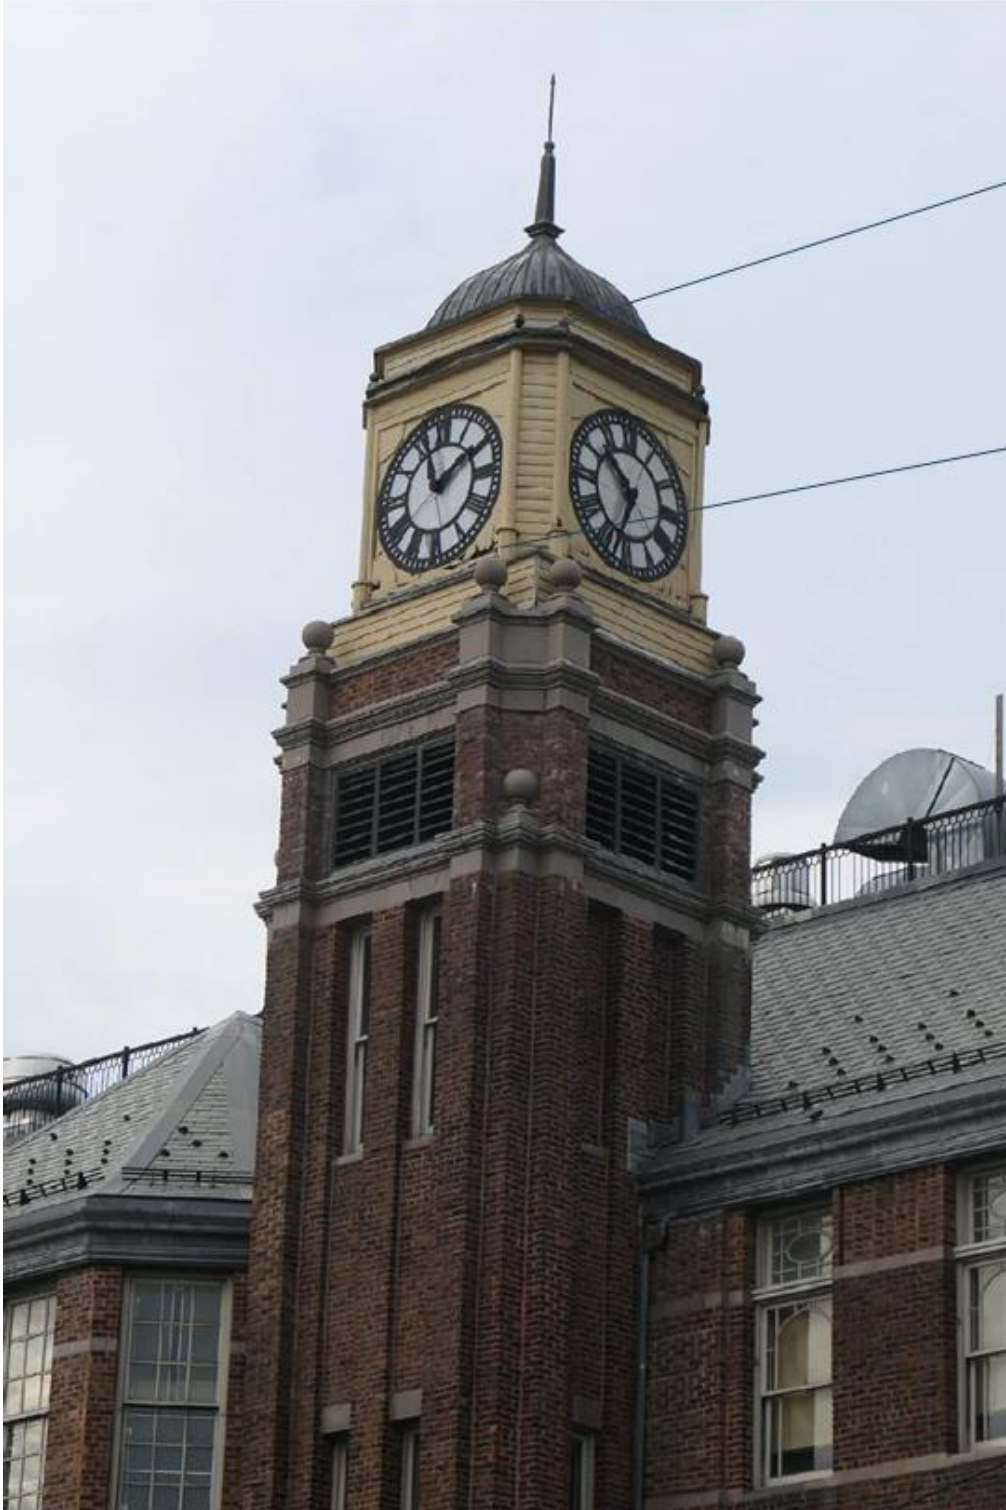
Wood soffit is damaged and loose.

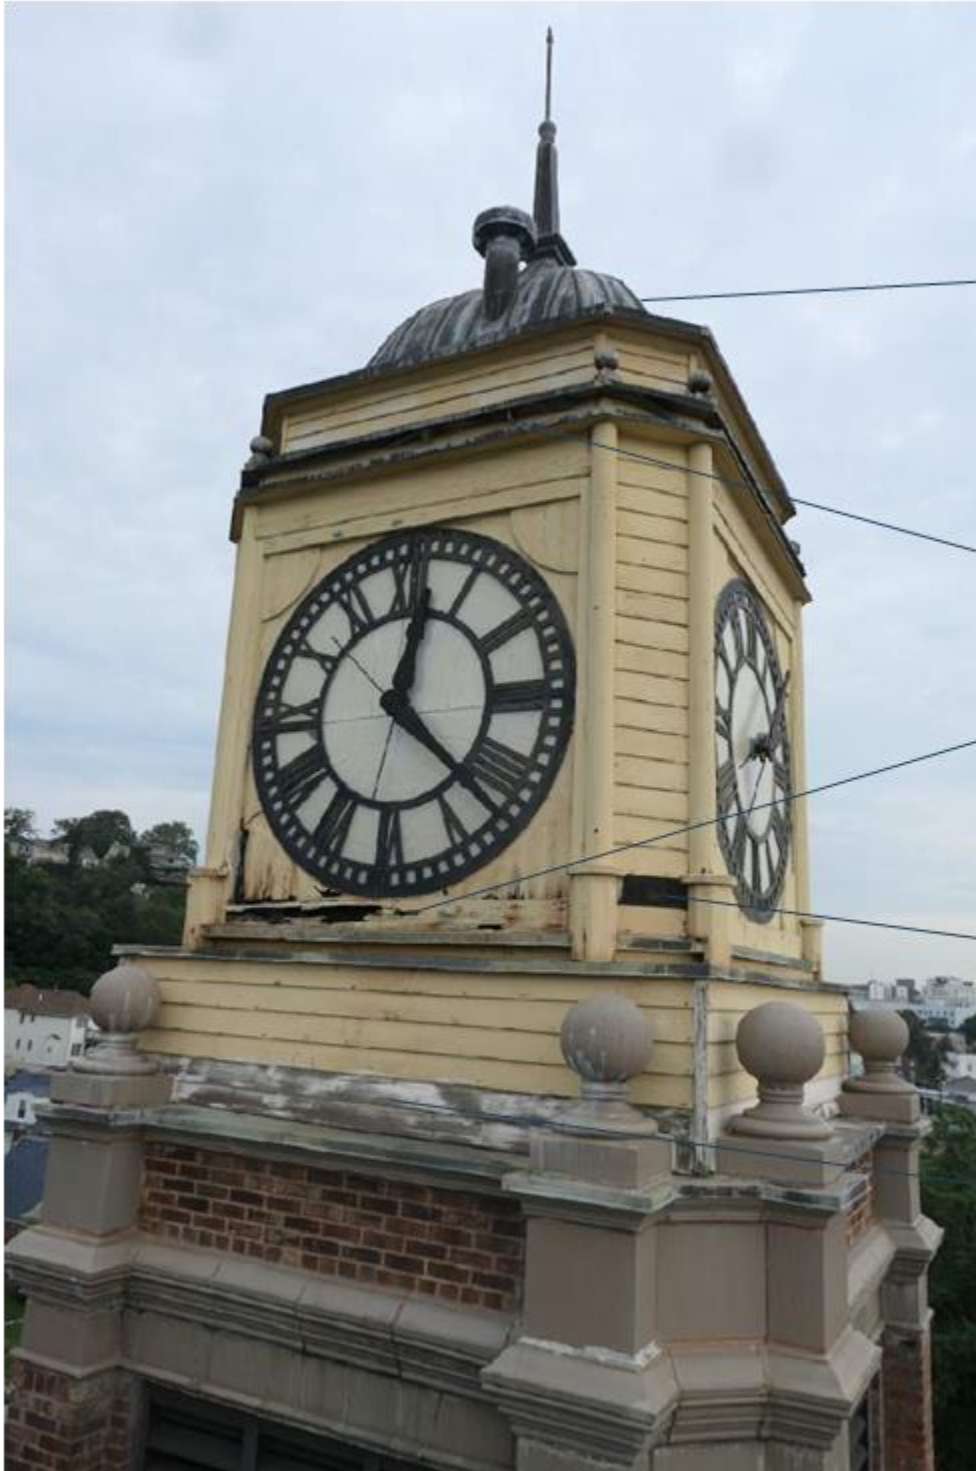
Copper roof in good condition.

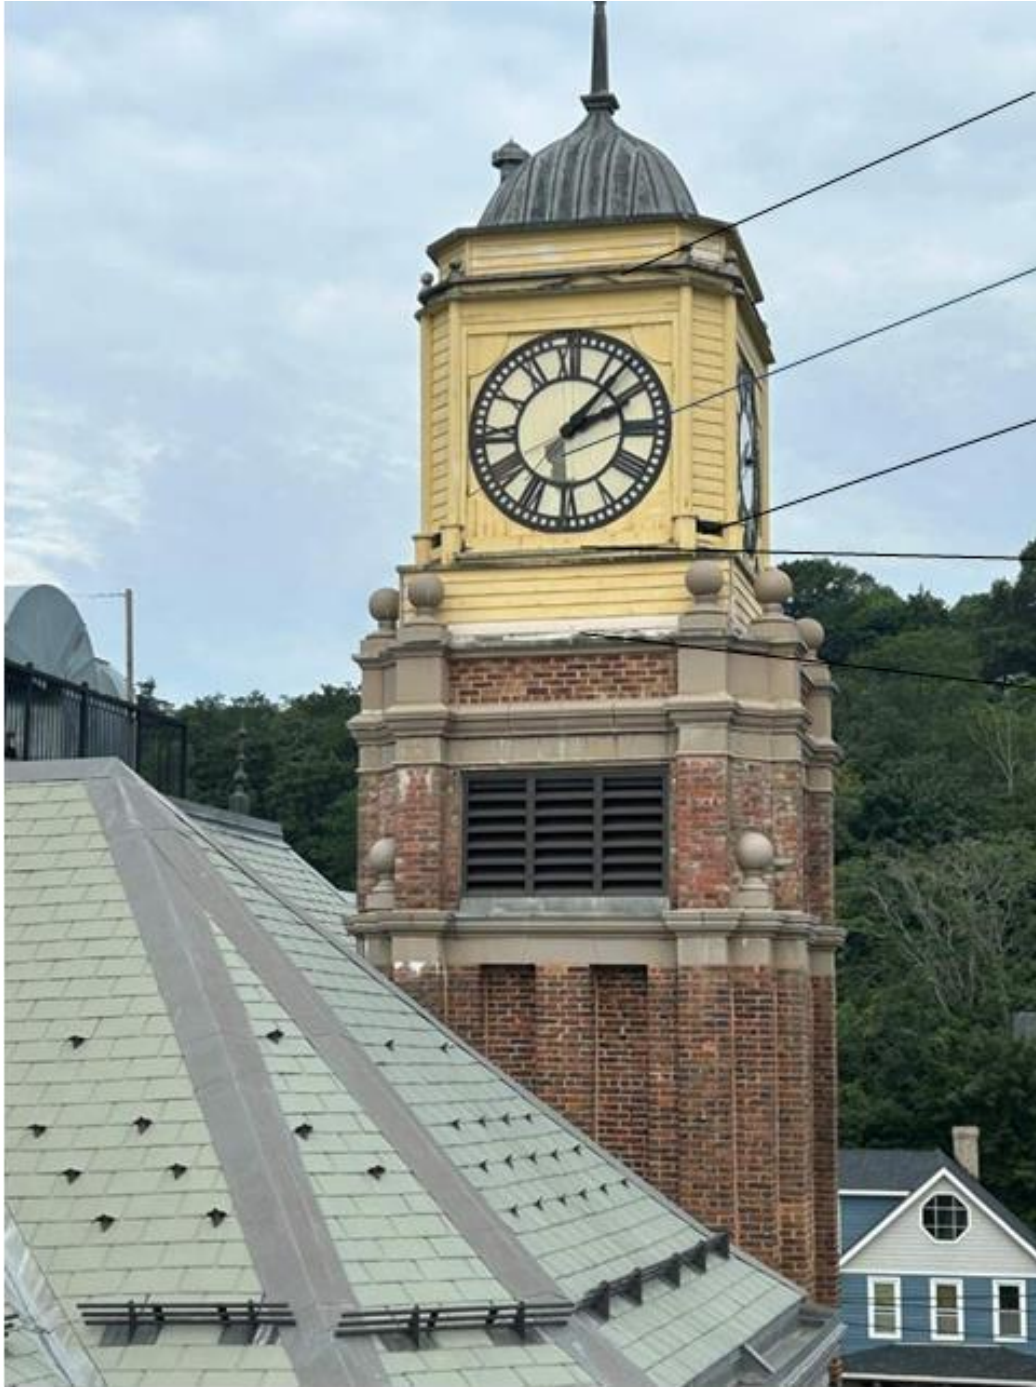
Damage to soffit at ledges.

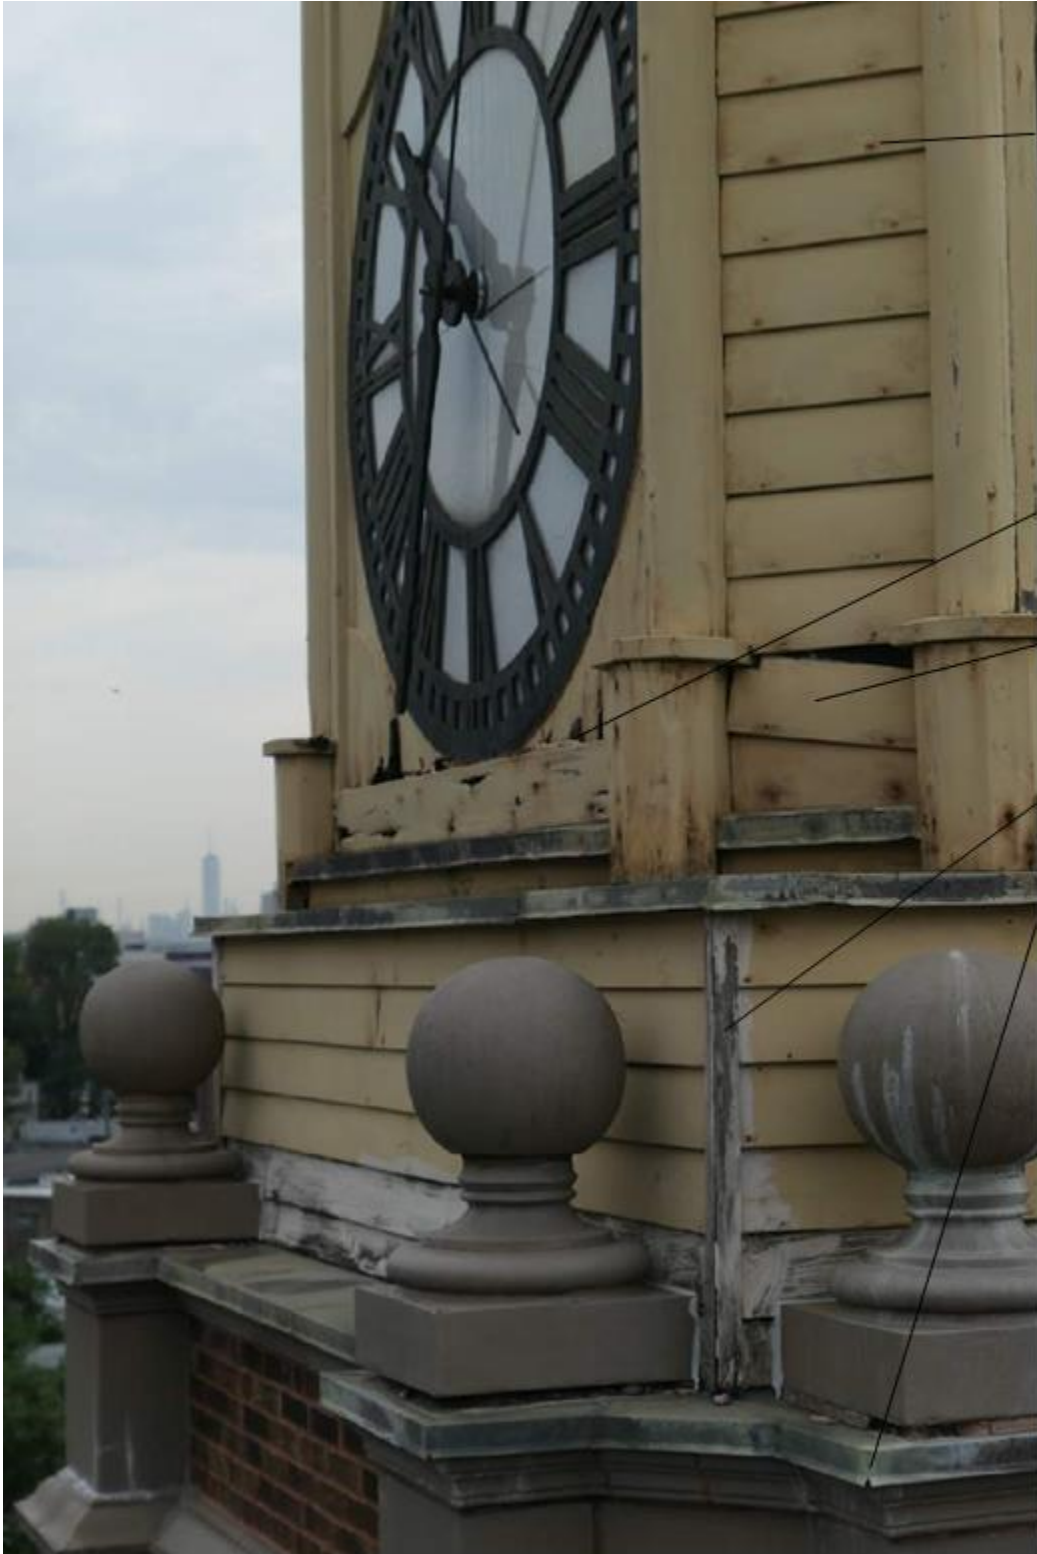
All siding is faded with fasteners rusting and bleeding through finish. Paint required.

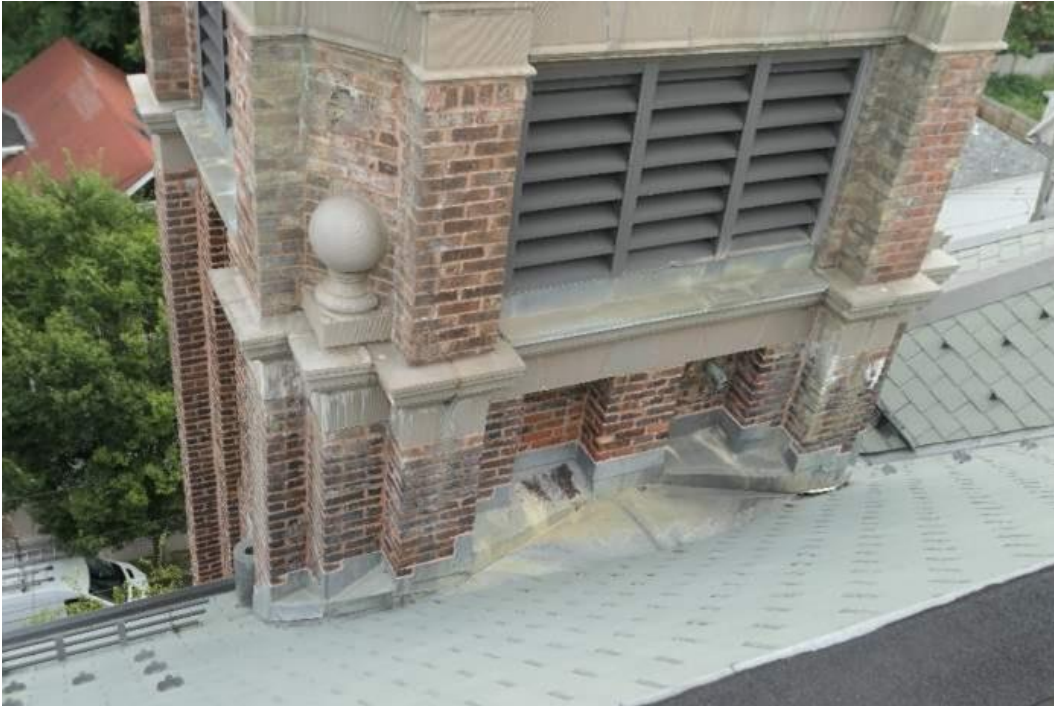
Photo 5 – Masonry, flashing and roofing below cupola in good condition.

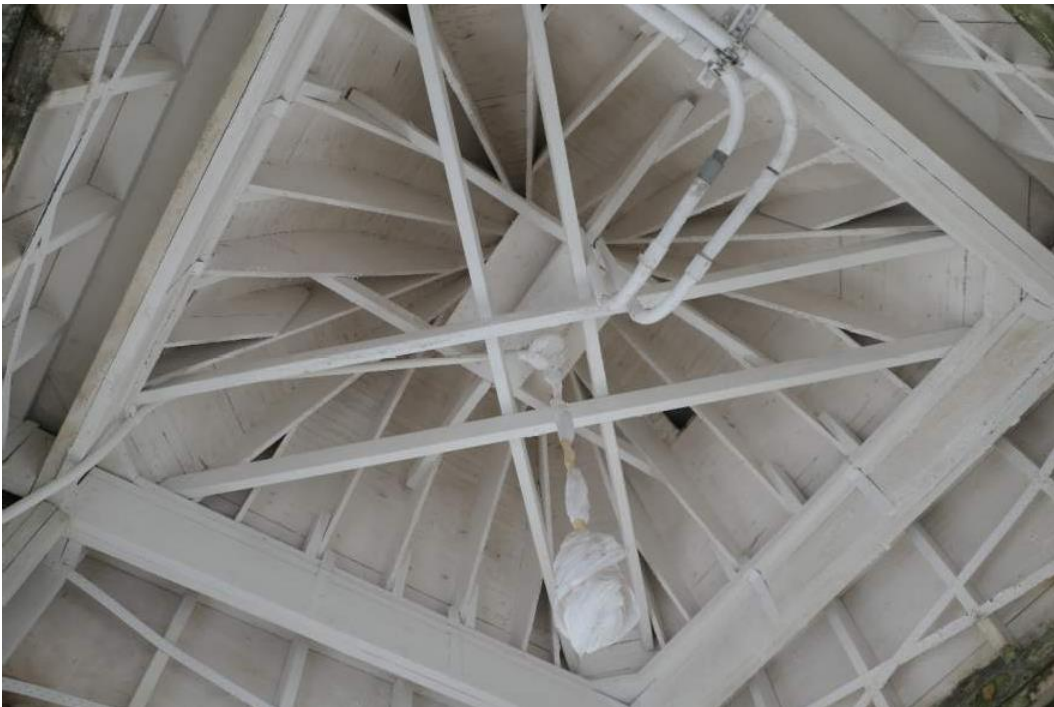
Photo 6 – Upper roof framing seen from the interior. No water staining or areas of rotted wood observed. No leaks from copper roofing. Light fixture is wrapped in plastic.

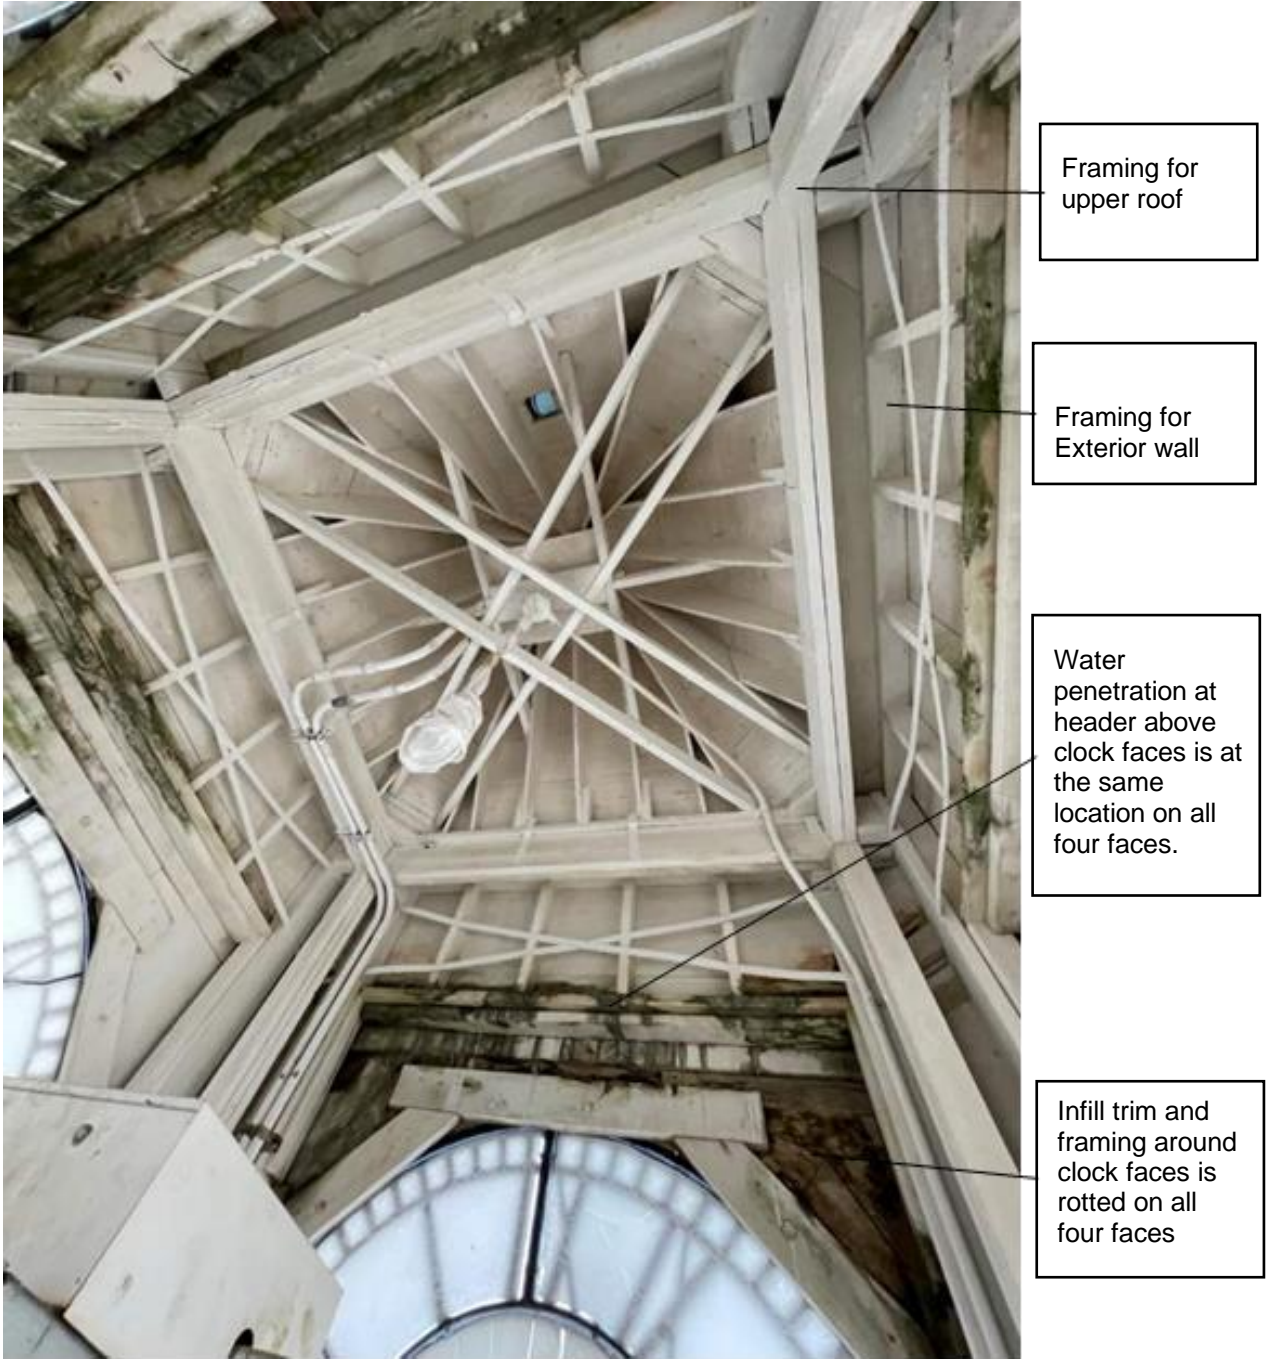
Photo 7 – View of interior framing and water penetration locations.

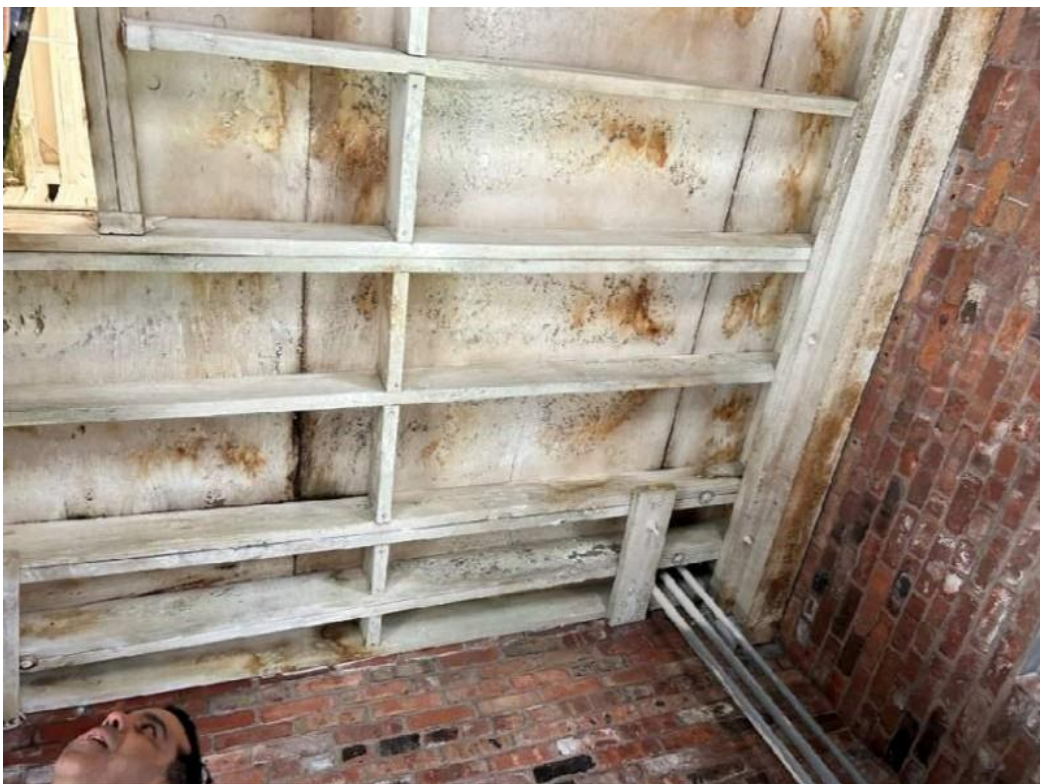
Photo 11 – View of framing and underside of plywood cupola flooring. Water staining and areas of rotted wood observed. This is consistent on all four faces. Trim and panel infill around clock faces is severely rotted.

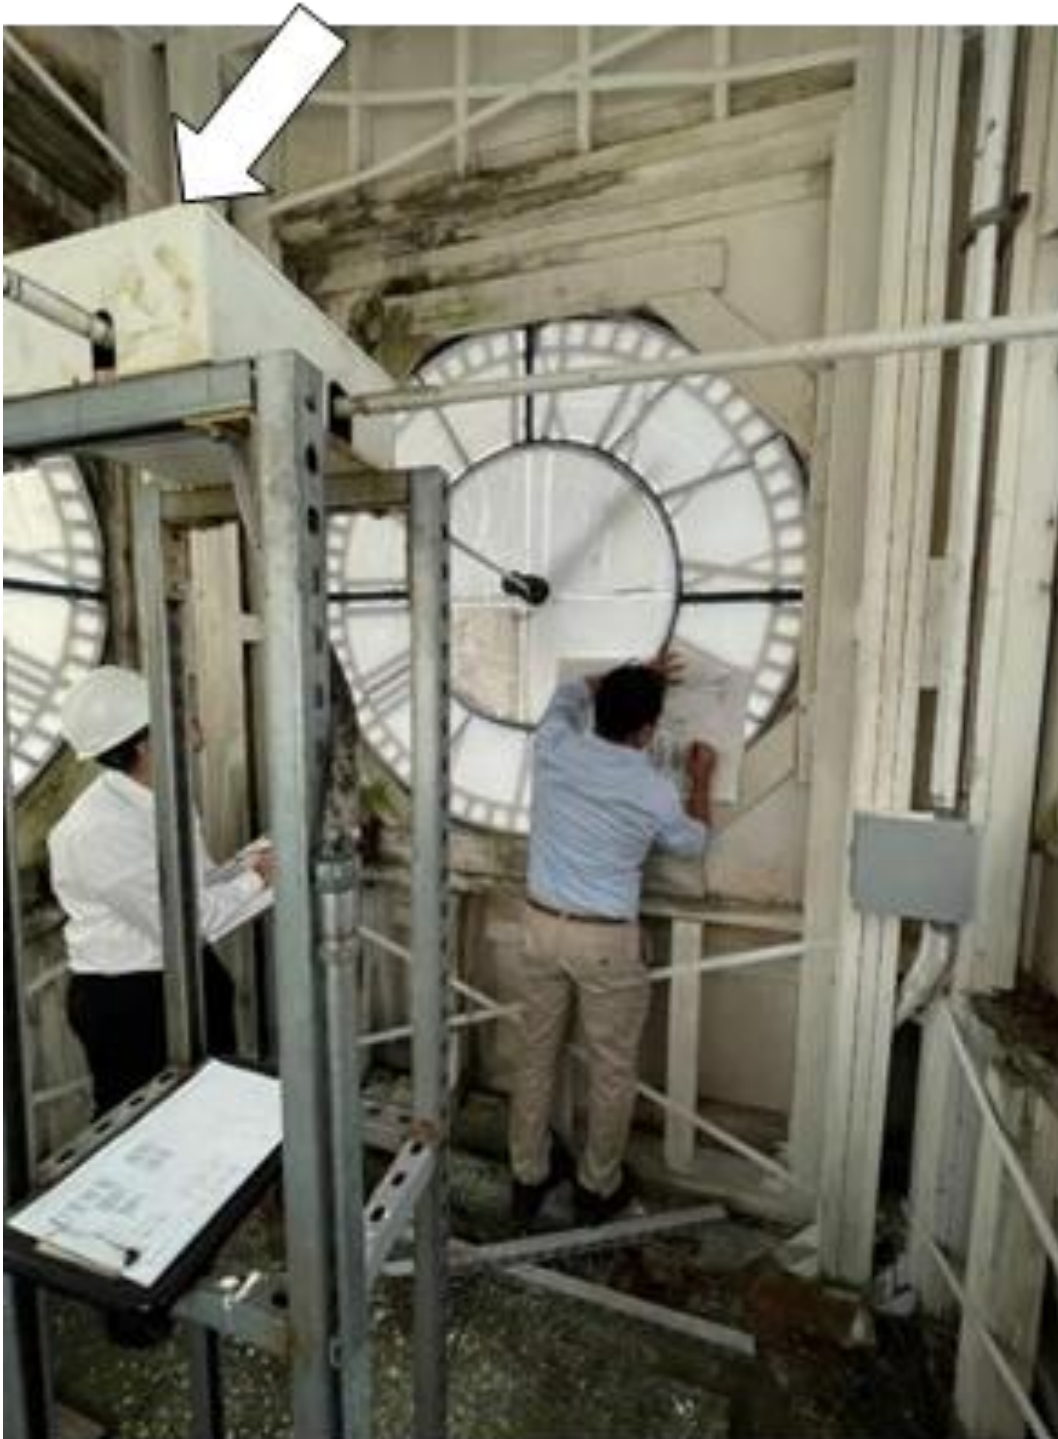
Photo 12 – Central clock mechanism controls hands on all four faces. Clocks are not working.

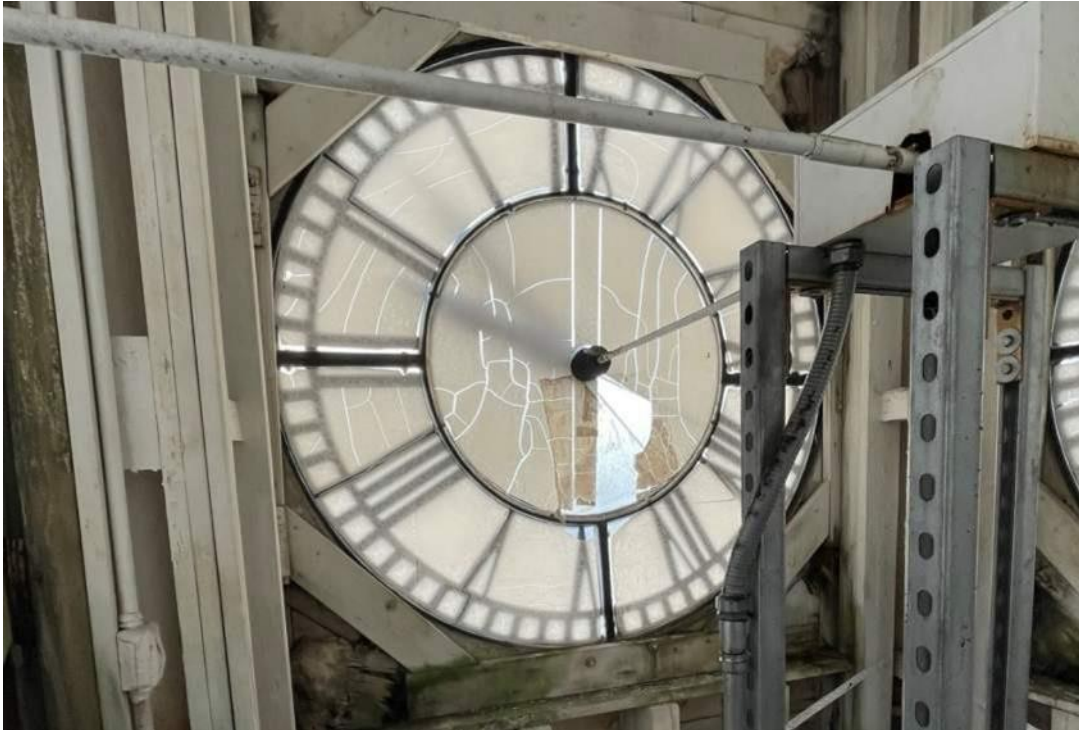
Photo 13 – Damaged clock face translucent film.

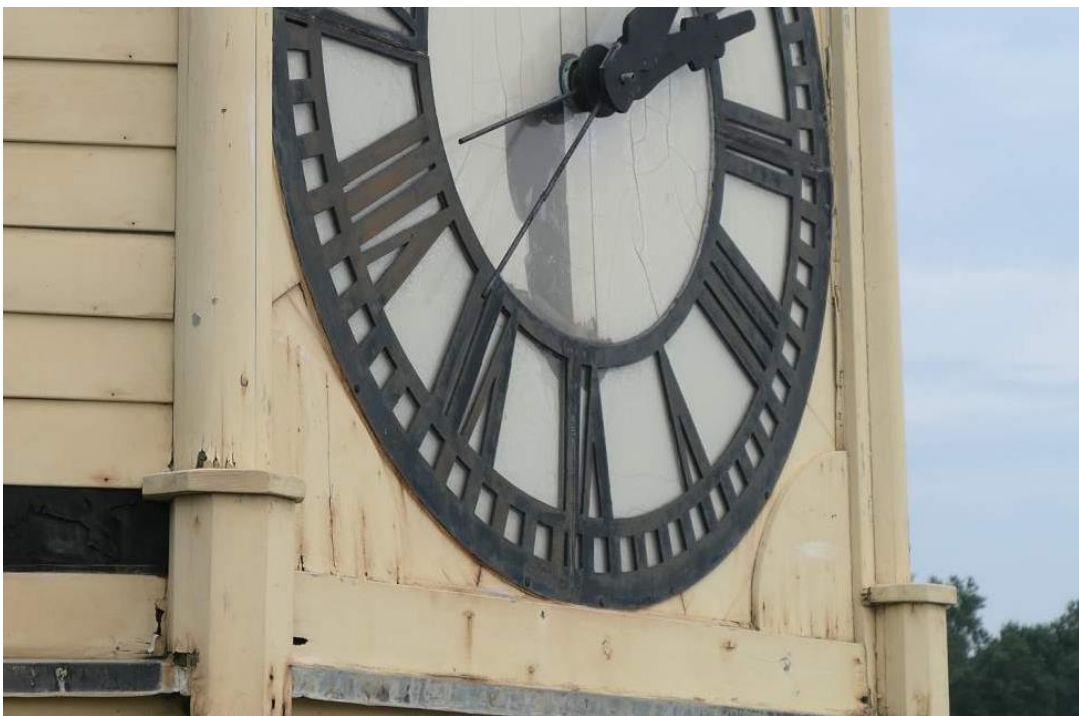
Photo 14 – Exterior metal dial, numerals and clock hands have a faded finish with some pitting noted. Refinish.

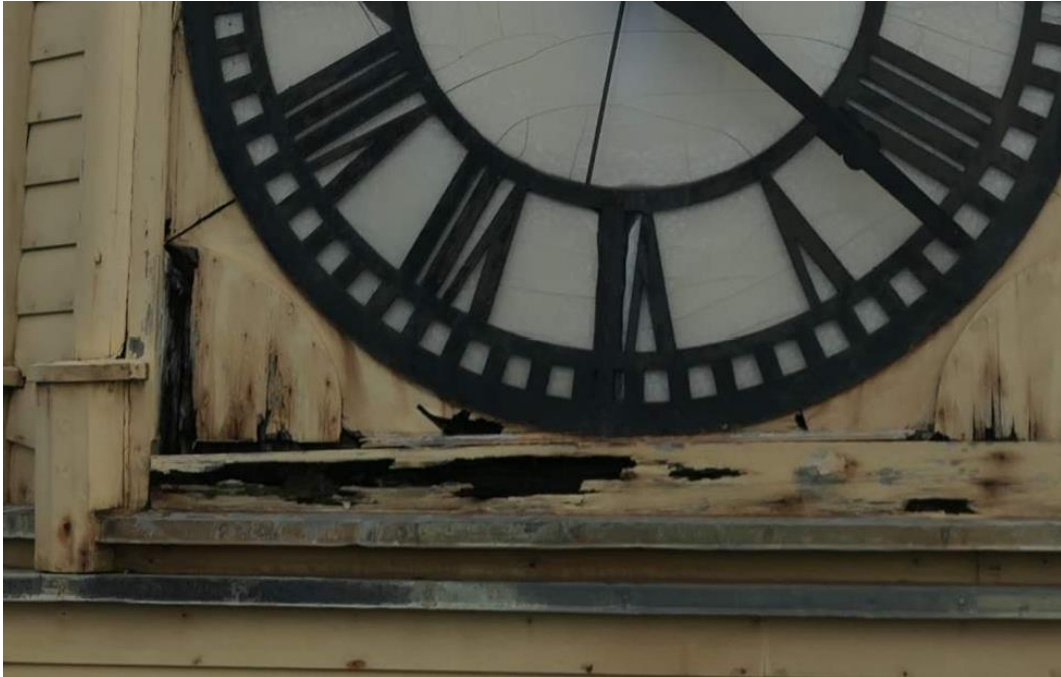
**Photo 15 – Faded clock dial and rotted trim on south elev.**

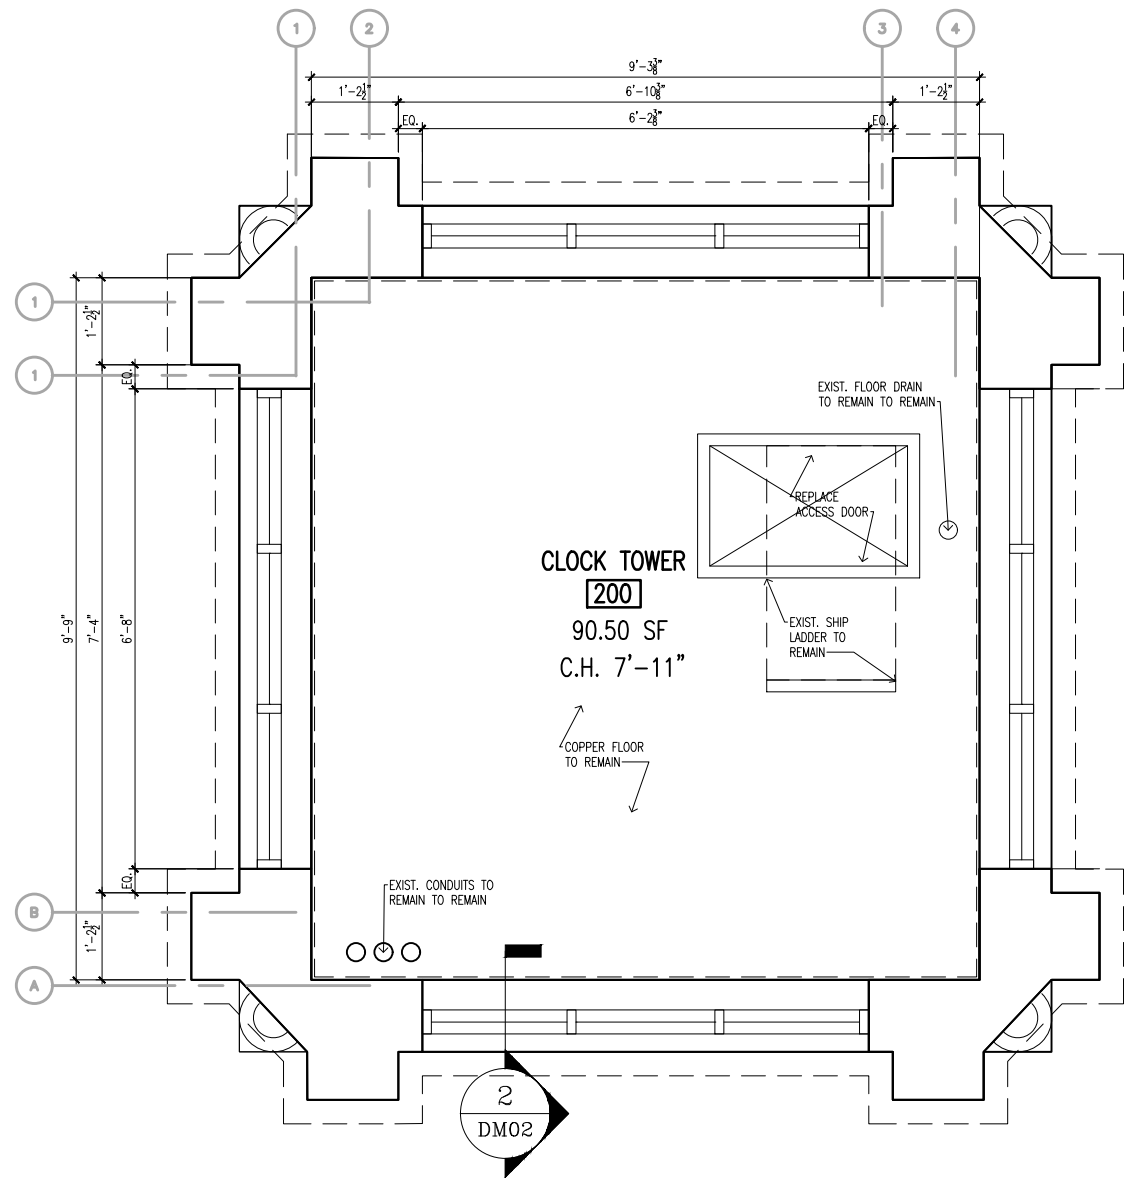
**1 DAMAGE MAPPING- 2ND FLR. PLAN**  
SCALE: 3/8" = 1'-0"

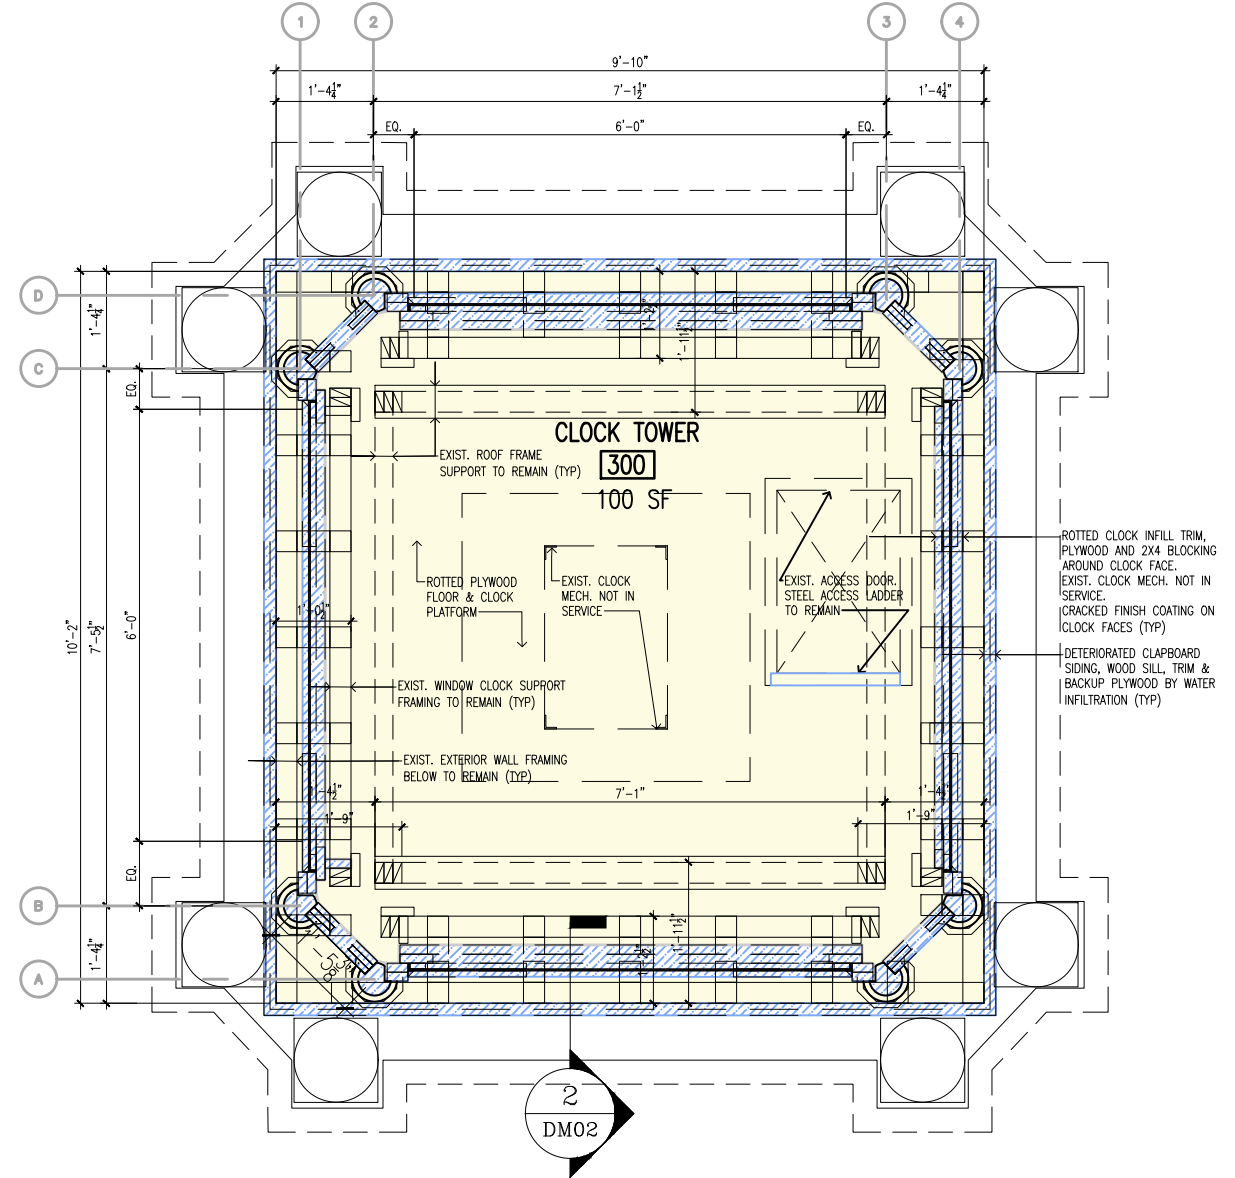
**2 DAMAGE MAPPING- 3RD FLR. PLAN**  
SCALE: 3/8" = 1'-0"
