# Capital Improvement Program

Architecture & Engineering

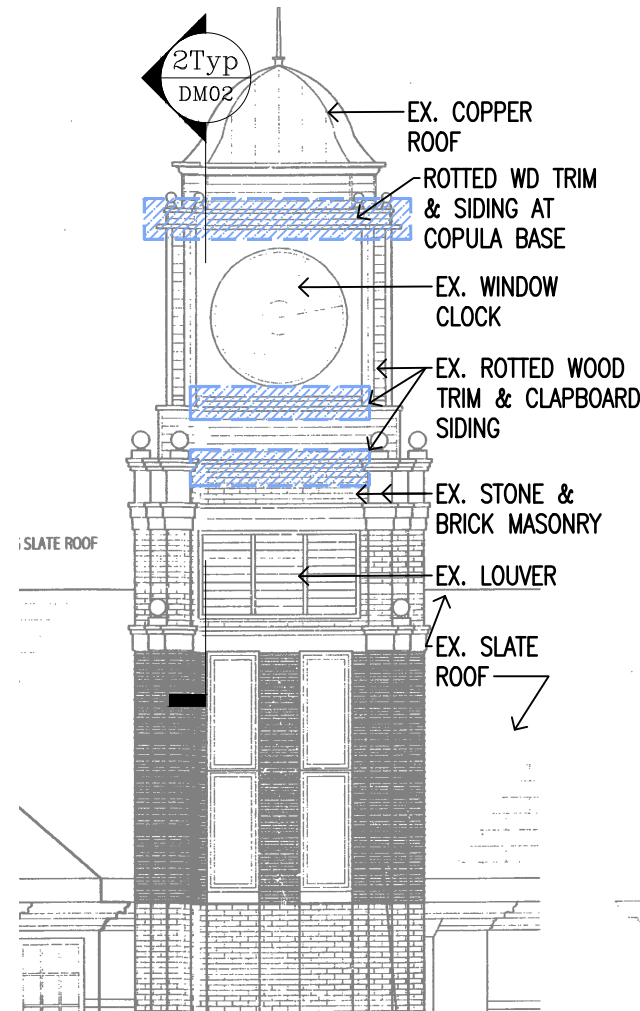
**2** DAMAGE MAPPING— NORTH ELEV.  
SCALE: 1/8" = 1'-0"

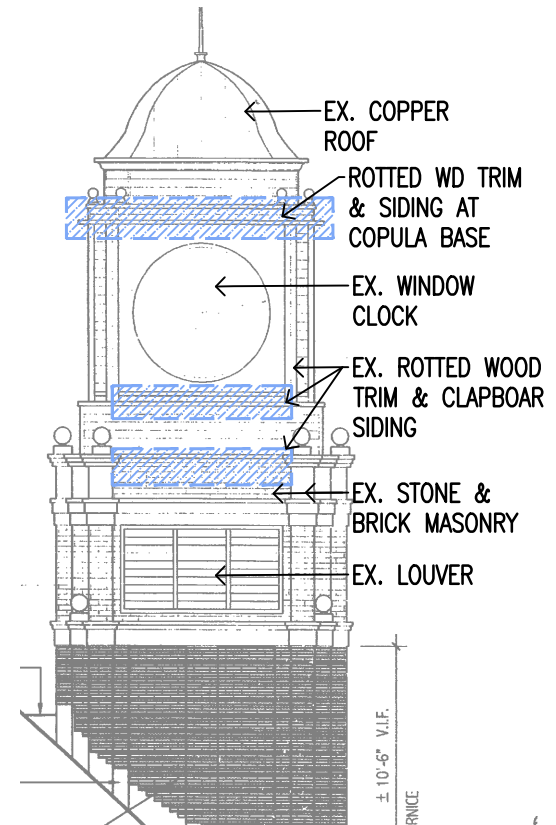
**3** DAMAGE MAPPING— SOUTH ELEV.  
SCALE: 1/8" = 1'-0"

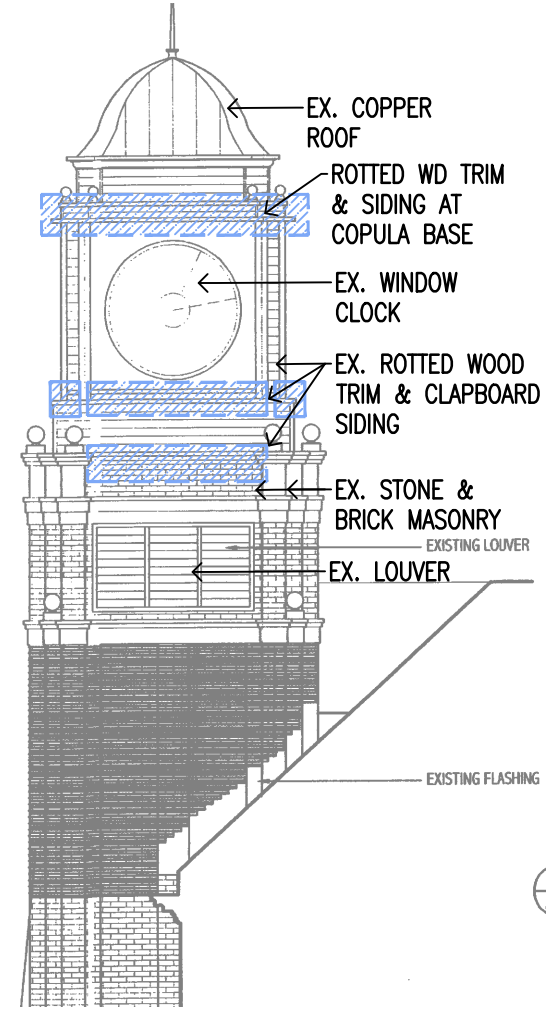
**4** DAMAGE MAPPING— EAST ELEV.  
SCALE: 1/8" = 1'-0"

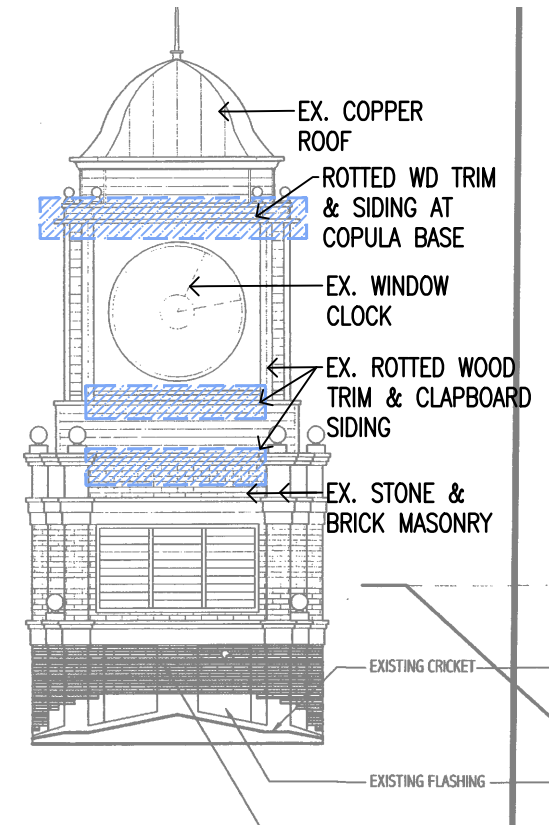
**5** DAMAGE MAPPING— WEST ELEV.  
SCALE: 1/8" = 1'-0"

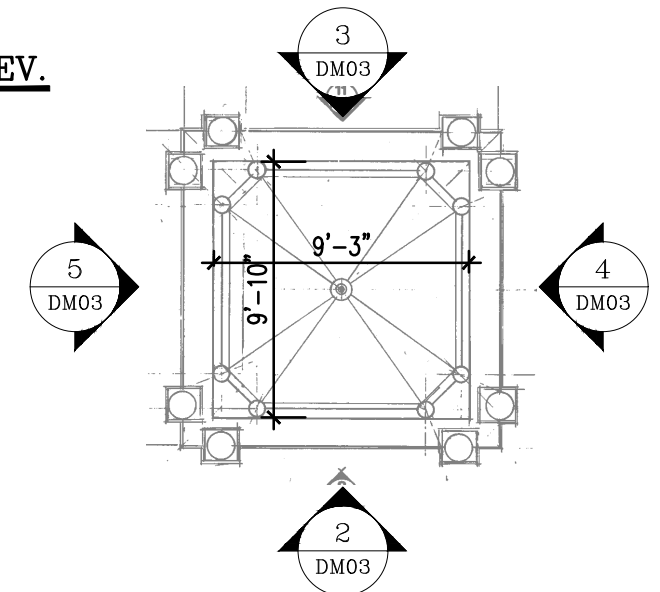
**1** KEY PLAN  
SCALE: 3/8" = 1'-0"

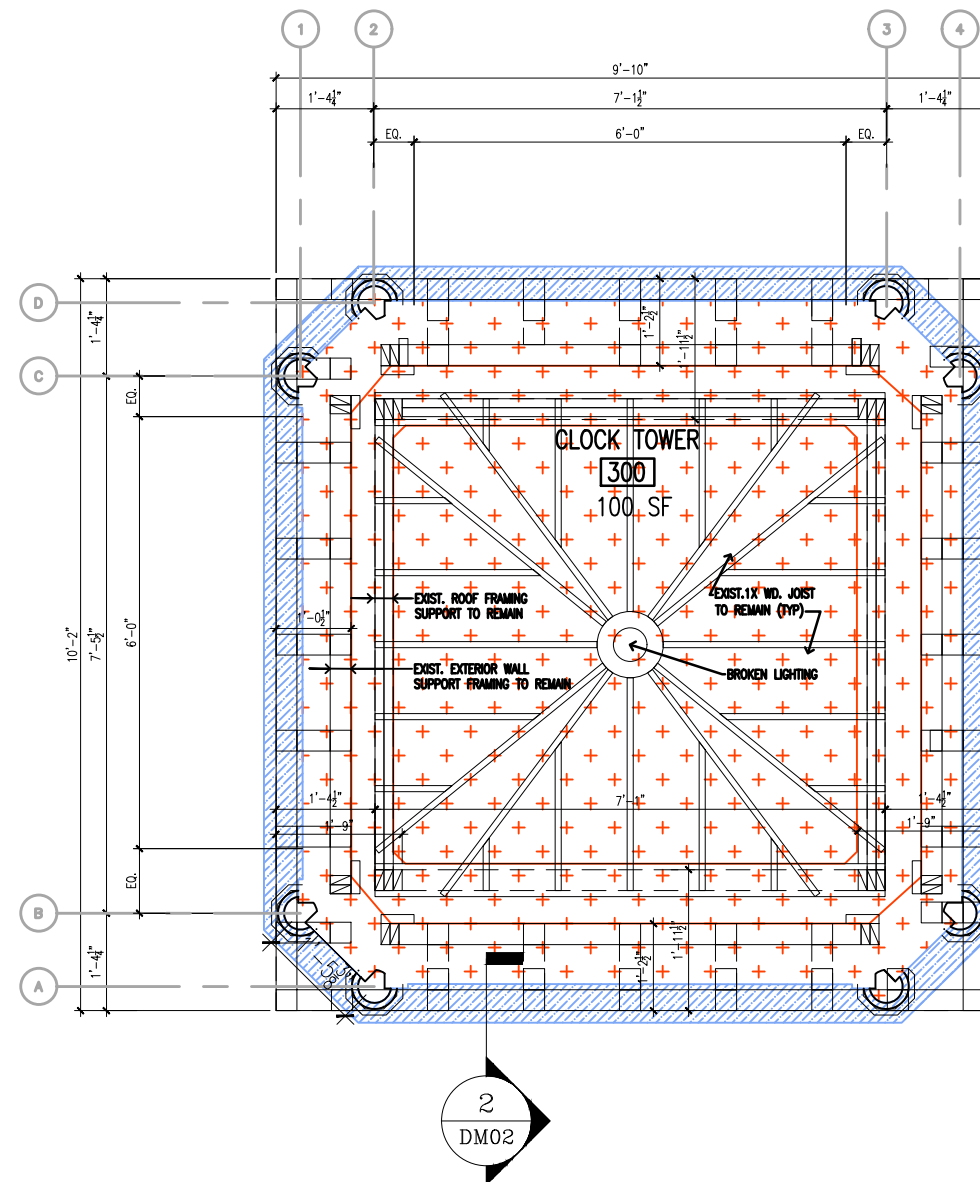
3 **3RD FLR. CLOCK TOWER- RCP**  
SCALE: 3/8" = 1'-0"

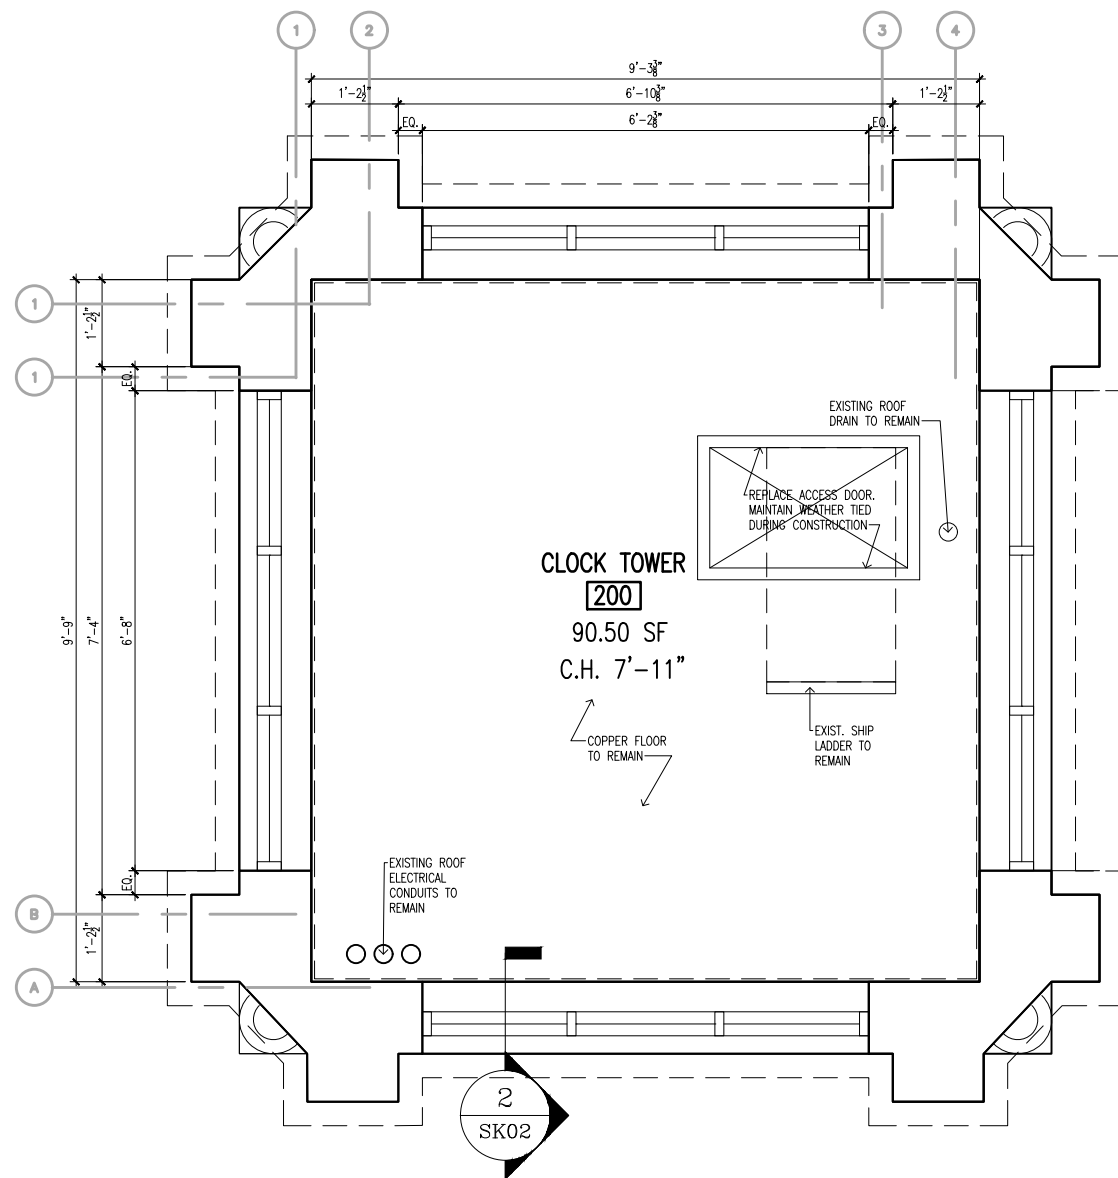
**1** RECOMMENDED WORK- 2ND FLR. PLAN  
 SCALE: 3/8" = 1'-0"

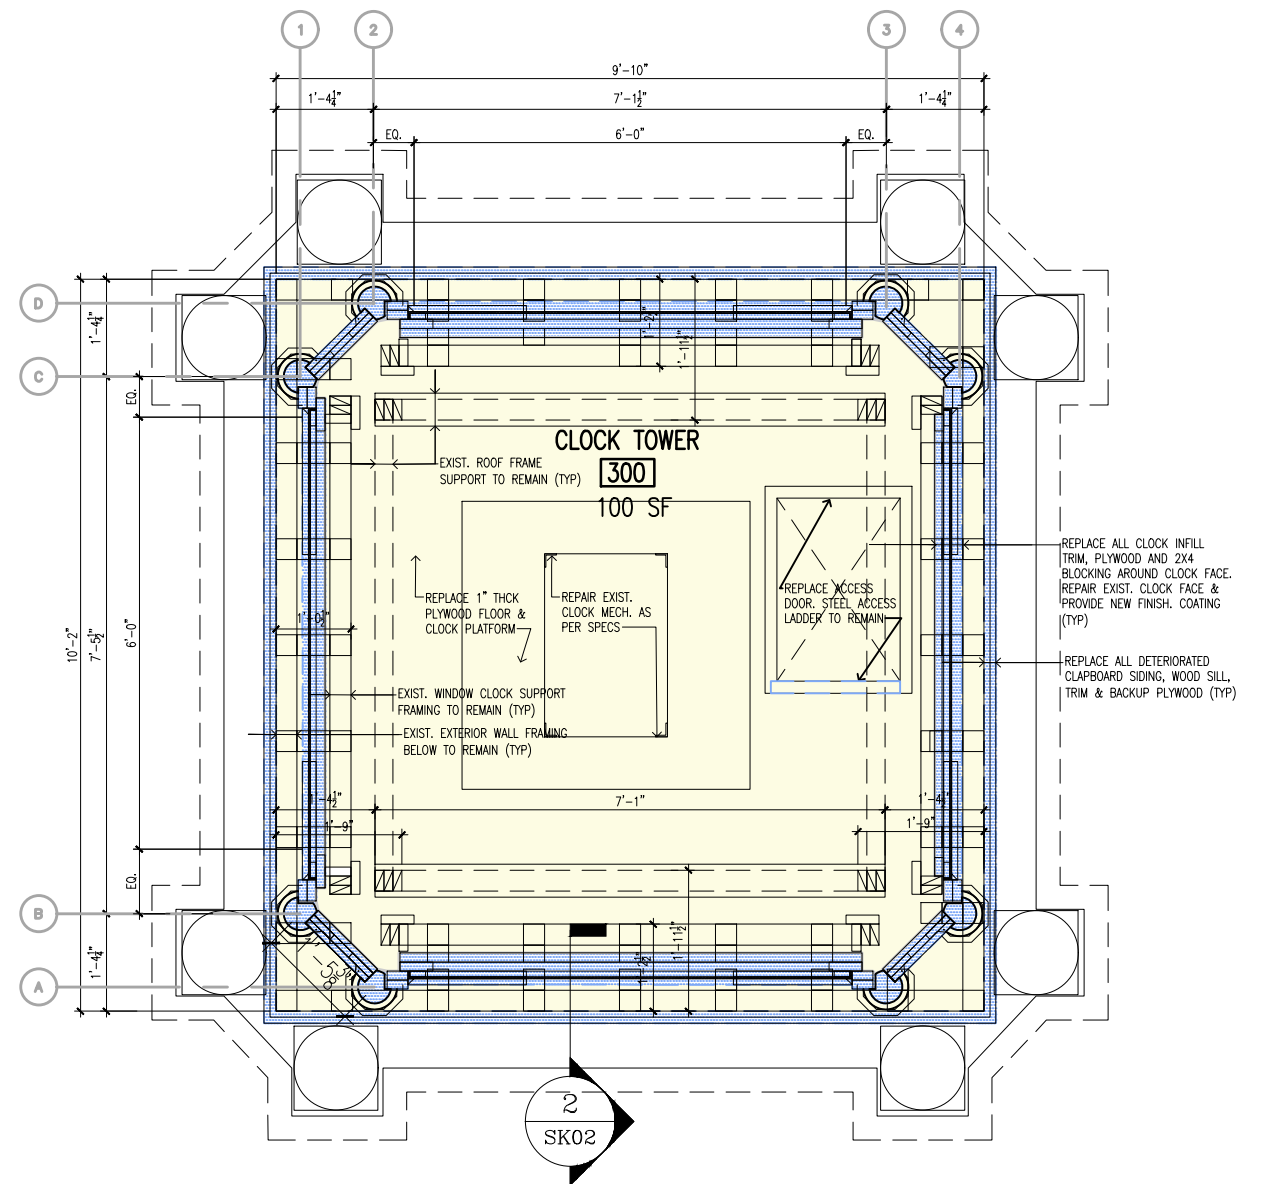
**2** RECOMMENDED WORK- 3RD FLR. PLAN  
 SCALE: 3/8" = 1'-0"

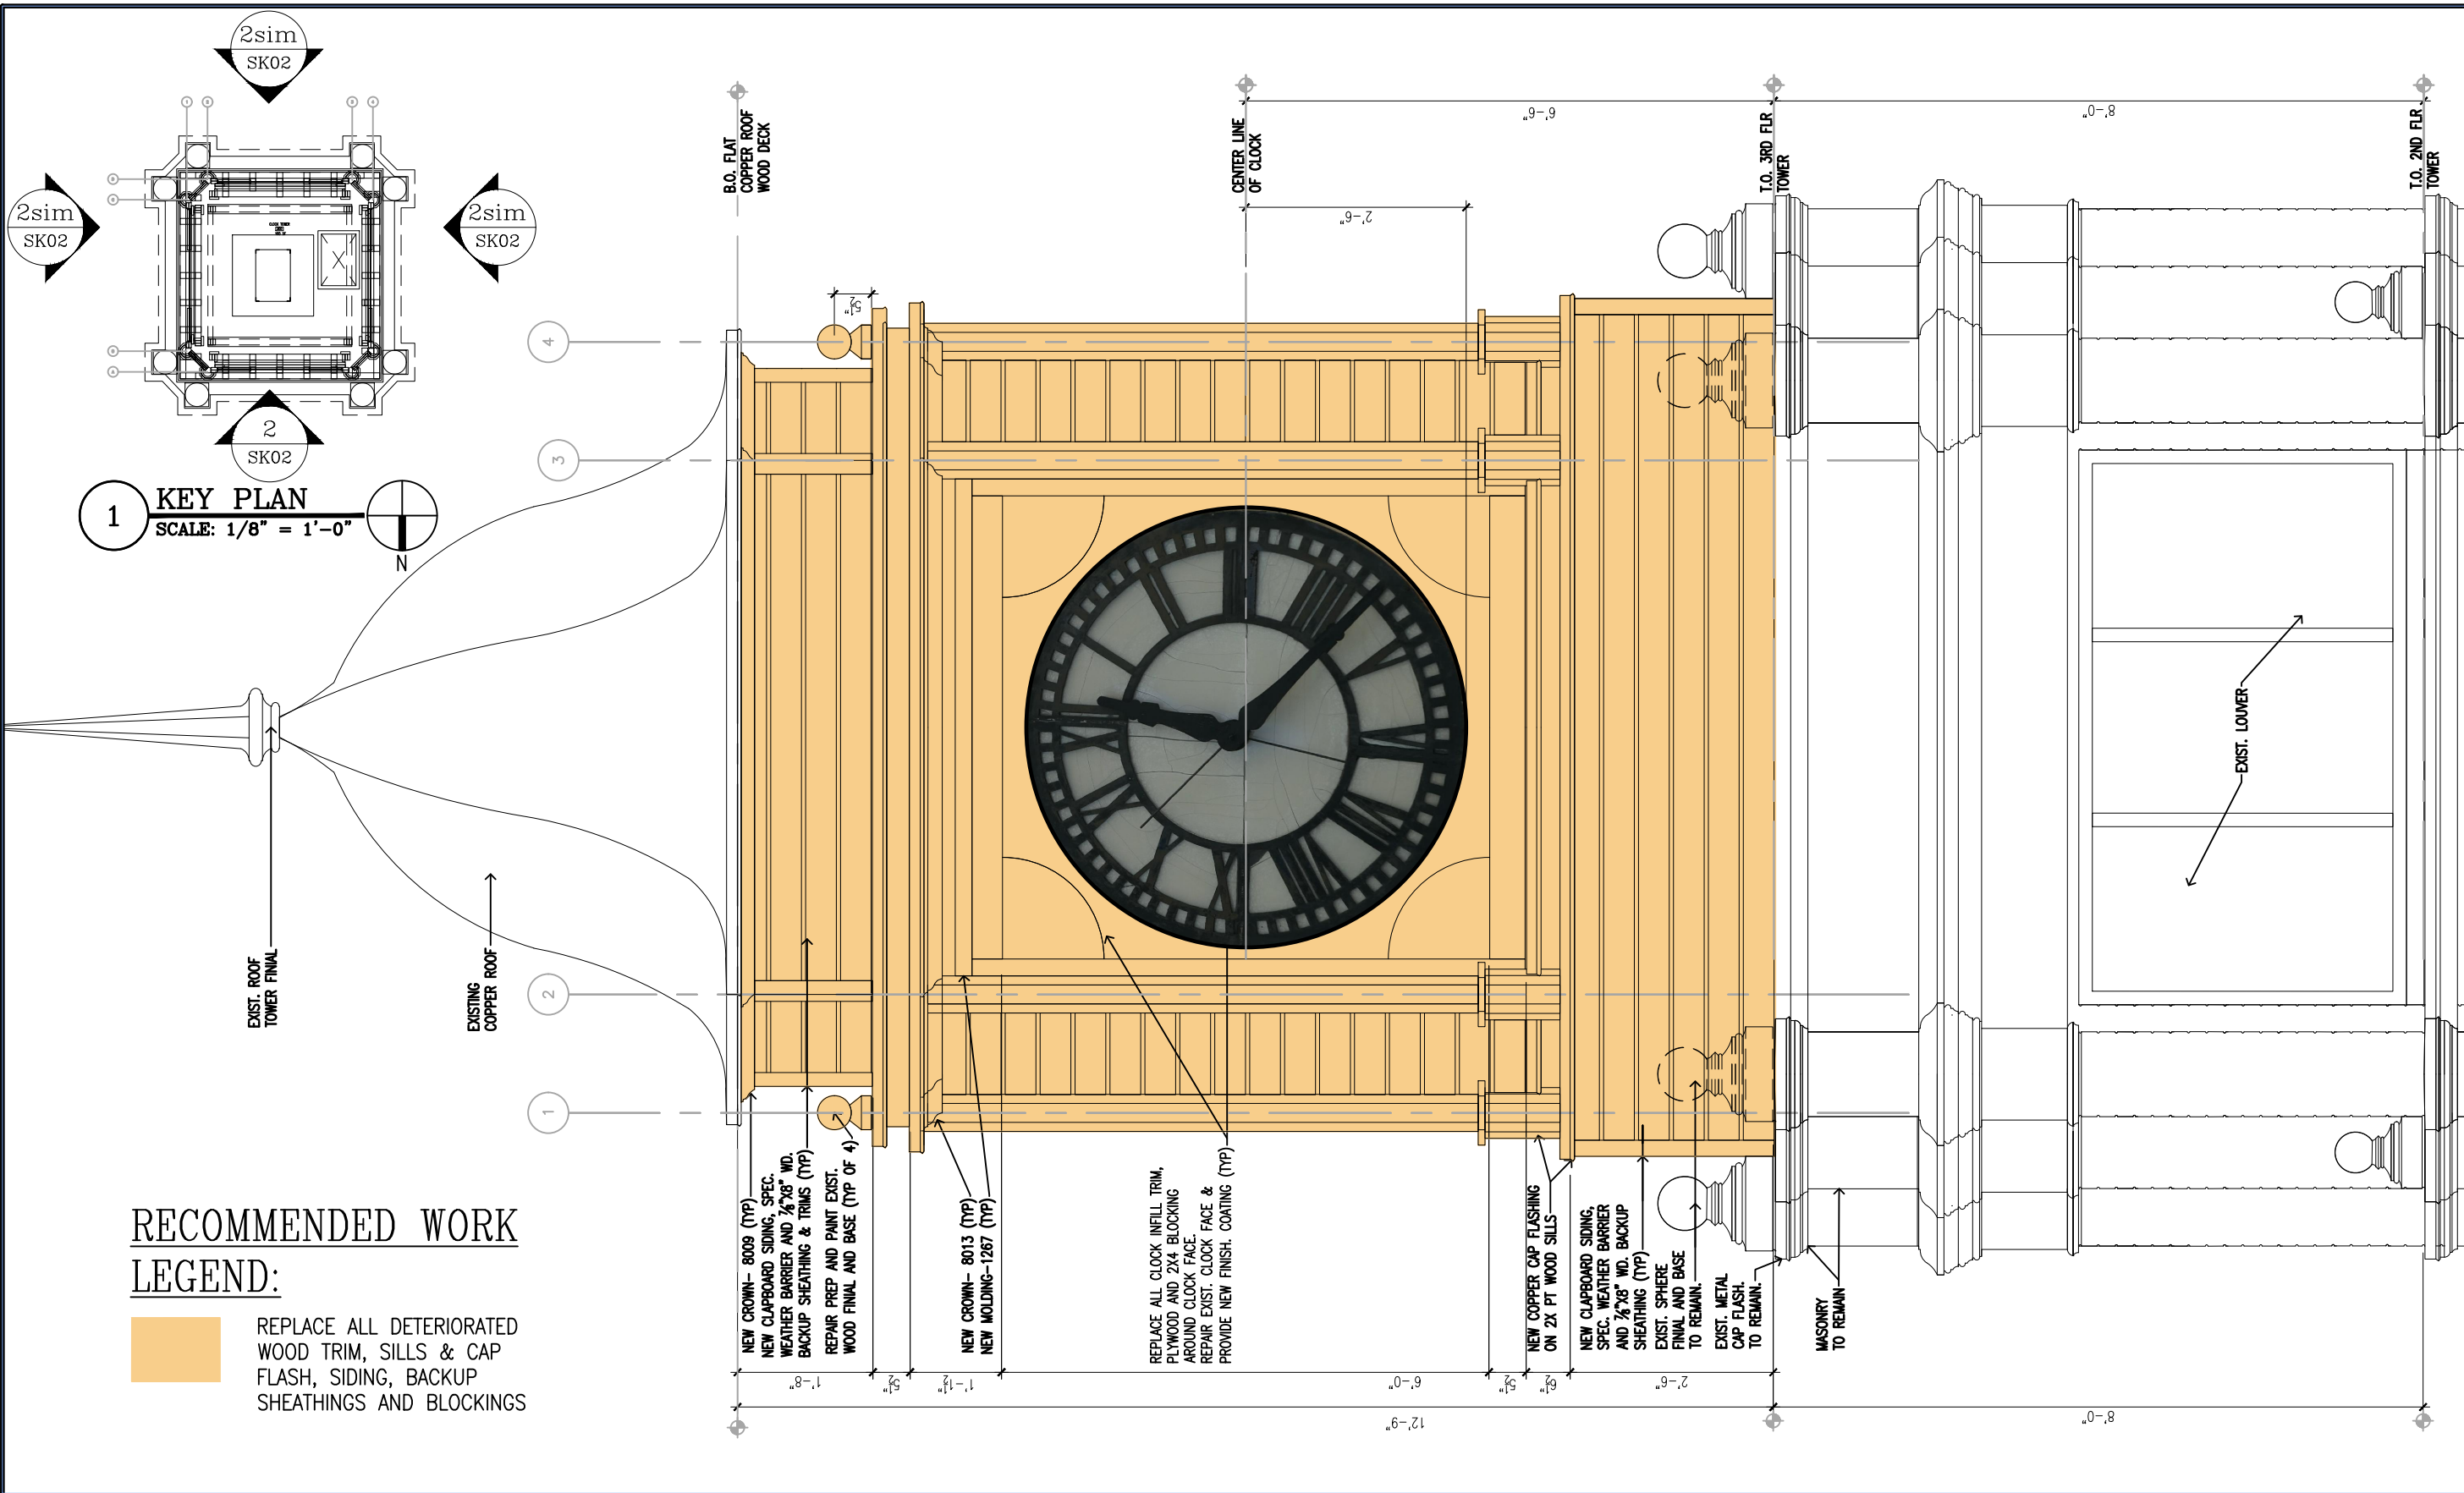
Project: PS 829 STATEN ISLAND AREA OFFICE  
TOWER RED DOT

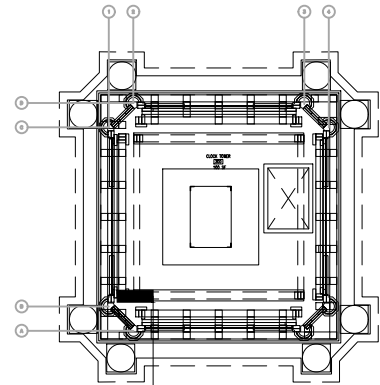
REPLACE ALL DETERIORATED WOOD TRIM, SILLS & CAP FLASH, SIDING, BACKUP SHEATHINGS AND BLOCKINGS
