# Capital Improvement Program

Architecture & Engineering

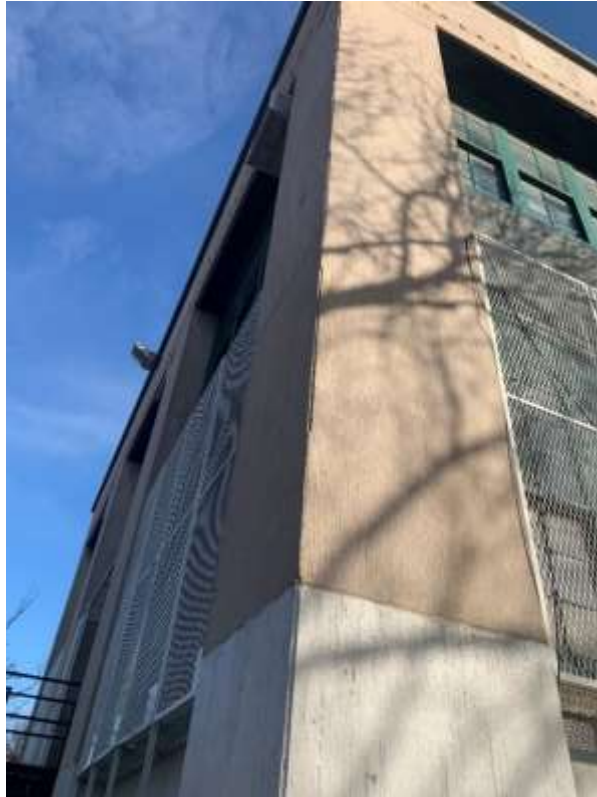
Photo M03 – Deteriorated joint grout at bottom area at Southwest corner.

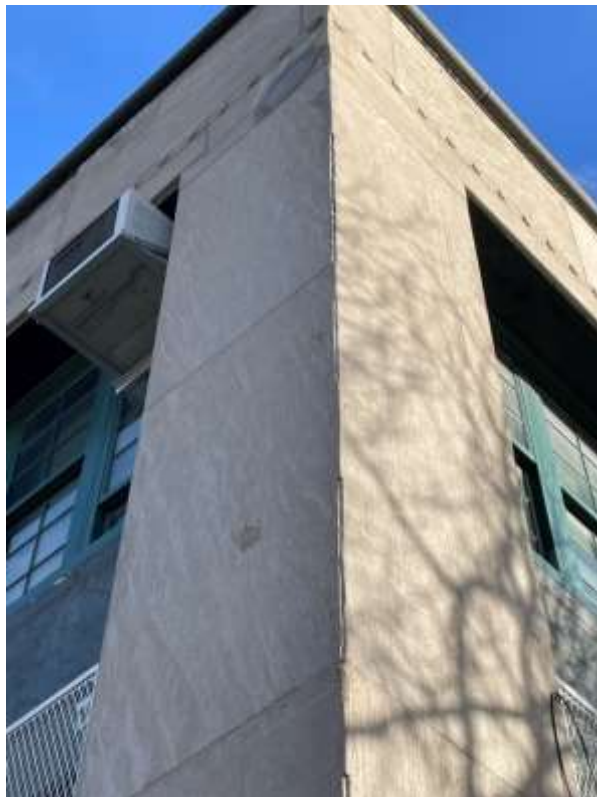
Photo M04 – Deteriorated joint grout at upper area at Southwest corner.

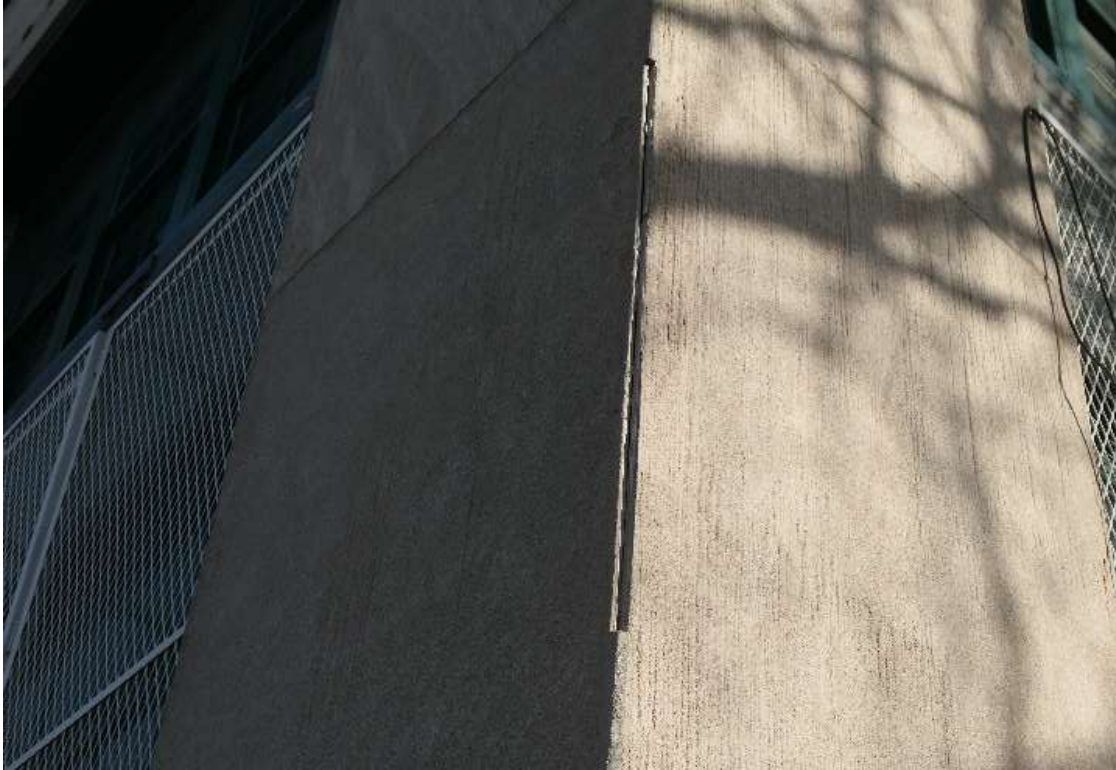
Photo M05 – Detail of deteriorated joint grout at Limestone.

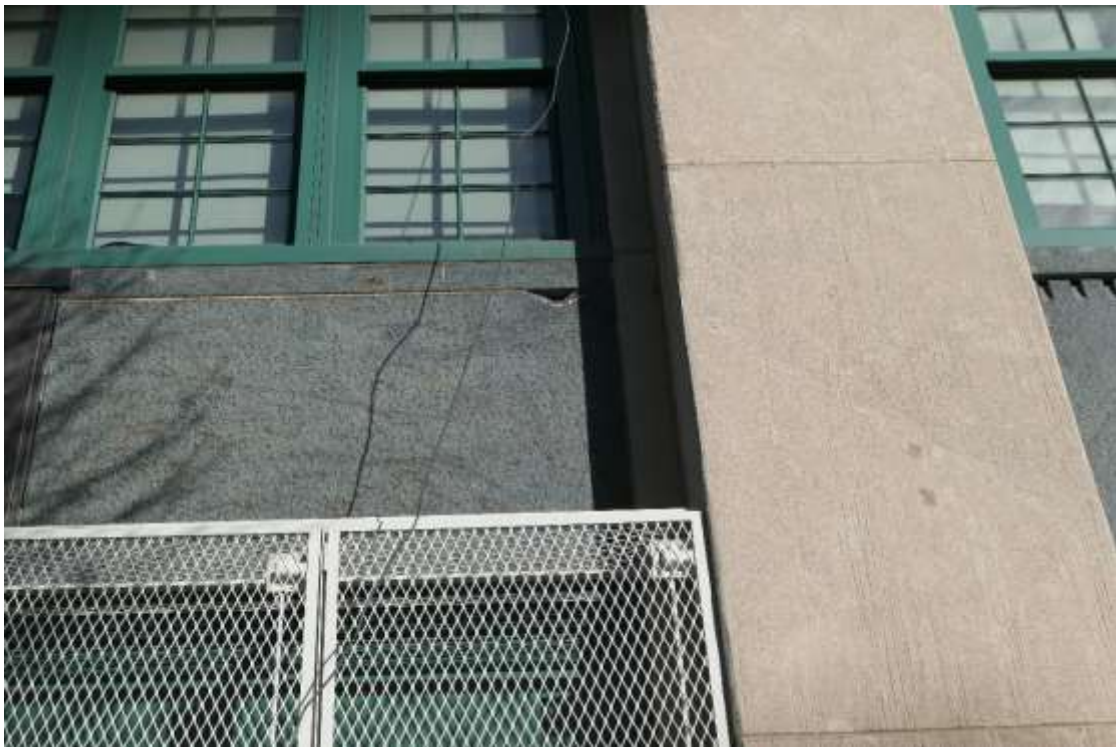
Photo M06 – Halfmoon crack and missing granite piece at South Façade.

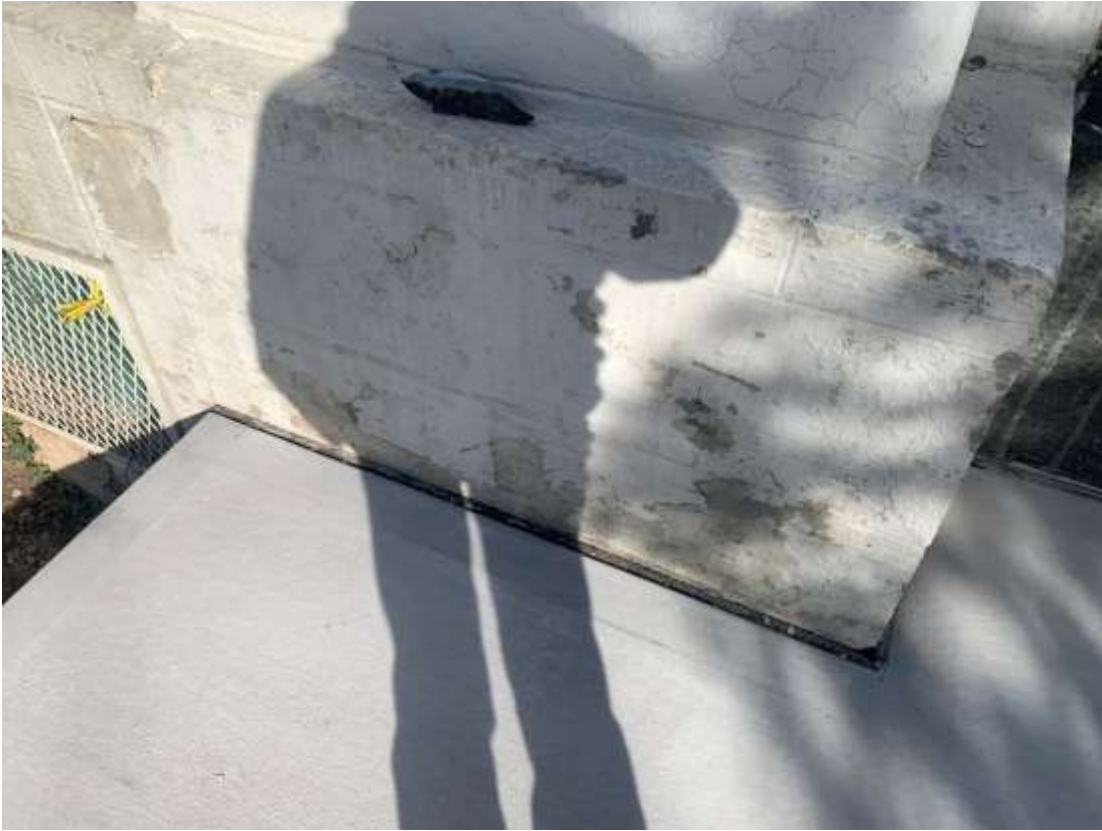
Photo M07 – Open joint at stairs landing at South entrance.

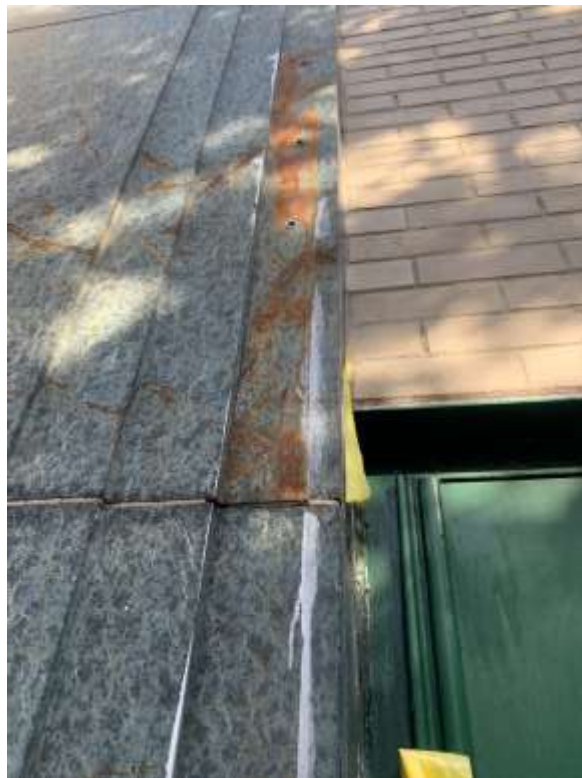
Photo M08 – Deteriorated mortar joints at East entrance.

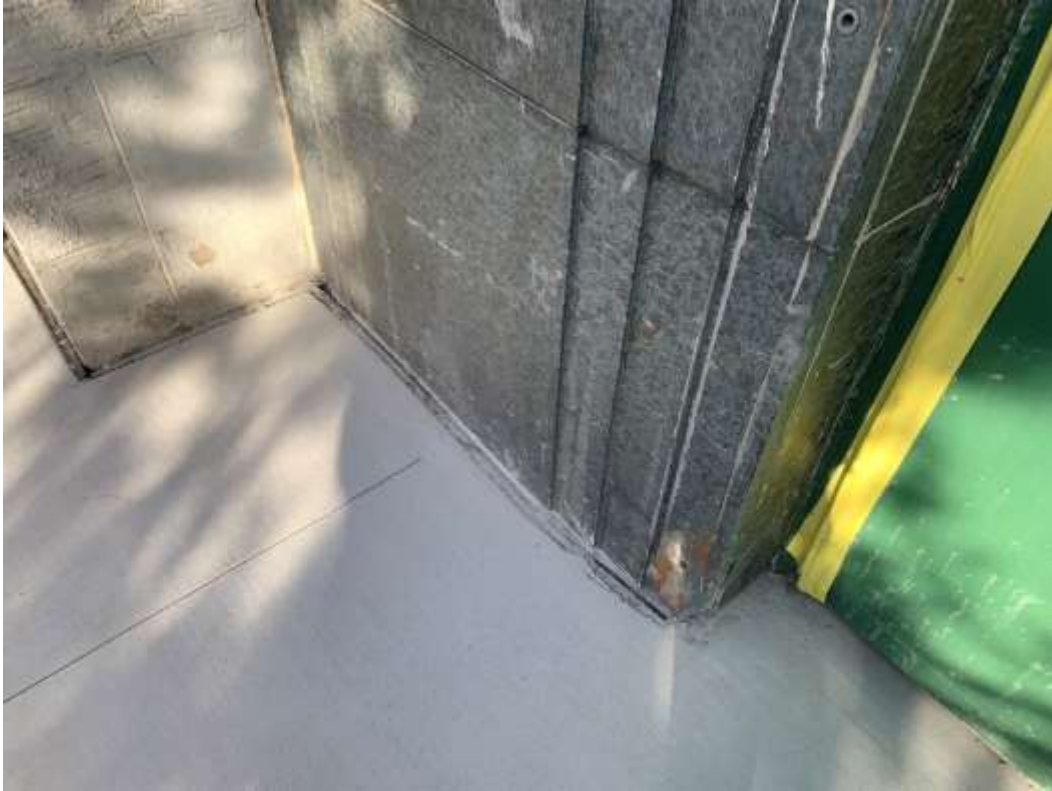
Photo M09 – Open joint between new landing and existing building's foundation at South entrance

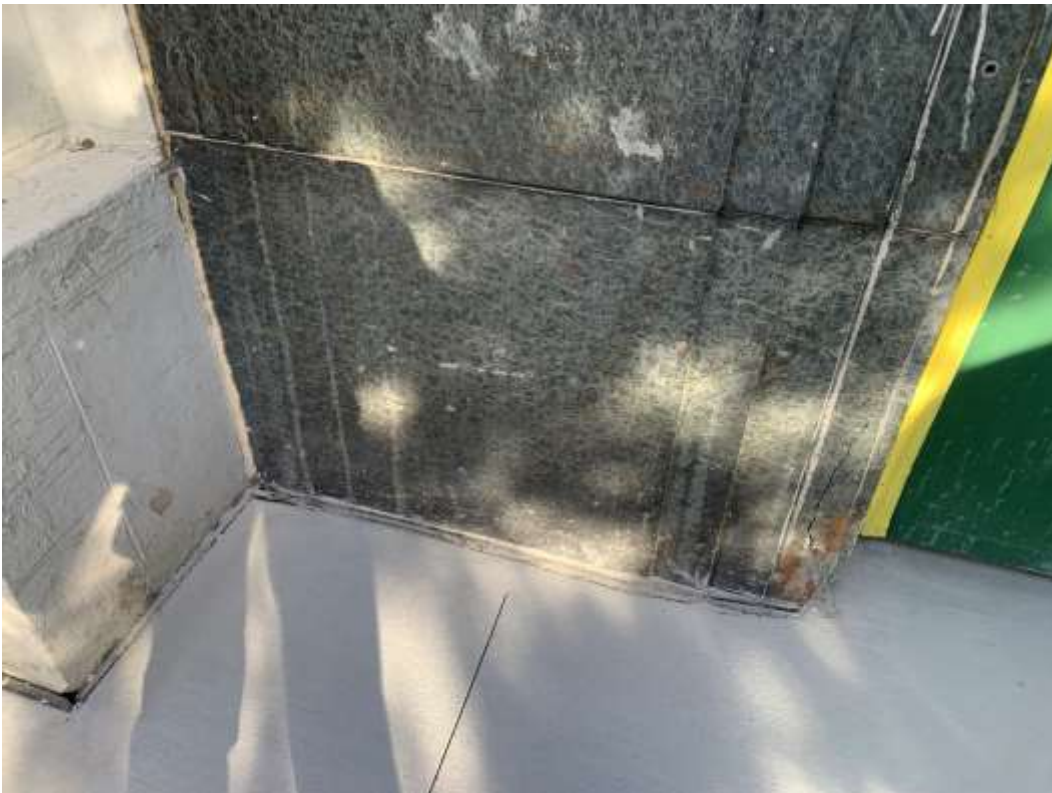
Photo M10 – Cracks and missing stone in granite at Main Entrance, South Elevation.

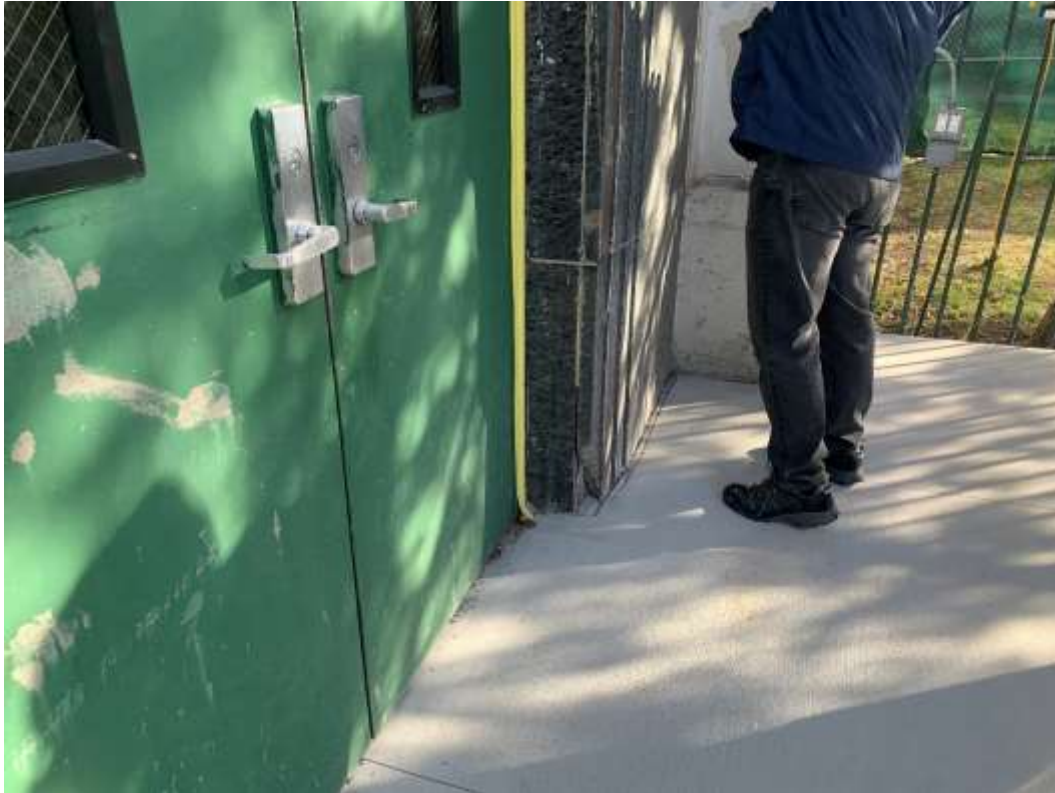
Photo M11– Missing stone and deteriorated mortar joint at Main Entrance.

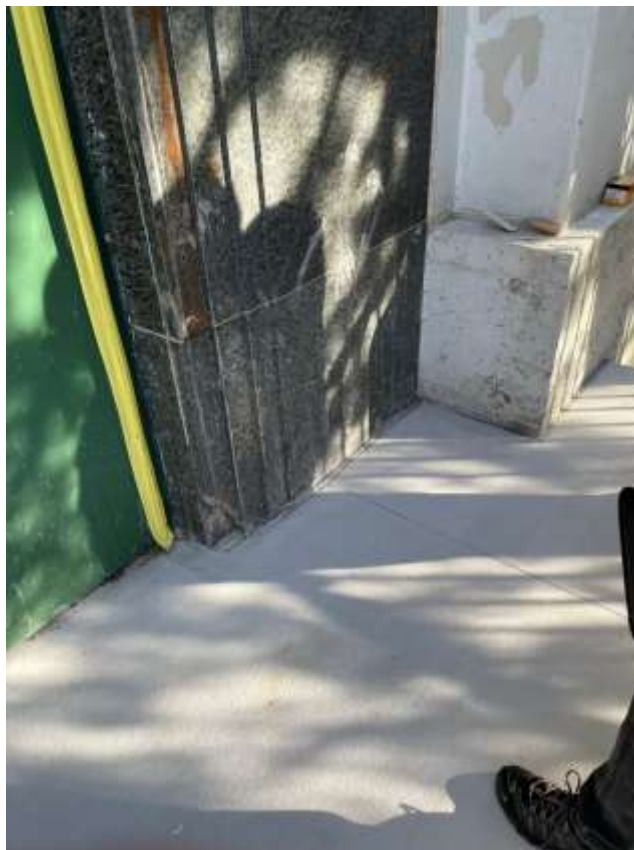
Photo M12 – Missing stone and deteriorated mortar joint at Main Entrance.

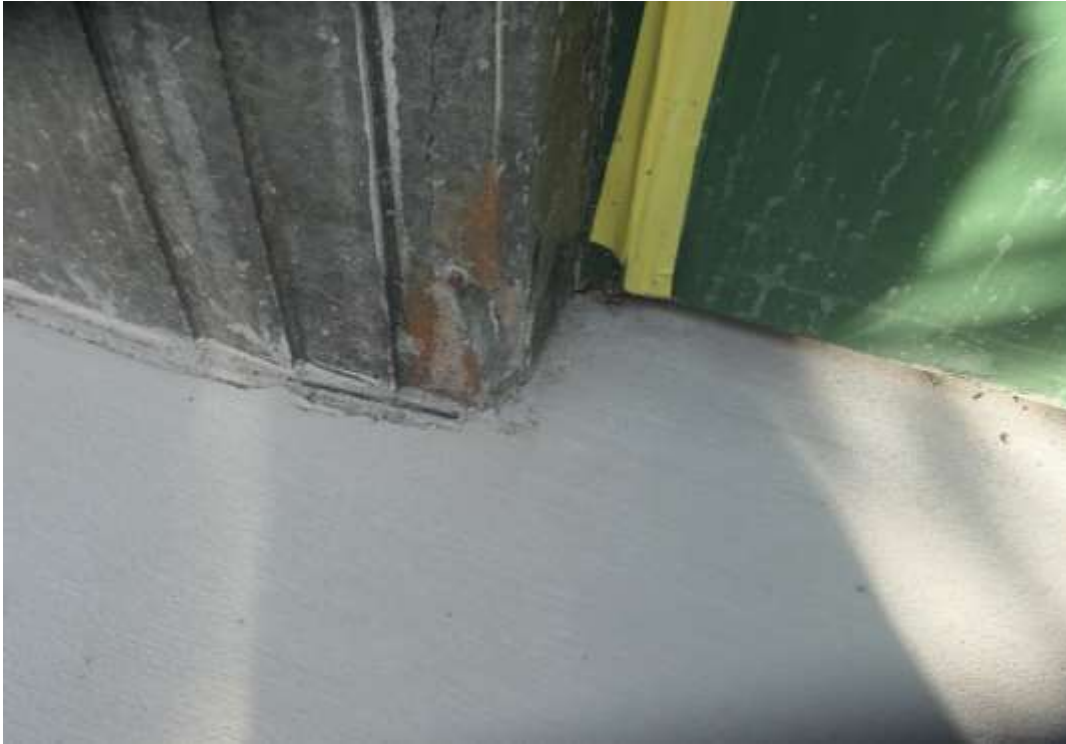
Photo M13 – Close detail to the missing stone and crack in granite.

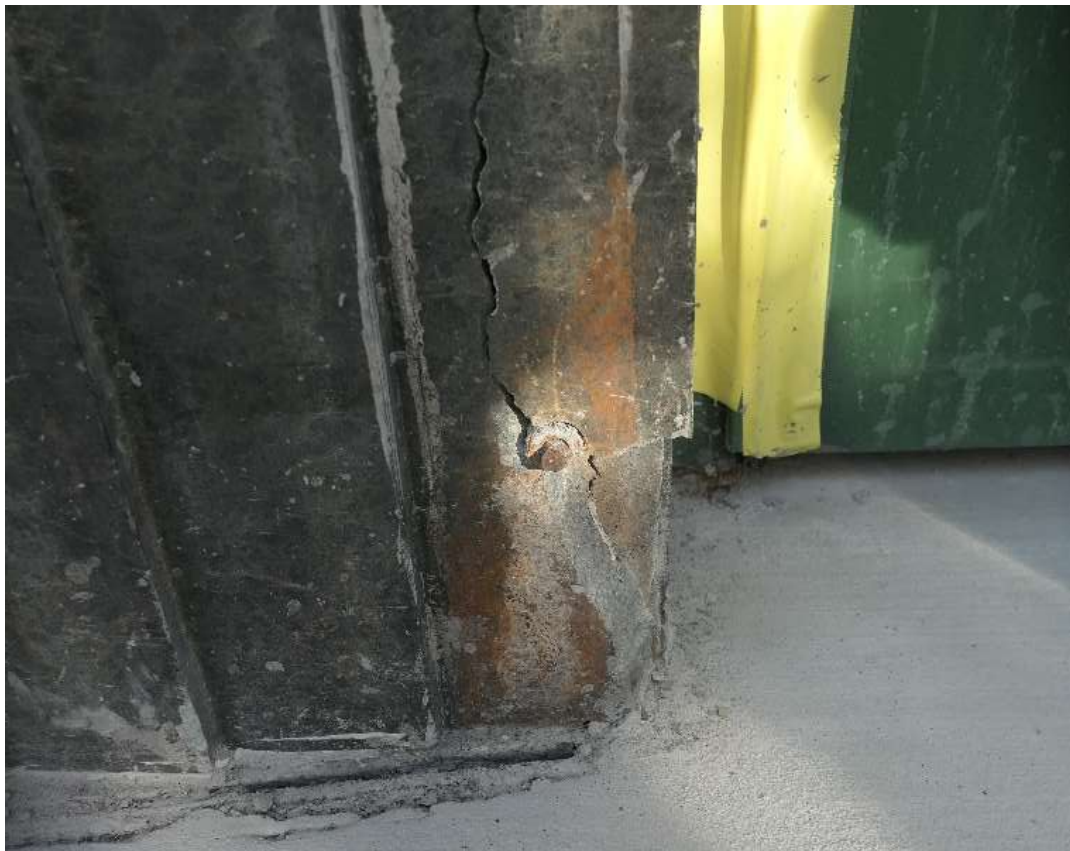
Photo M14 – Missing granite chunk and crack – South Façade.

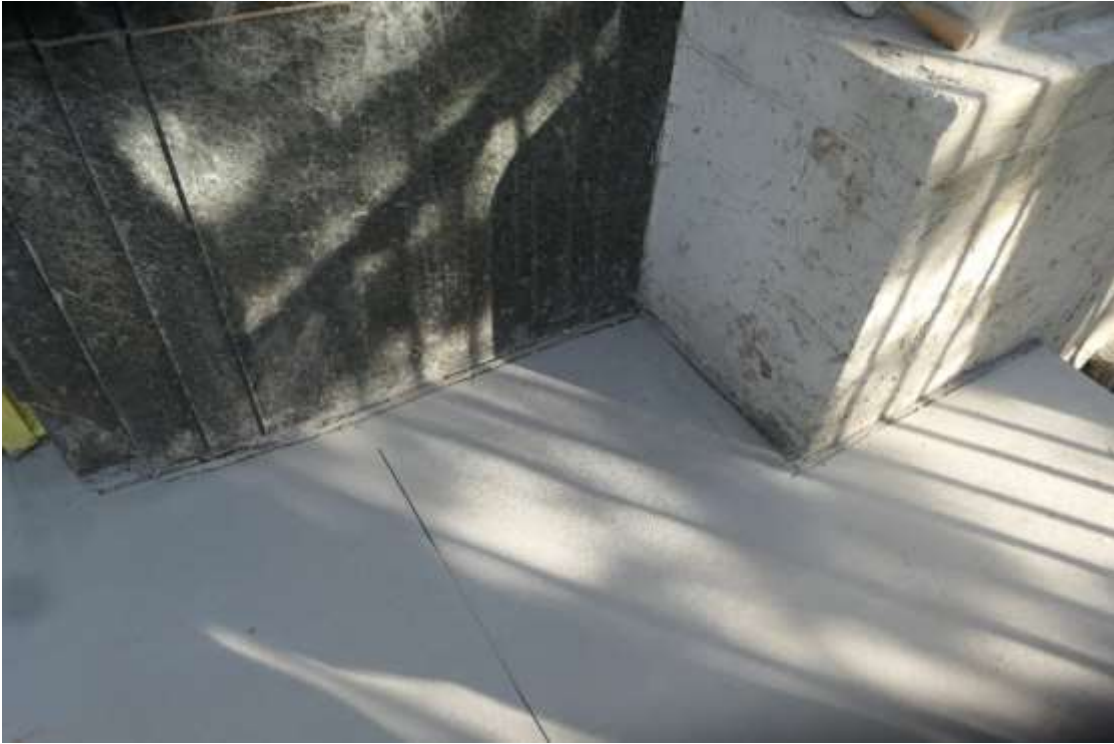
Photo M15 – Source of water infiltration at open joint between new landing and existing building's foundation at main entrance, south façade.

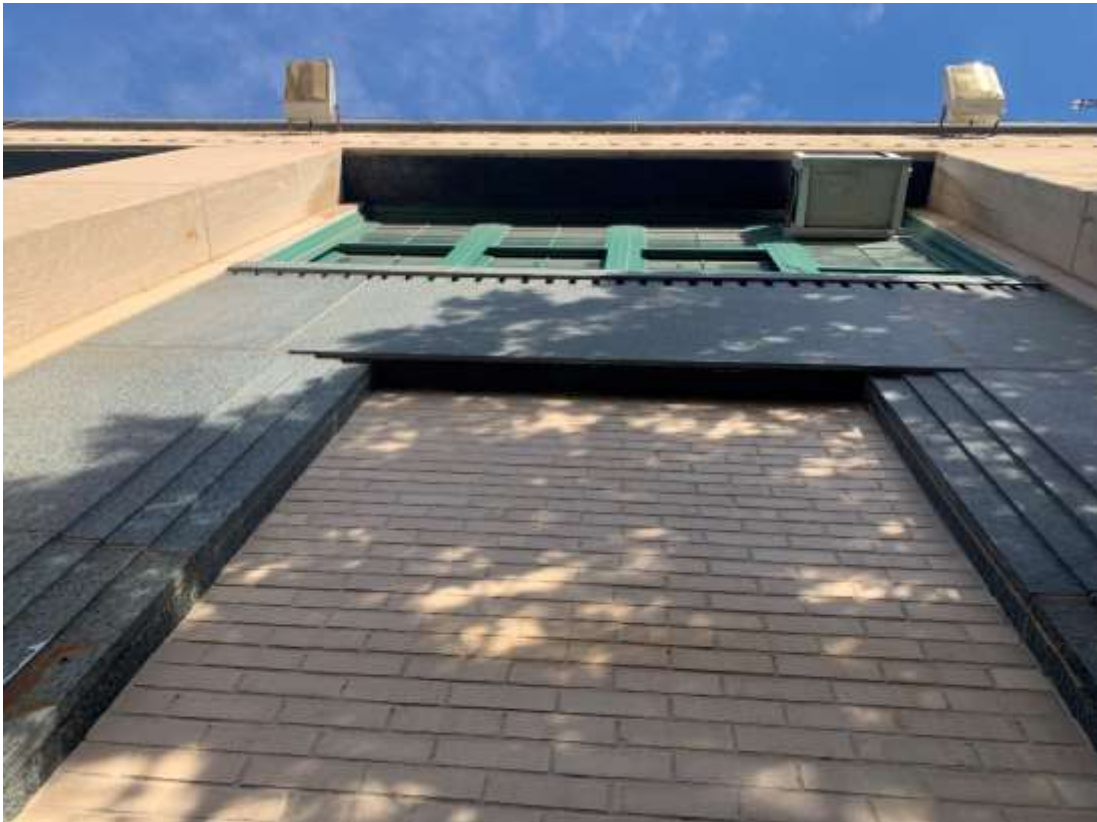
Photo M16 – Brick and stone above main entrance.

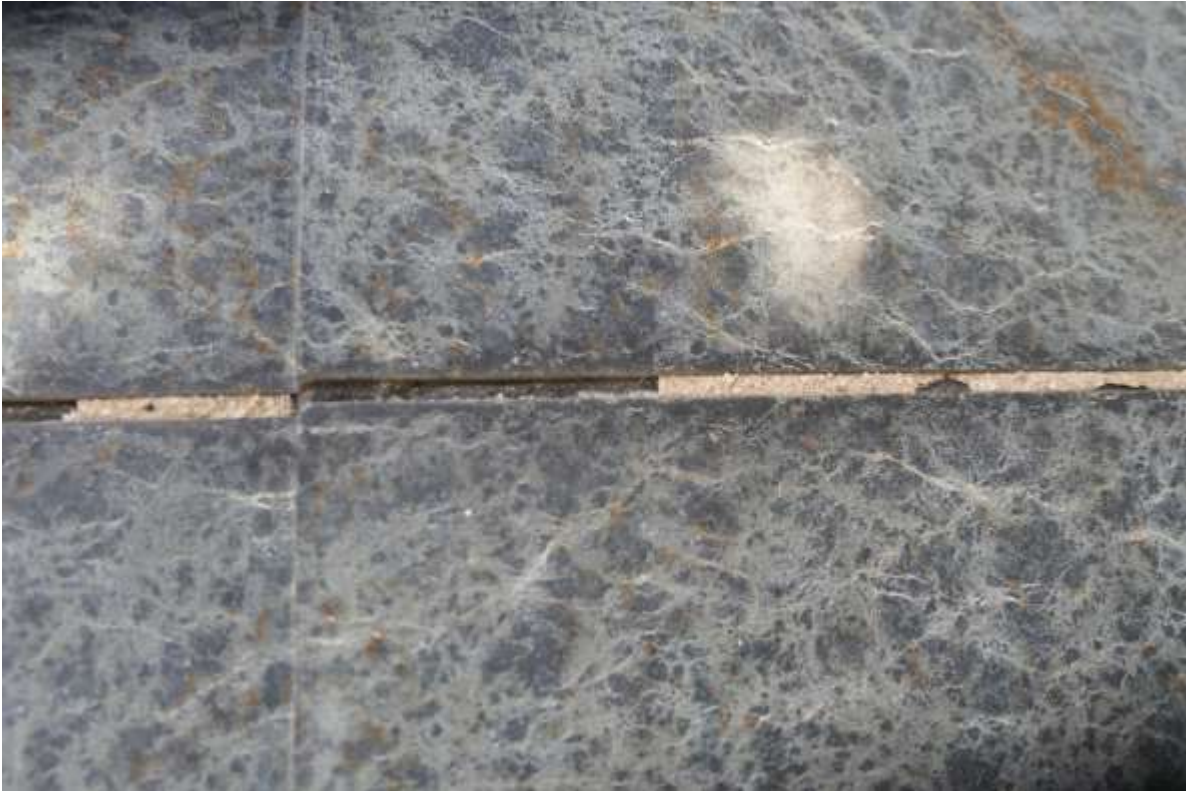
Photo M17 – Deteriorated mortar joints and loose missing grout at stone.

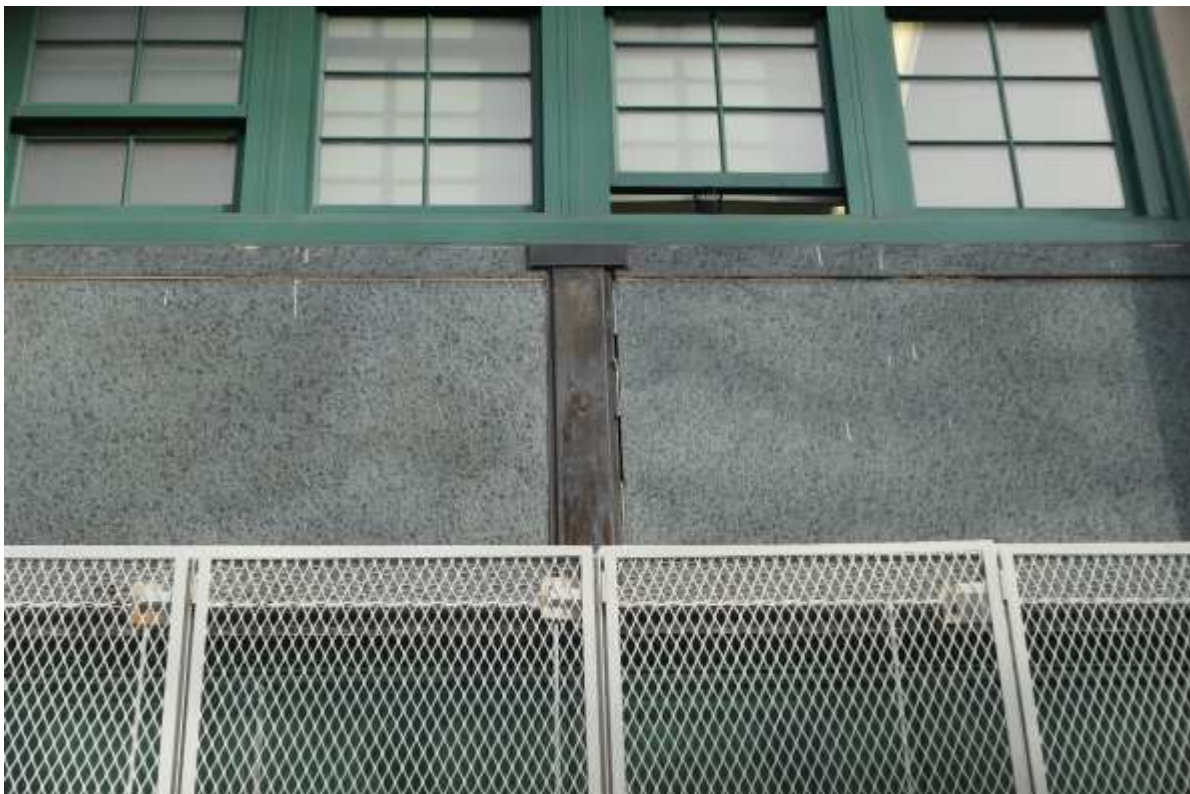
Photo M18 – Deteriorated mortar joints at granite panels.

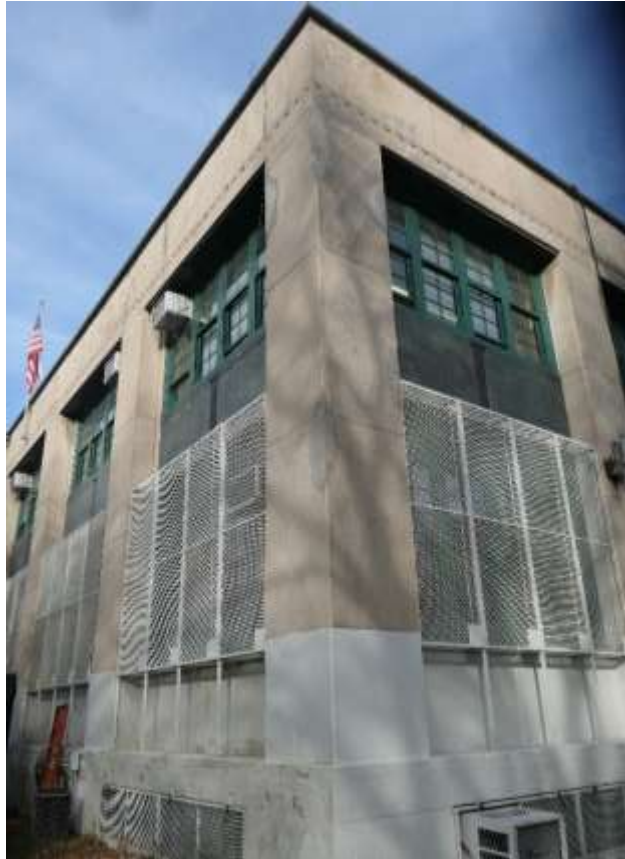
Photo M19 – Missing and deteriorated mortar joints at Southwest corner of the building.

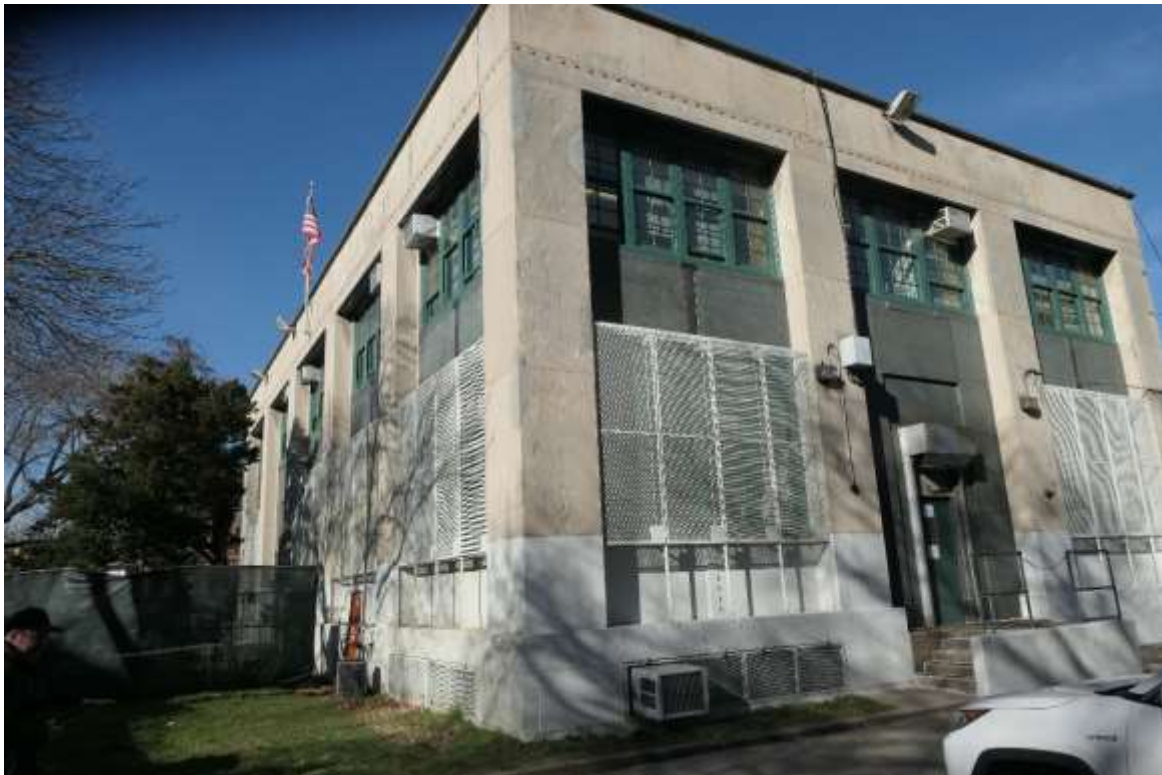
Photo M20 – South and East facades.

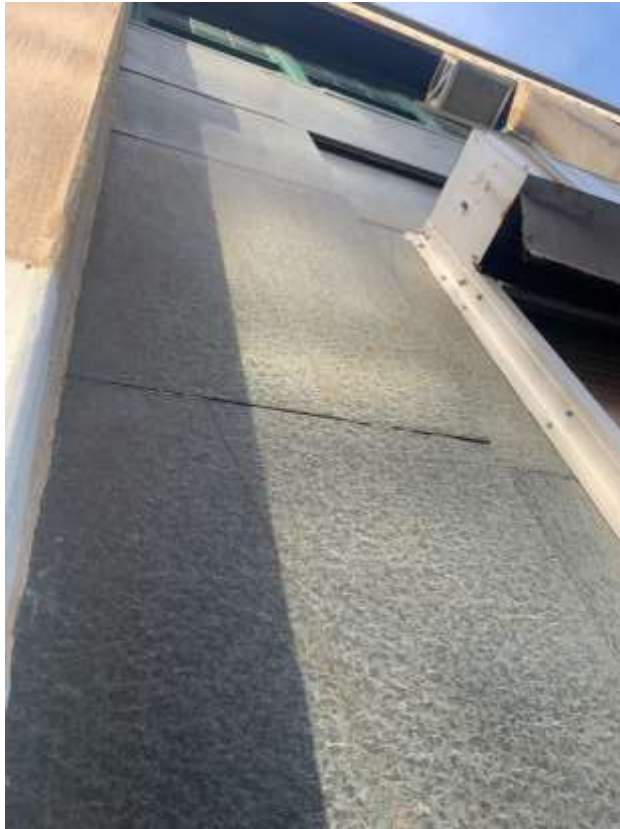
Photo M23 – Cracks at granite panels, East Façade.

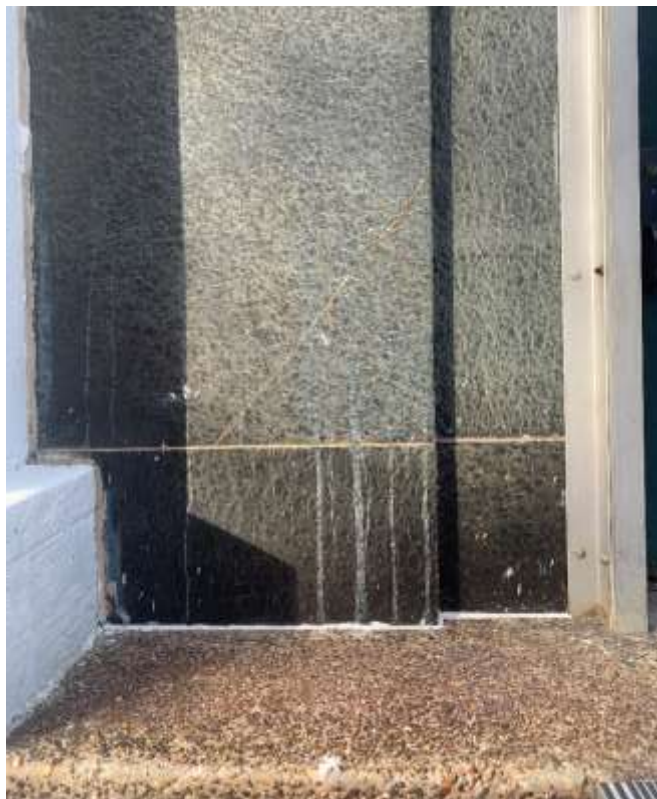
Photo M24 – Cracks at granite panels, East Façade.

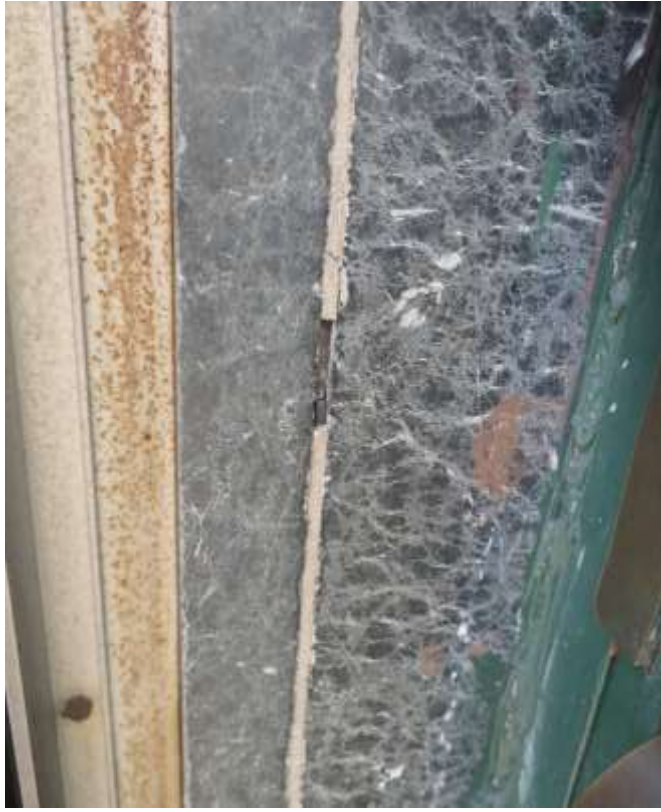
Photo M25 – Loose missing grout at stone.

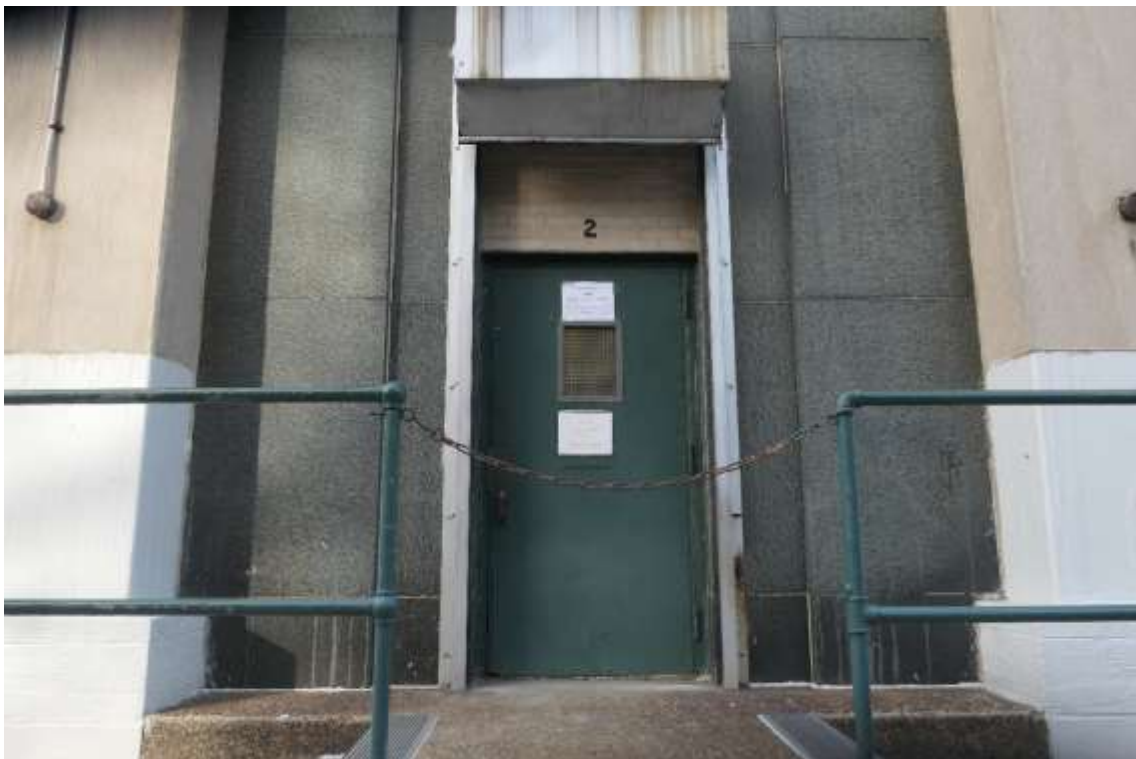
Photo M26 – Secondary entrance at East Façade.

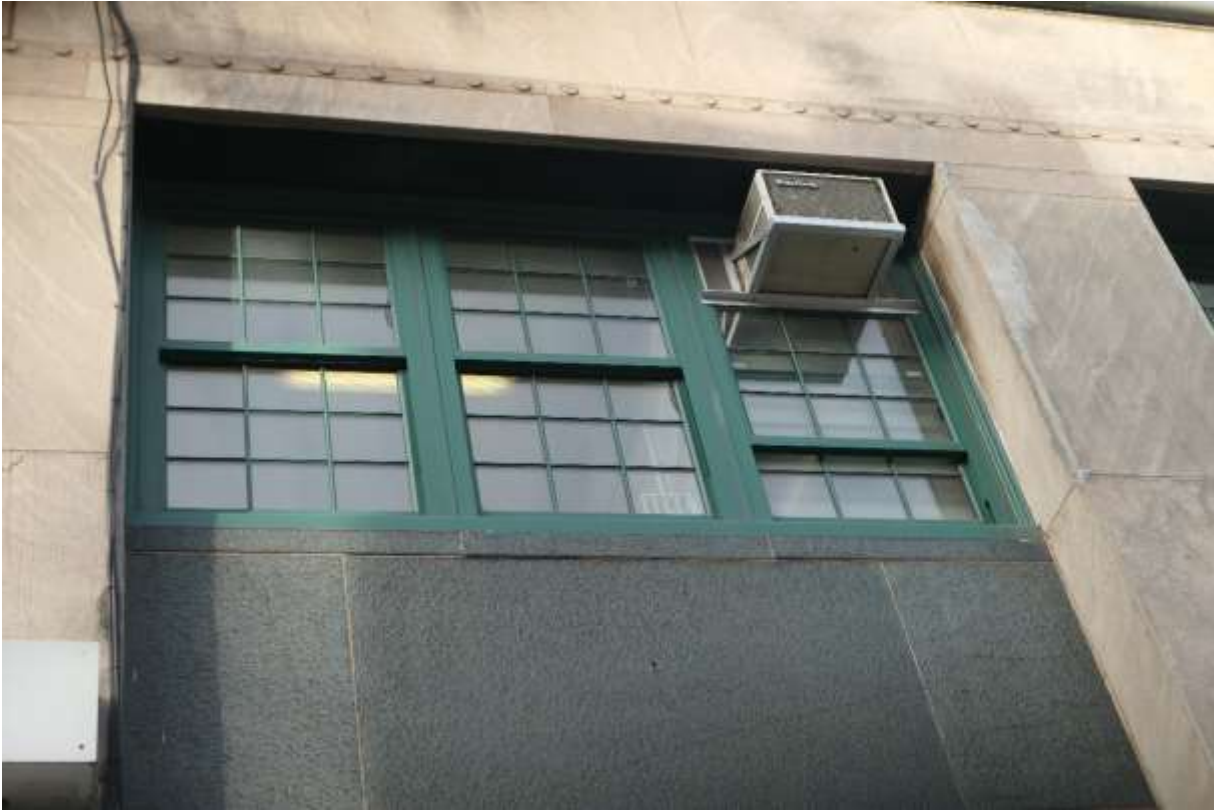
Photo M27 – Double hung windows and ACs are in good condition.

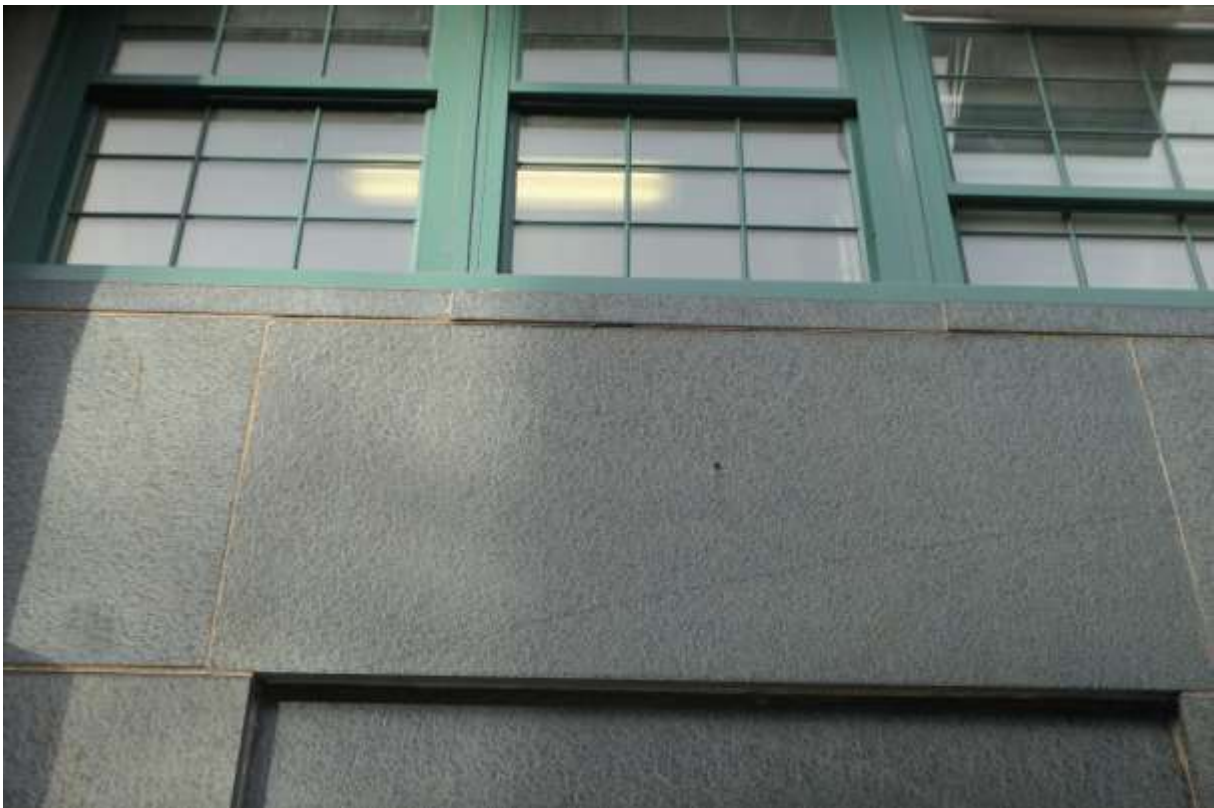
Photo M28 – Crack in granite above secondary entrance, East Façade.

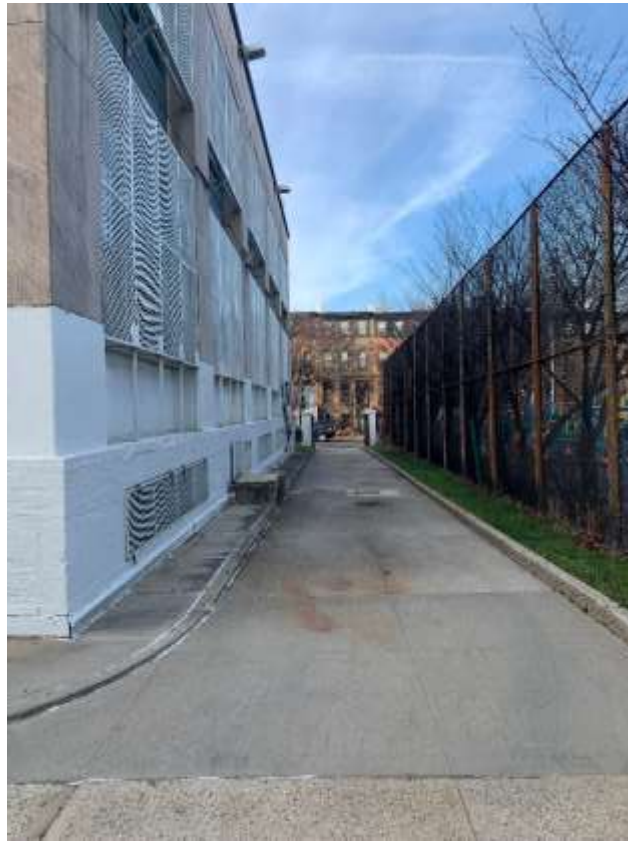
Photo M29 – View along back entrance – North Façade.

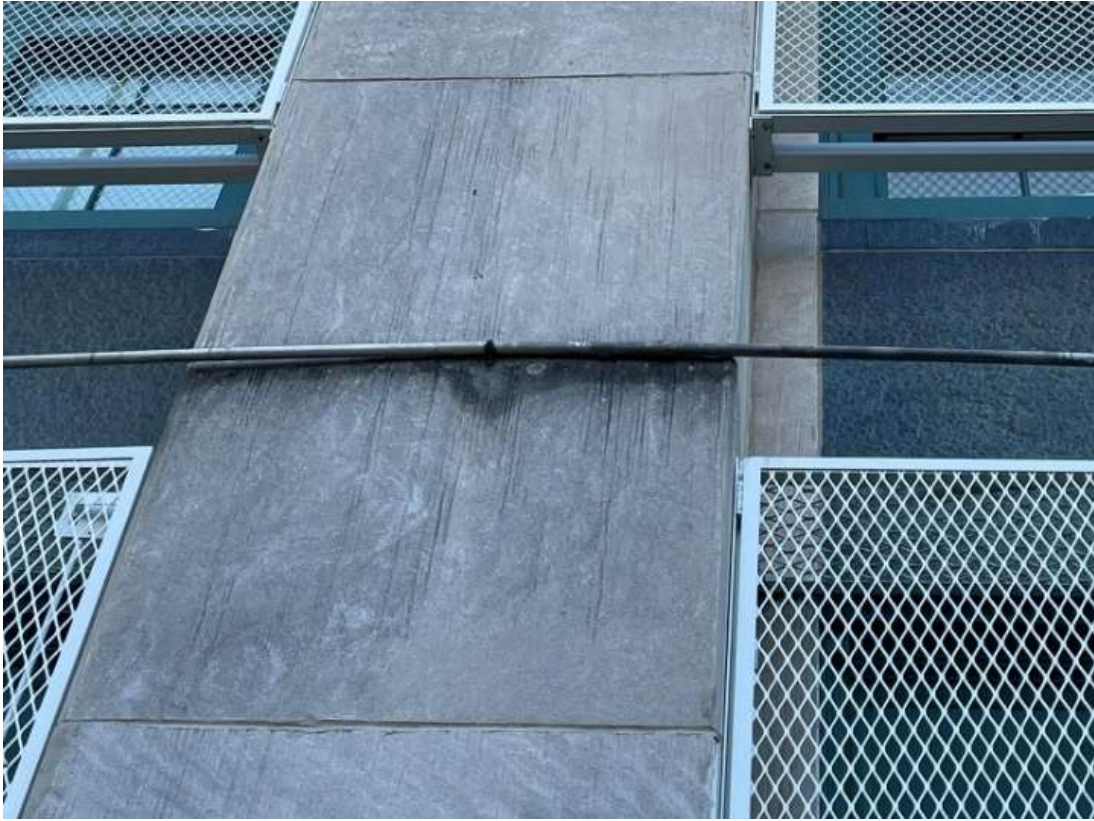
Photo M31 – Deteriorated mortar joints at all Facades.

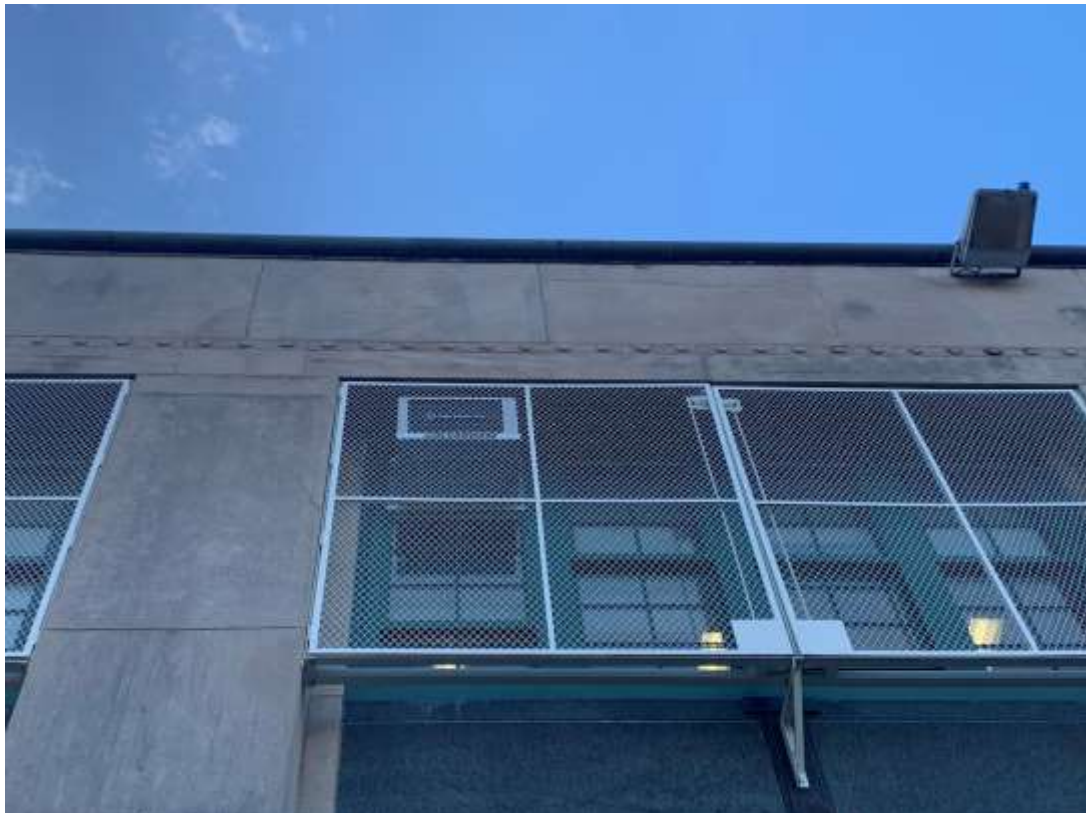
Photo M32 – Crack in Limestone, window guards are in good condition – North Façade.

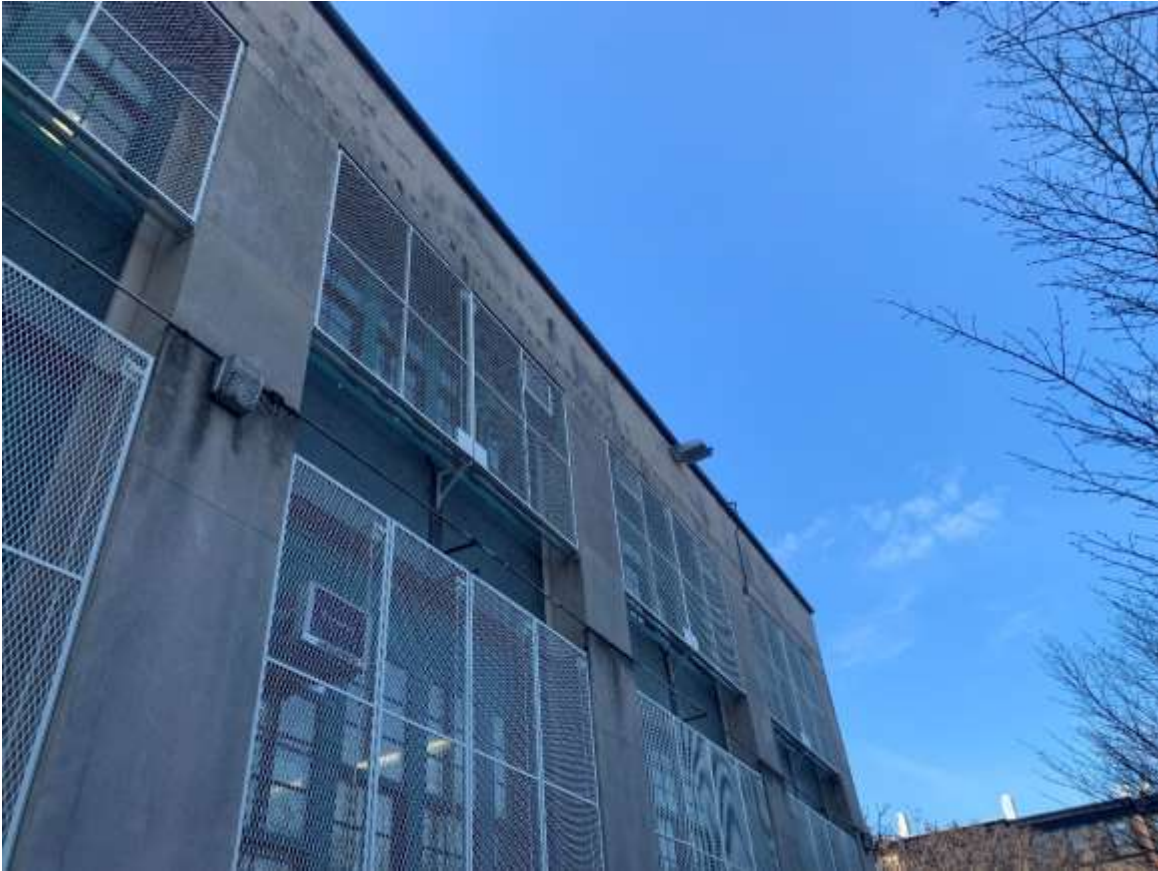
Photo M33 – Window guards are in good condition – North Façade.

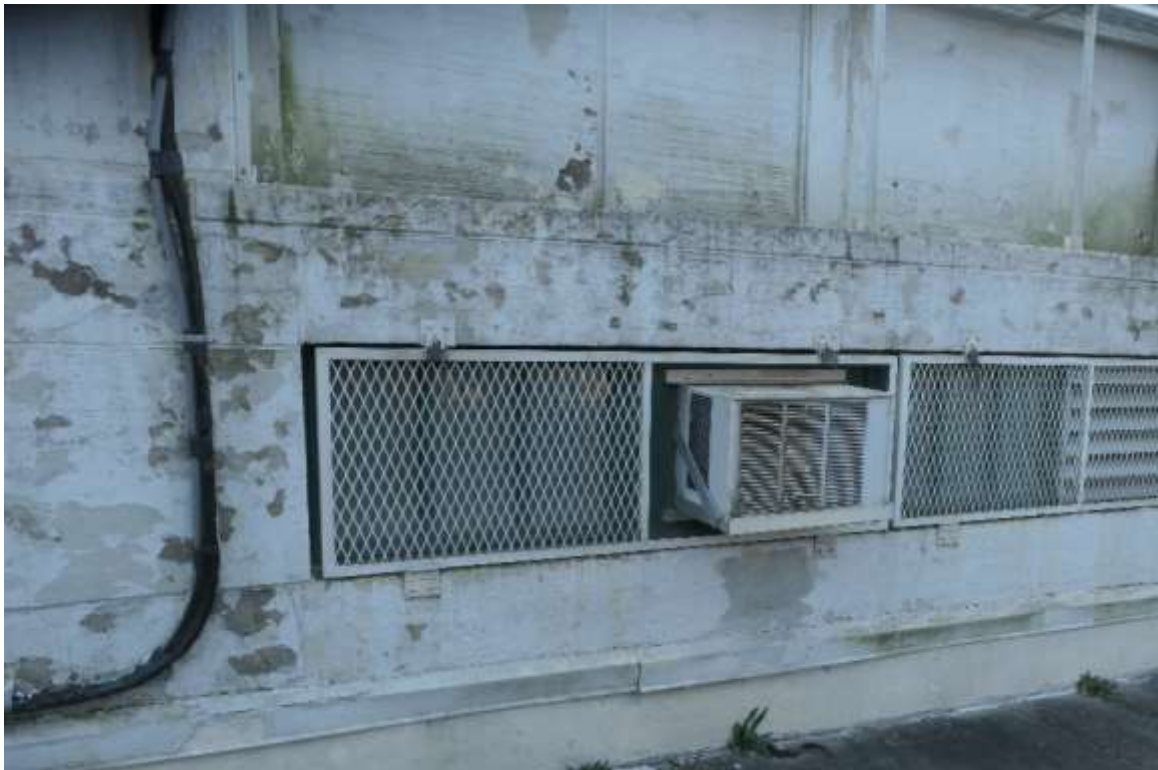
Photo M34 – Peeling paint – North Façade.
