# Capital Improvement Program

Architecture & Engineering

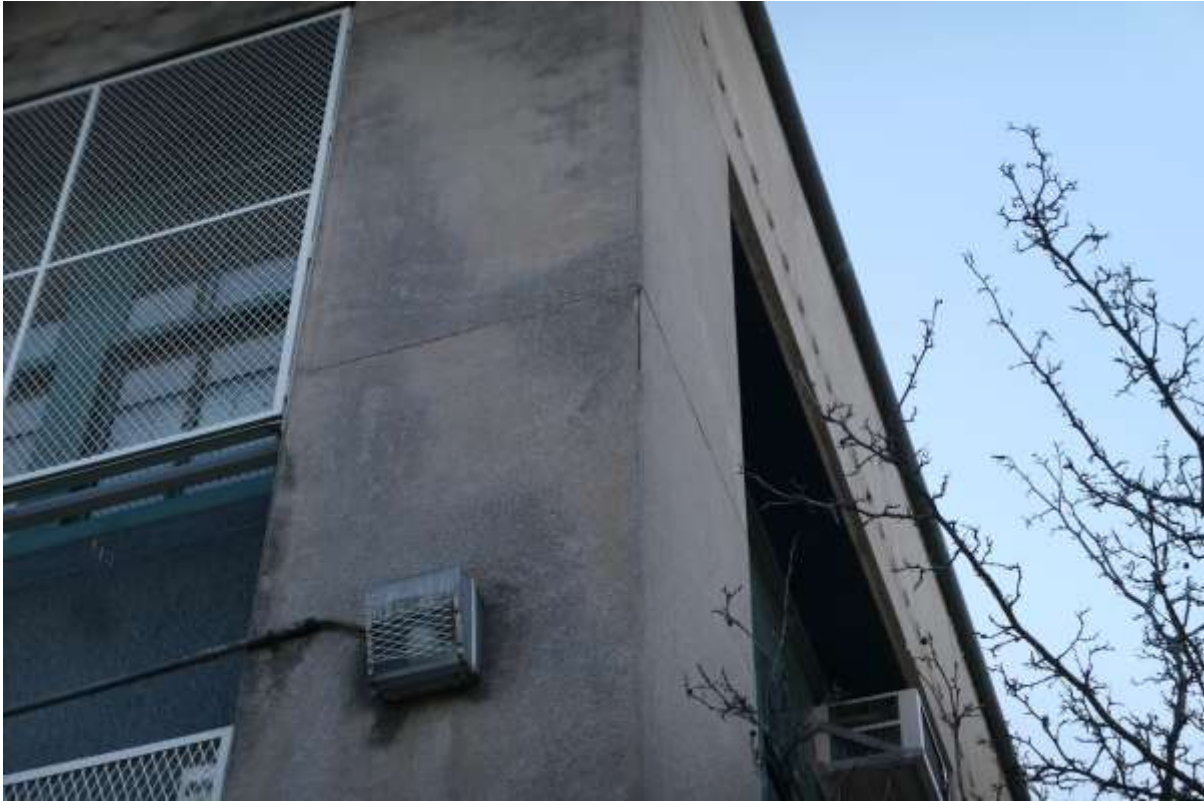
Photo M39 – Missing mortar at joints.

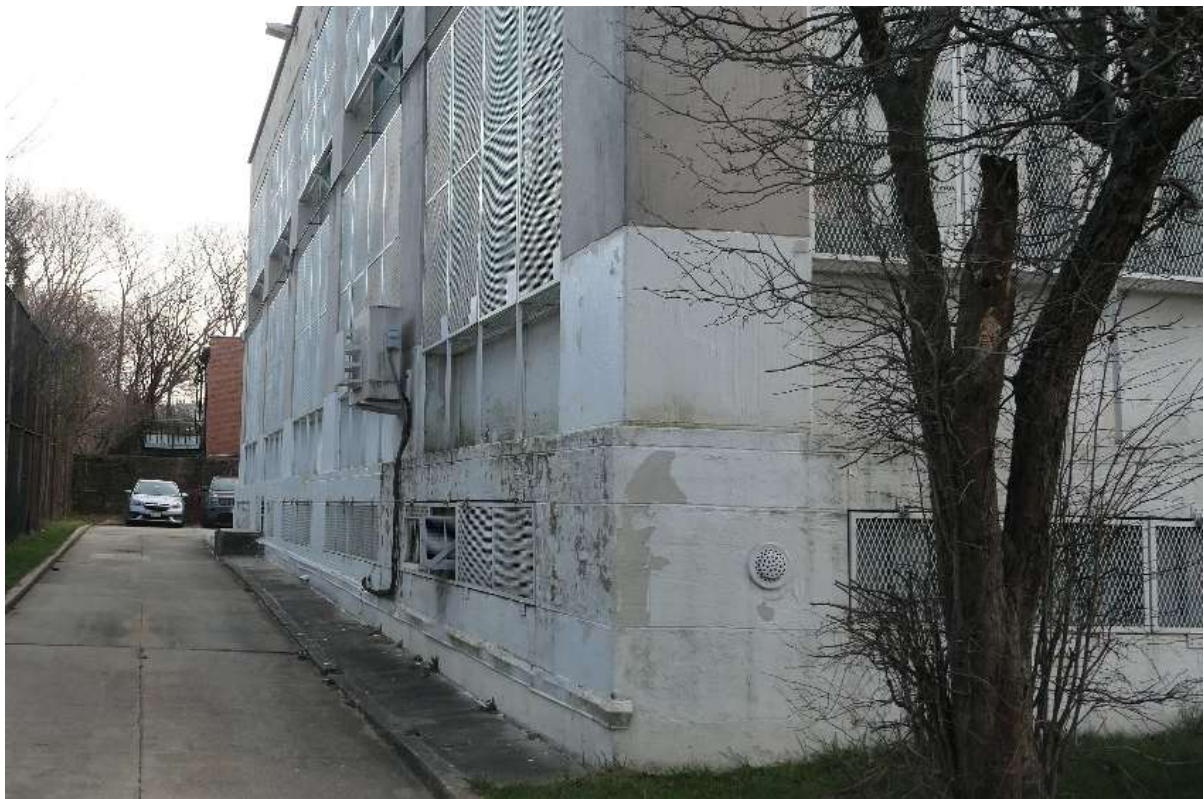
Photo M40– Northwest corner of the building.

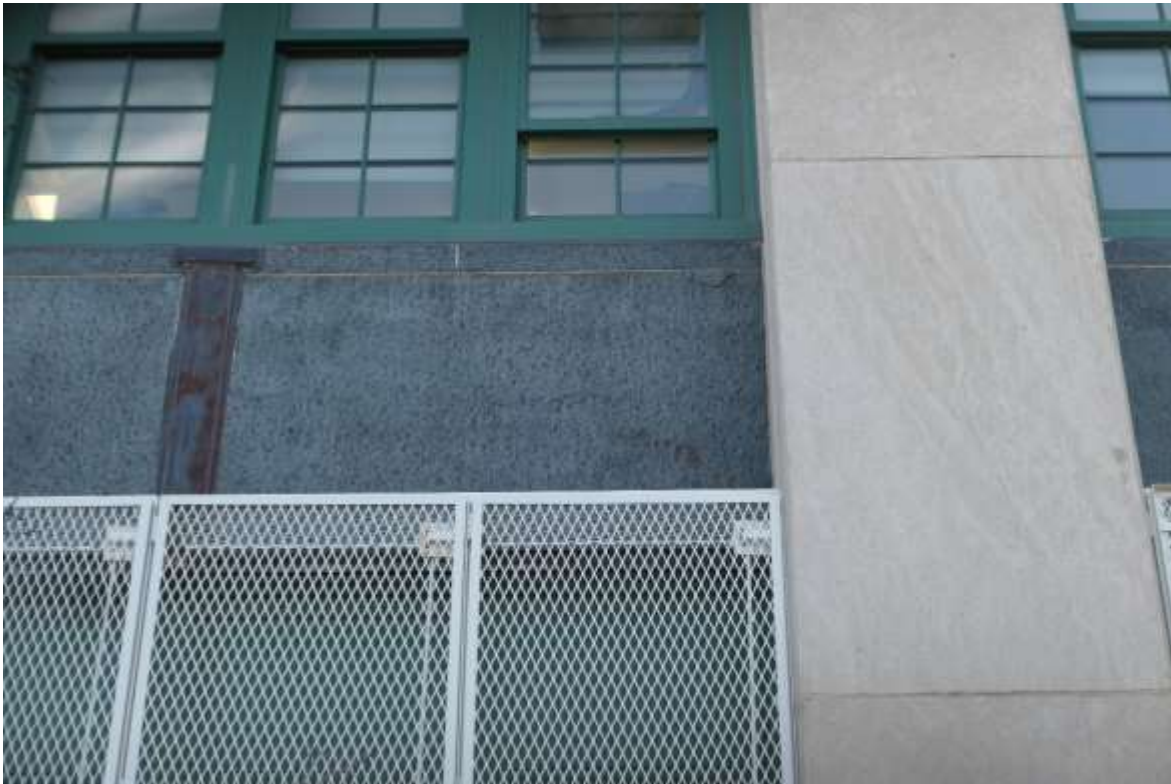
Photo M43 – Halfmoon crack in granite panel at West Façade.

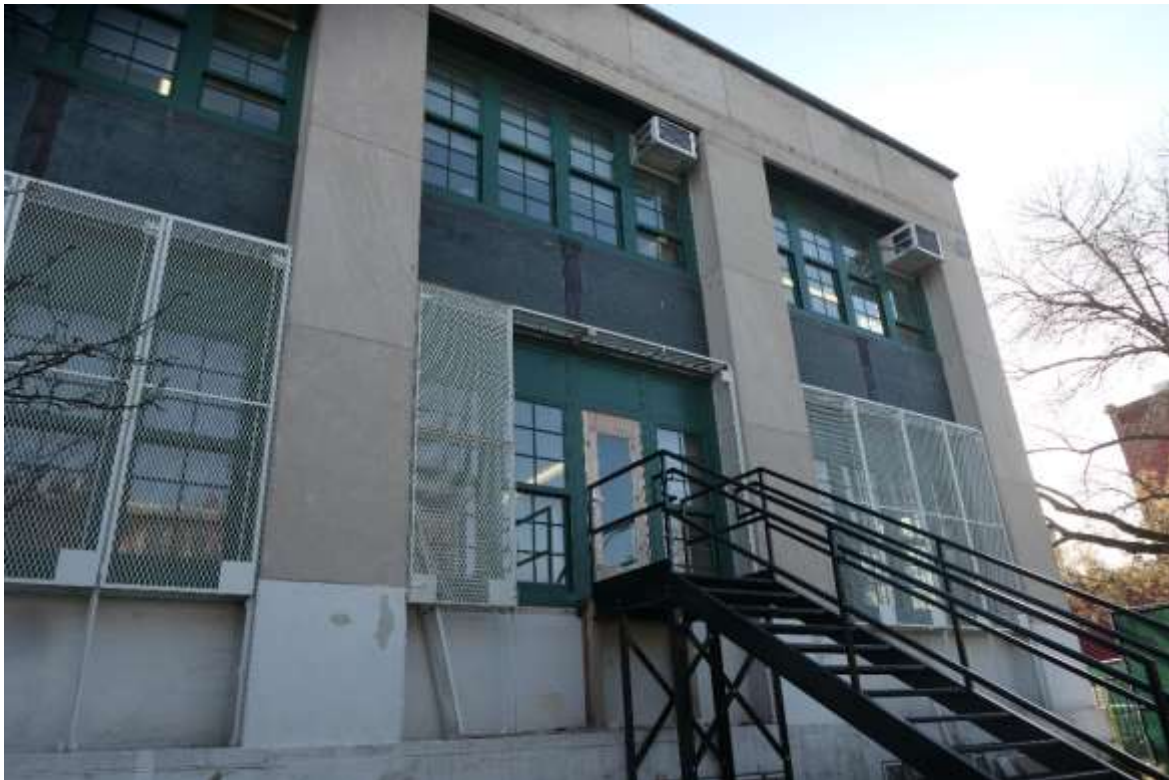
Photo M44 – Temporary access at West Façade.

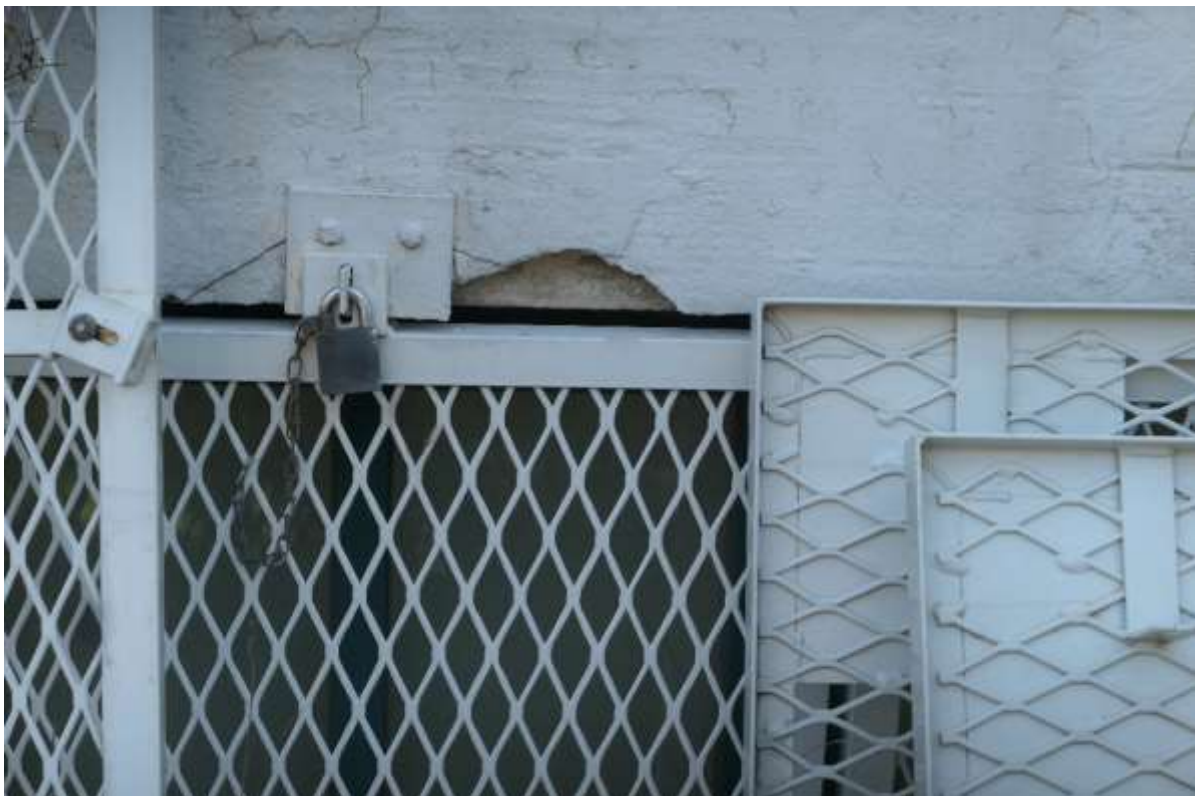
**Photo M46 – Missing stone at West Facade.**

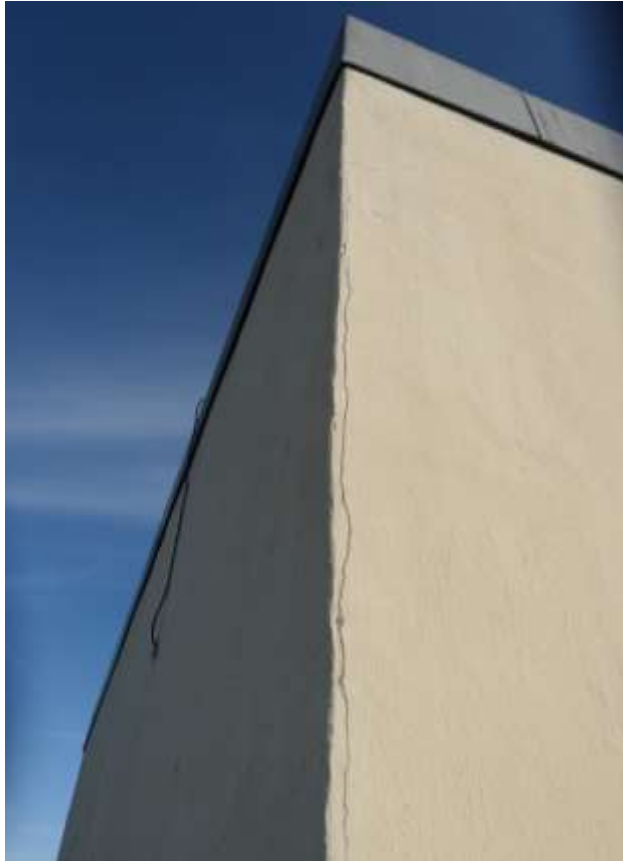
Photo M47 – Damaged stucco in bulkhead at southwest corner.

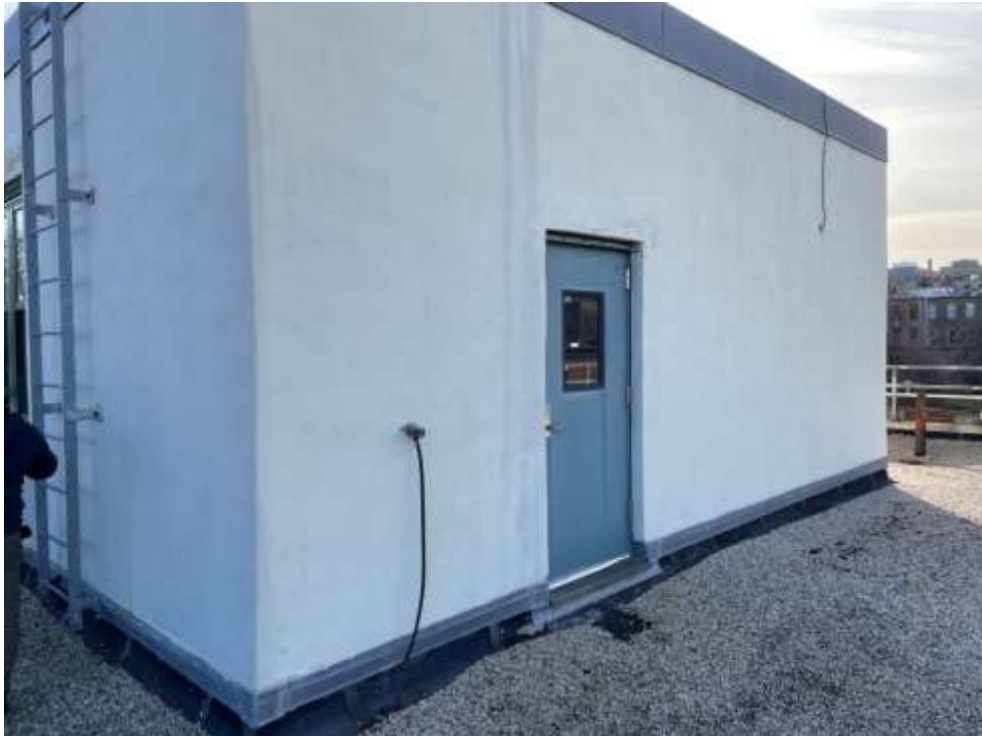
Photo M48 – Damaged stucco in bulkhead exterior door indicates water infiltration – West Bulkhead Façade.

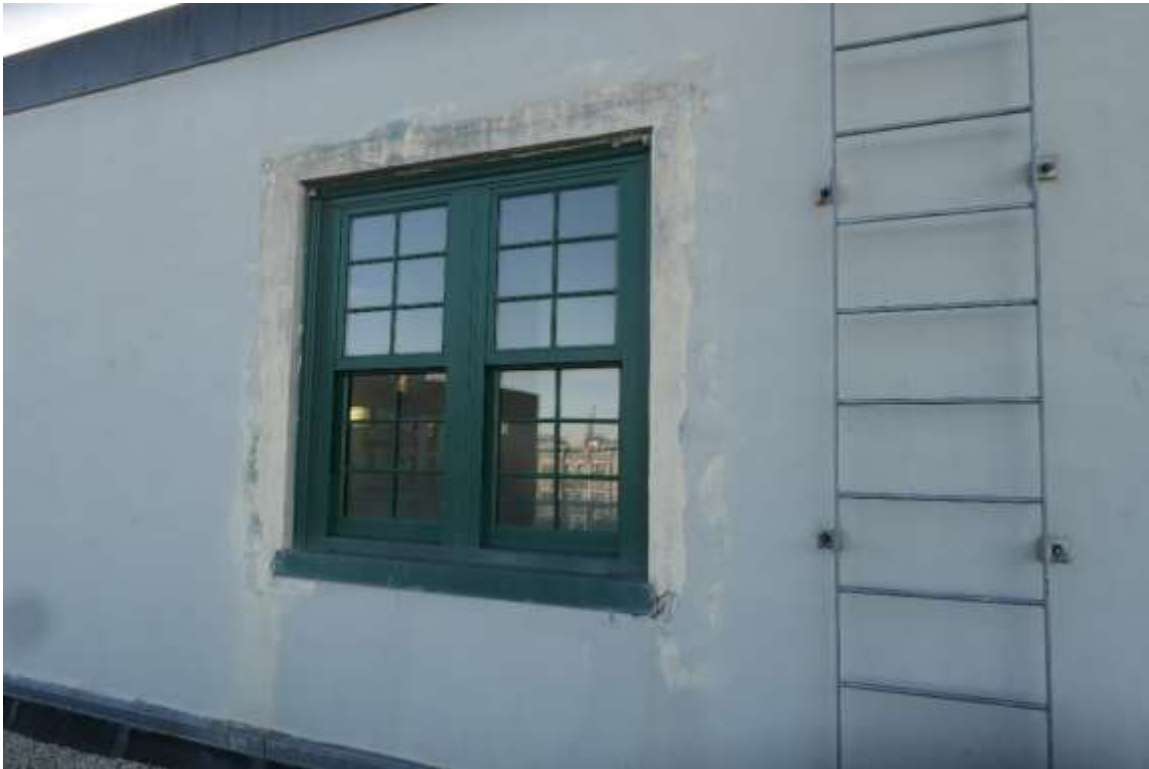
Photo M49 – Damaged stucco in windows perimeter indicates water infiltration, roof ladder is in good condition – North Bulkhead Façade.

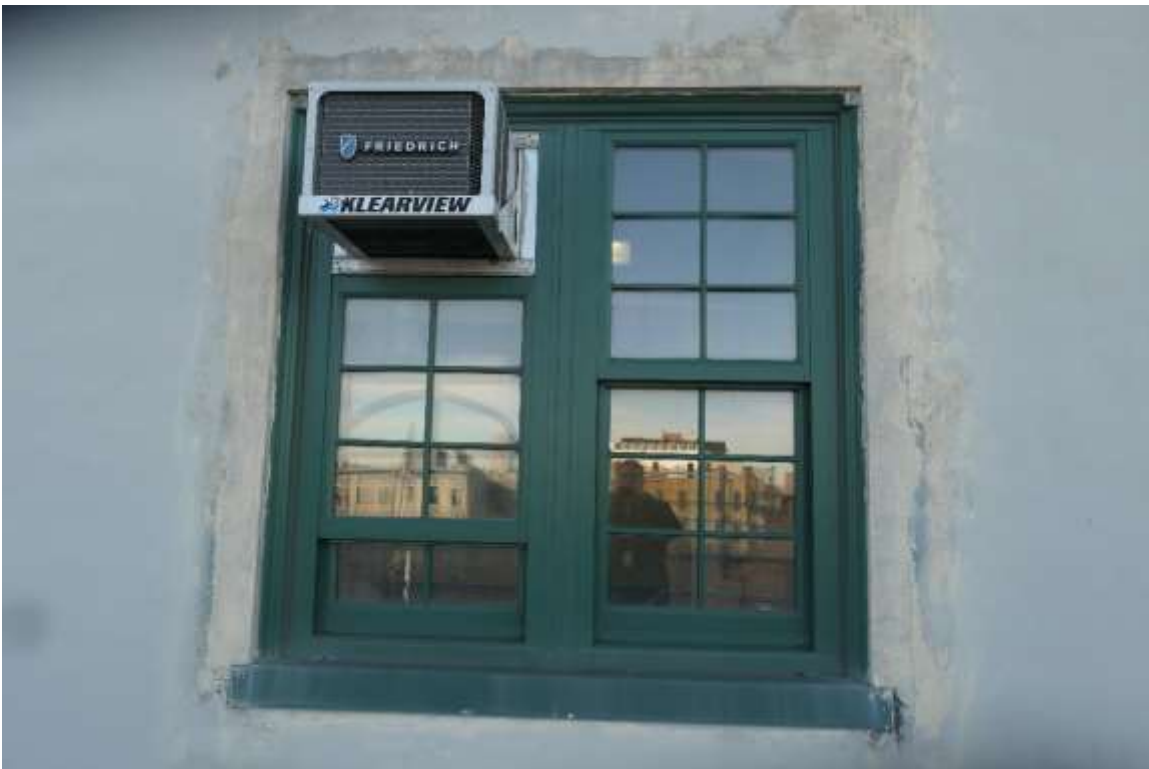
Photo M50 – Damaged stucco in windows perimeter indicates water infiltration – North Bulkhead Façade.

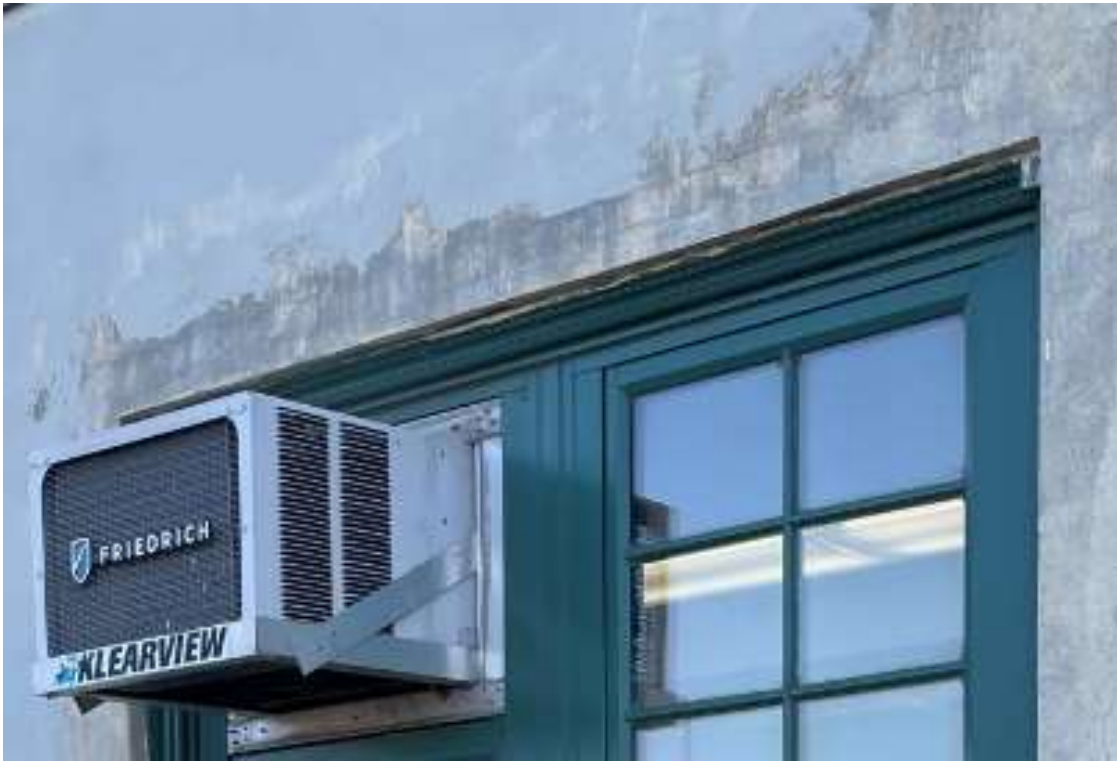
Photo M51 – Damaged stucco in windows perimeter indicates water infiltration – North Bulkhead Façade.

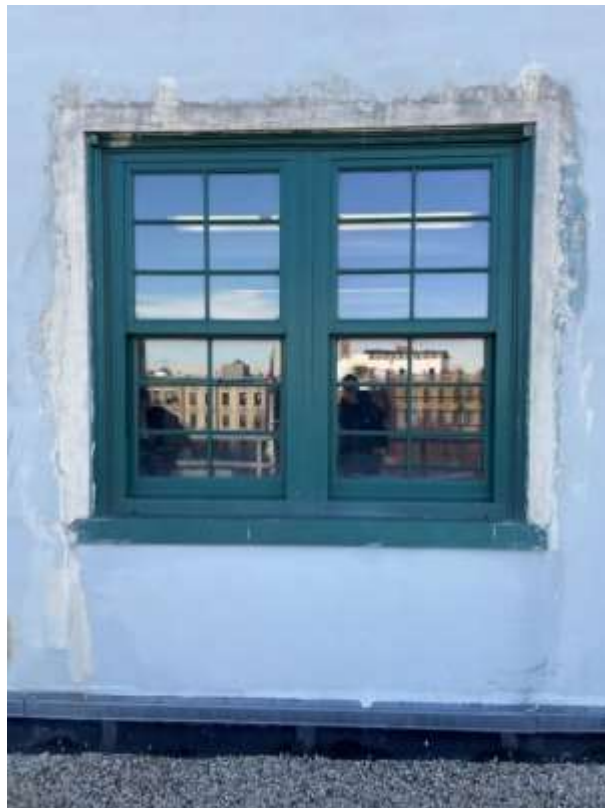
Photo M52– Damaged stucco in windows perimeter indicates water infiltration – North Bulkhead Façade.

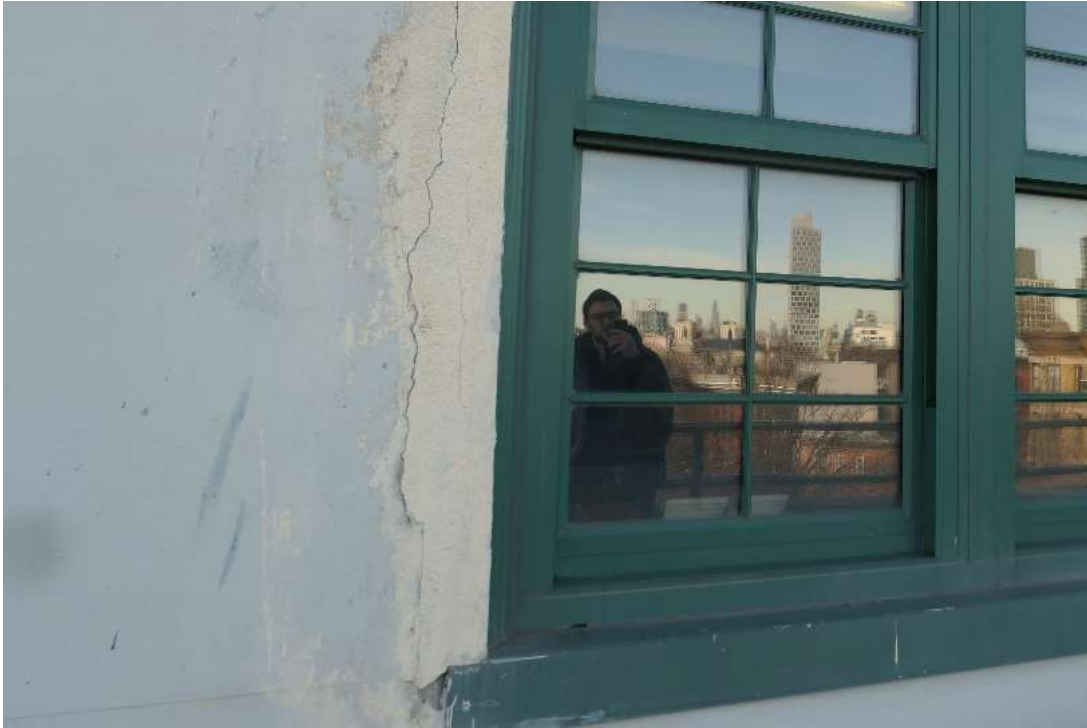
Photo M53 – Damaged stucco in windows perimeter indicates water infiltration – North Bulkhead Façade.

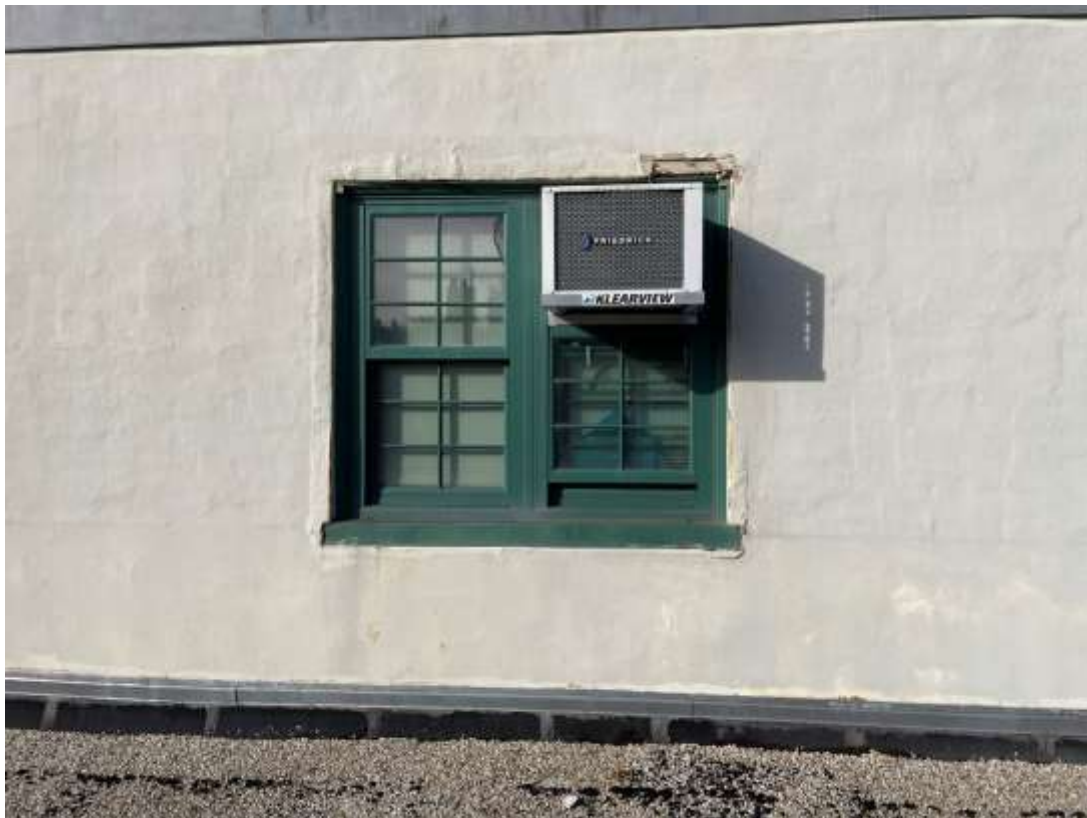
Photo M54 – Damaged stucco and missing stucco in windows perimeter indicates water infiltration – East Bulkhead Façade.

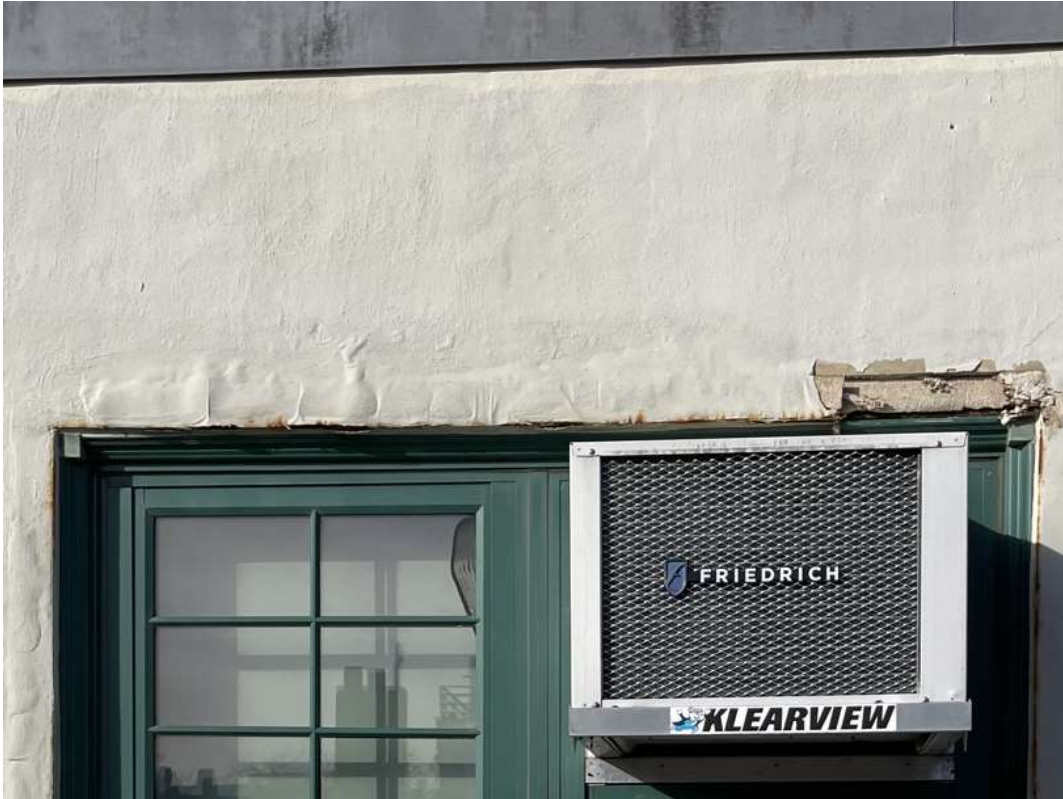
Photo M55 – Detail of damaged stucco and missing stucco in window lintel indicates the source of water infiltration – East Bulkhead Façade.

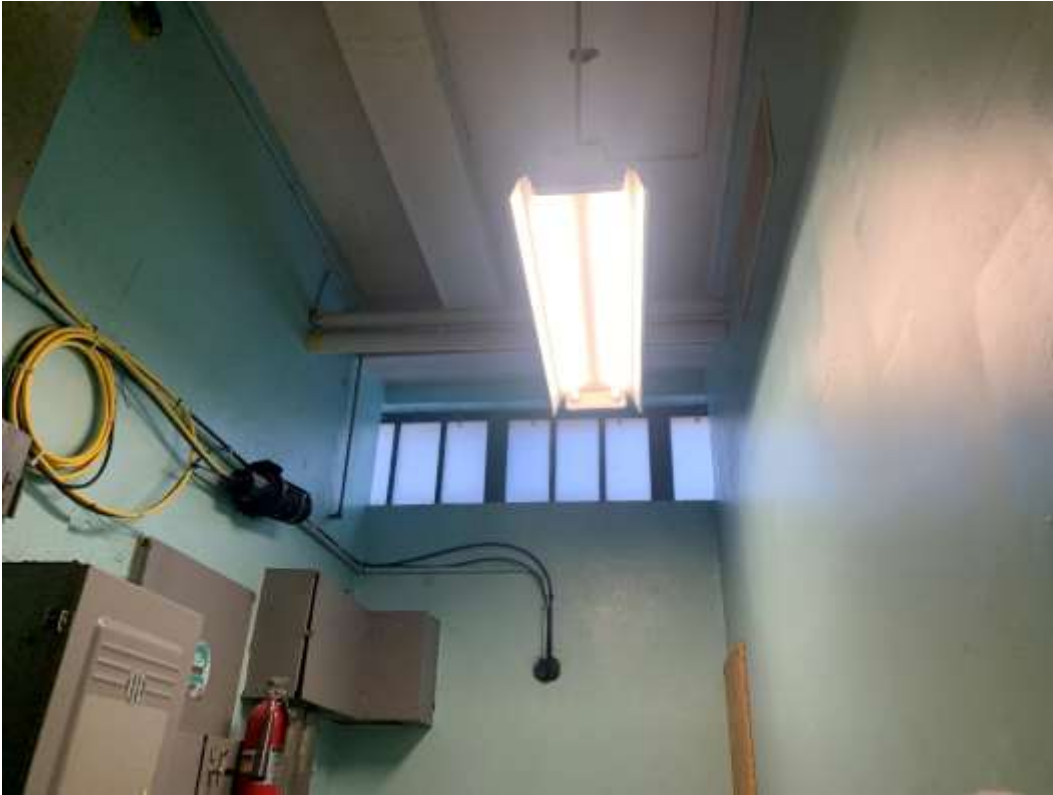
Photo A01 – View of electrical closet B2B.

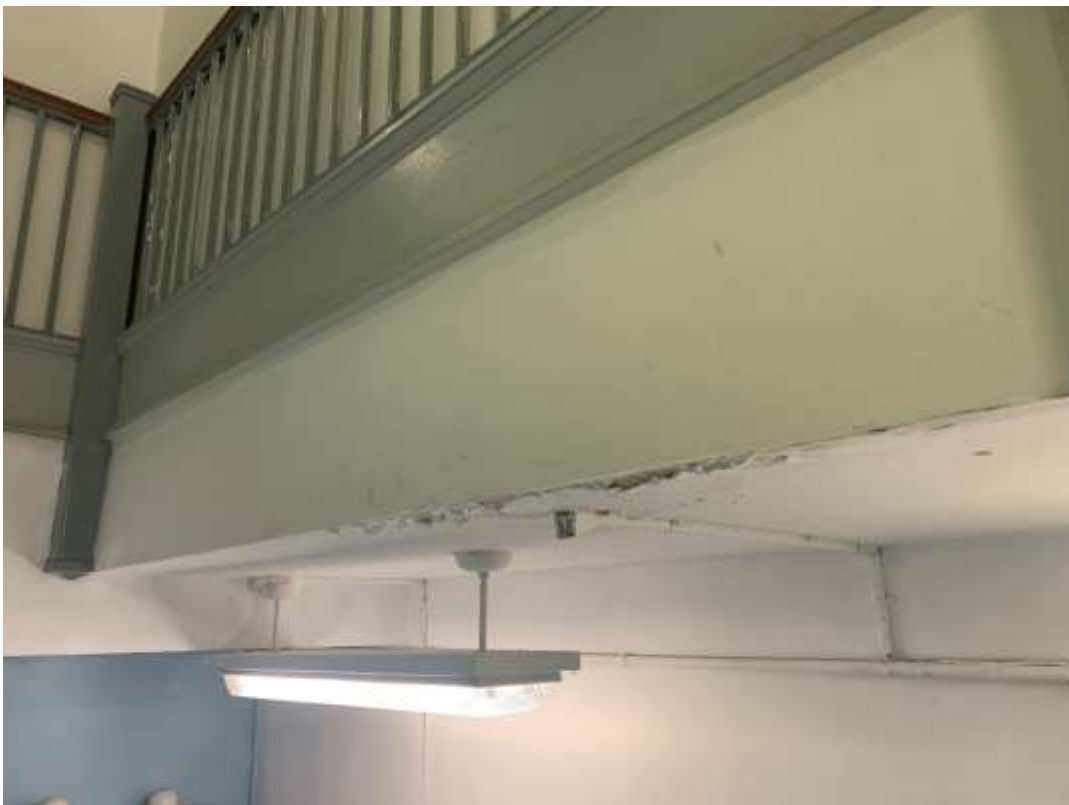
**Photo A06 – Deteriorated ceiling at basement stair #2.**

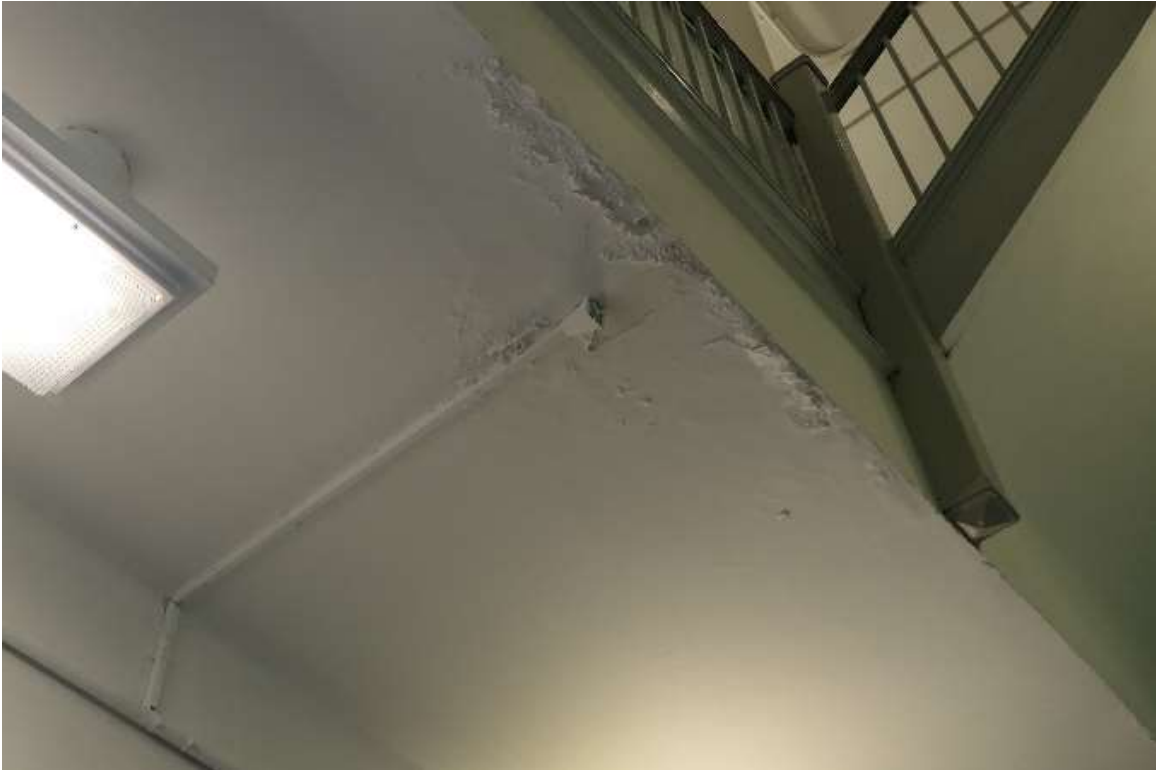
Photo A07– Deteriorated ceiling at basement stair #2.

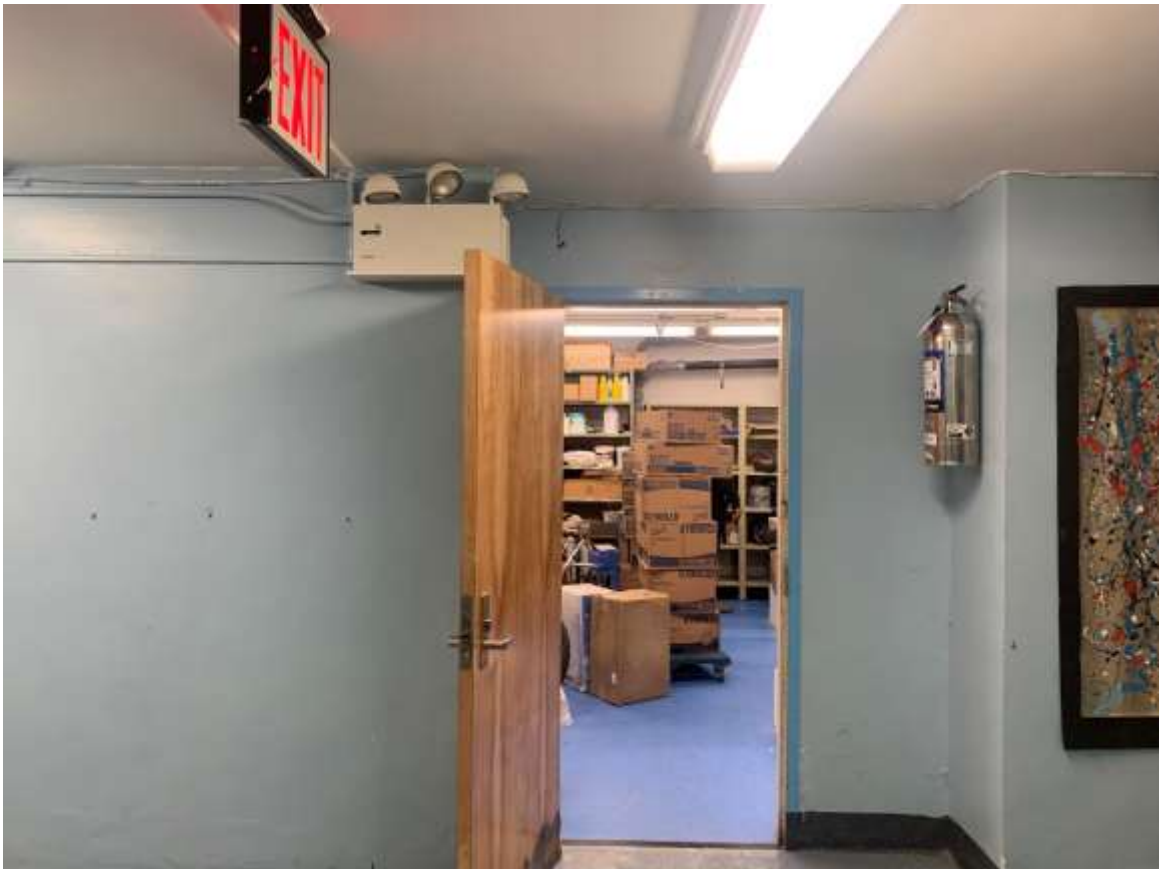
Photo A08 – View inside storage room B4 and damaged door.

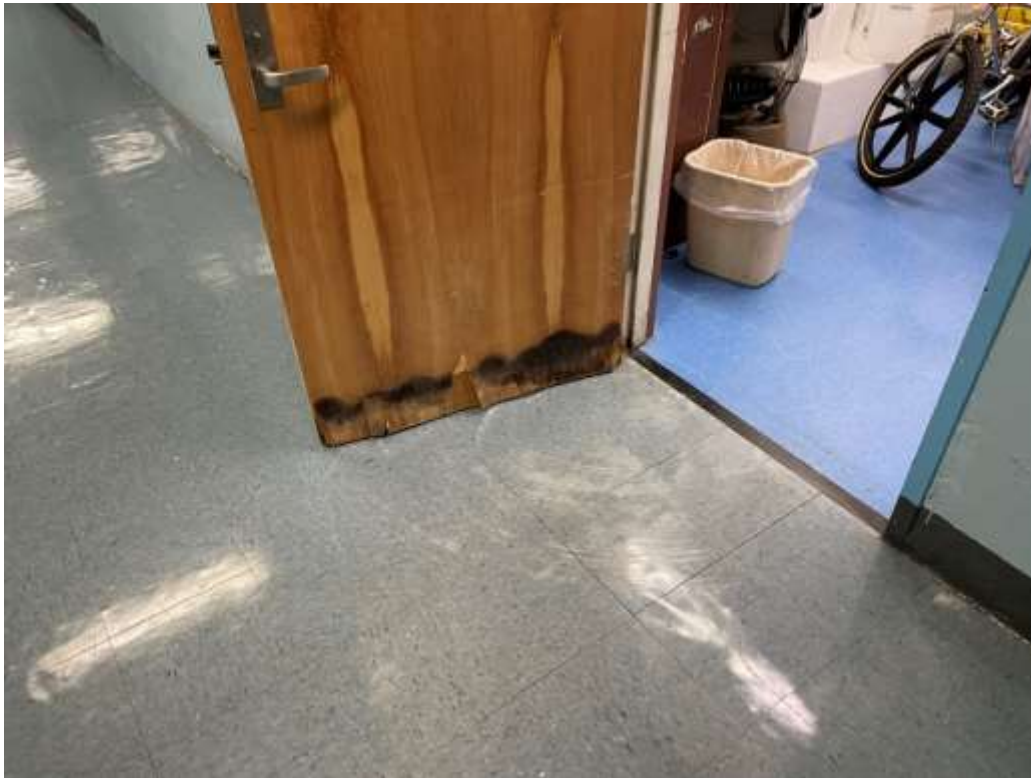
Photo A09 – Door water damage in Storage room B4.

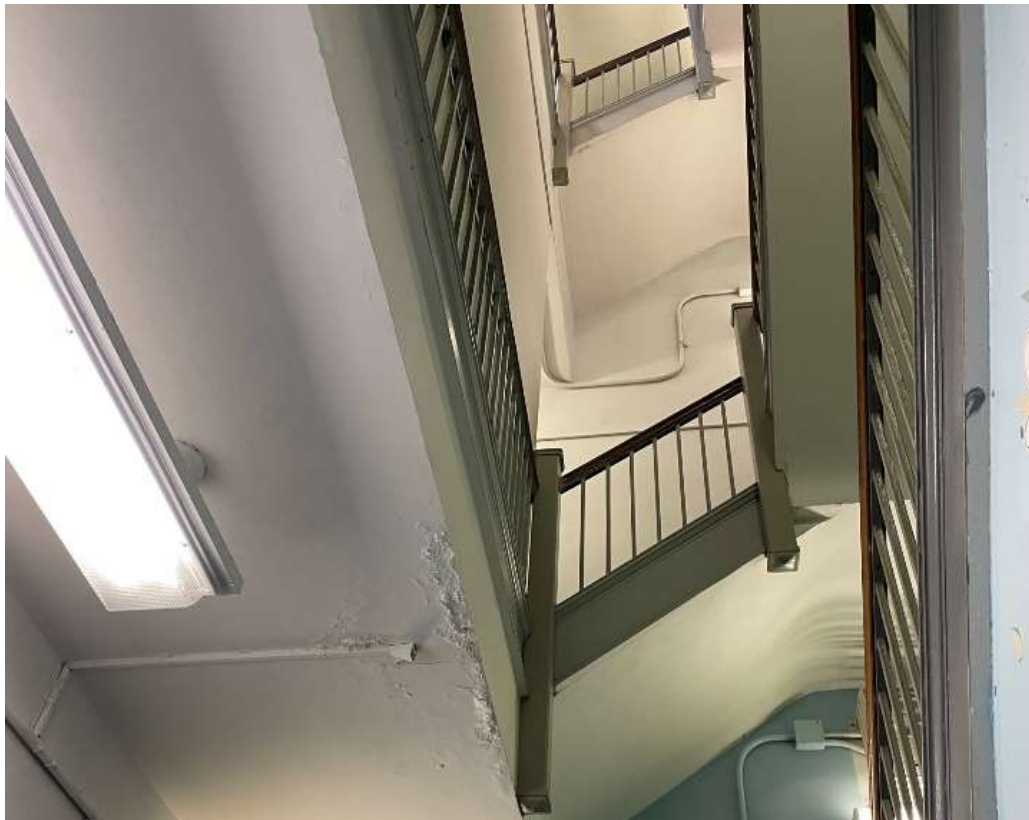
Photo A10 – View of stair #2, and damaged ceiling.

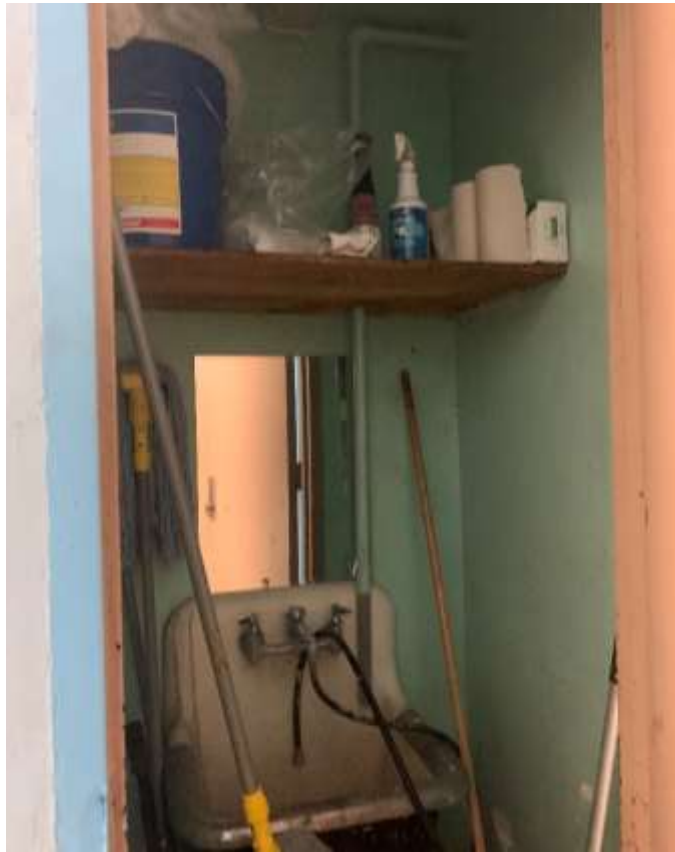
Photo A11 – Closet next to restroom at Basement Level B5.

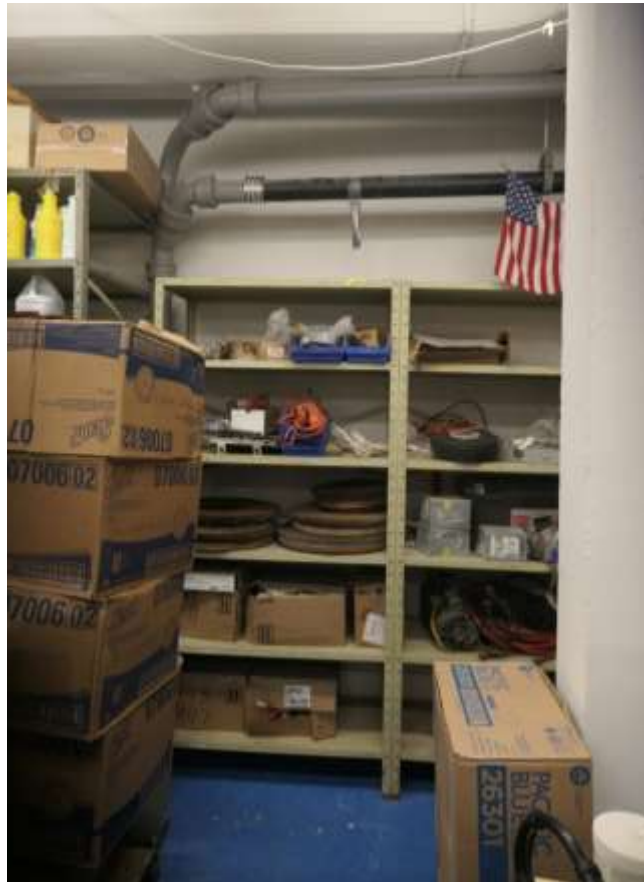
Photo A15 – View of Storage Room B4, view along the wall where the source of infiltration is located.

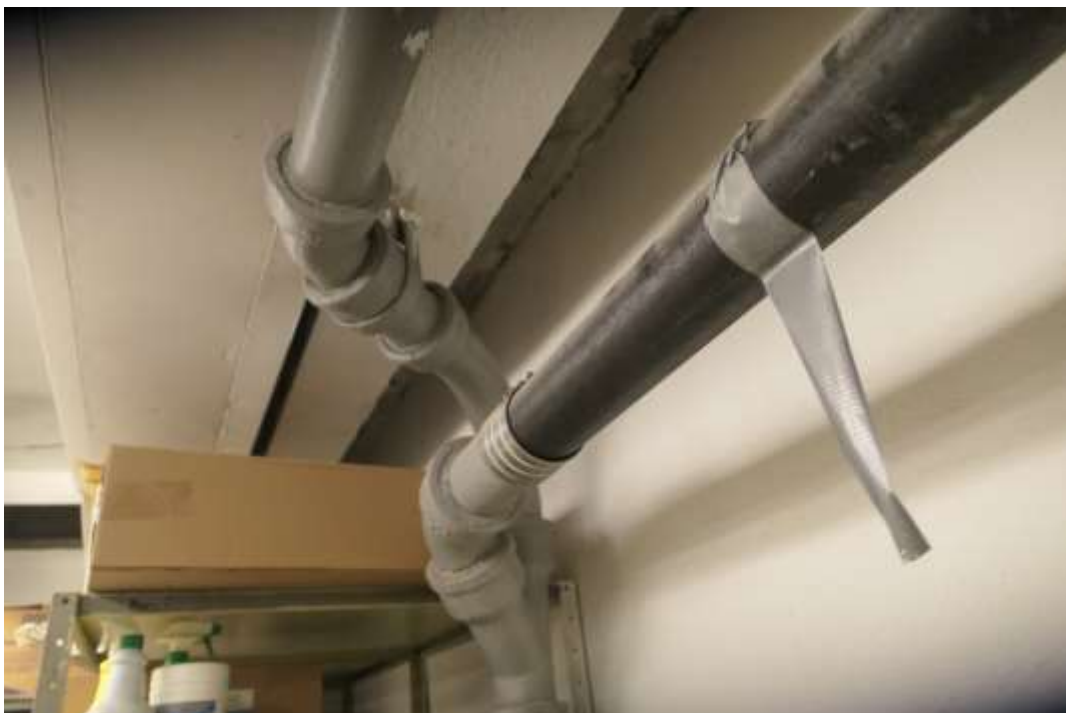
Photo A16 – Source of water infiltration is located at the ceiling line of Storage Room B4.

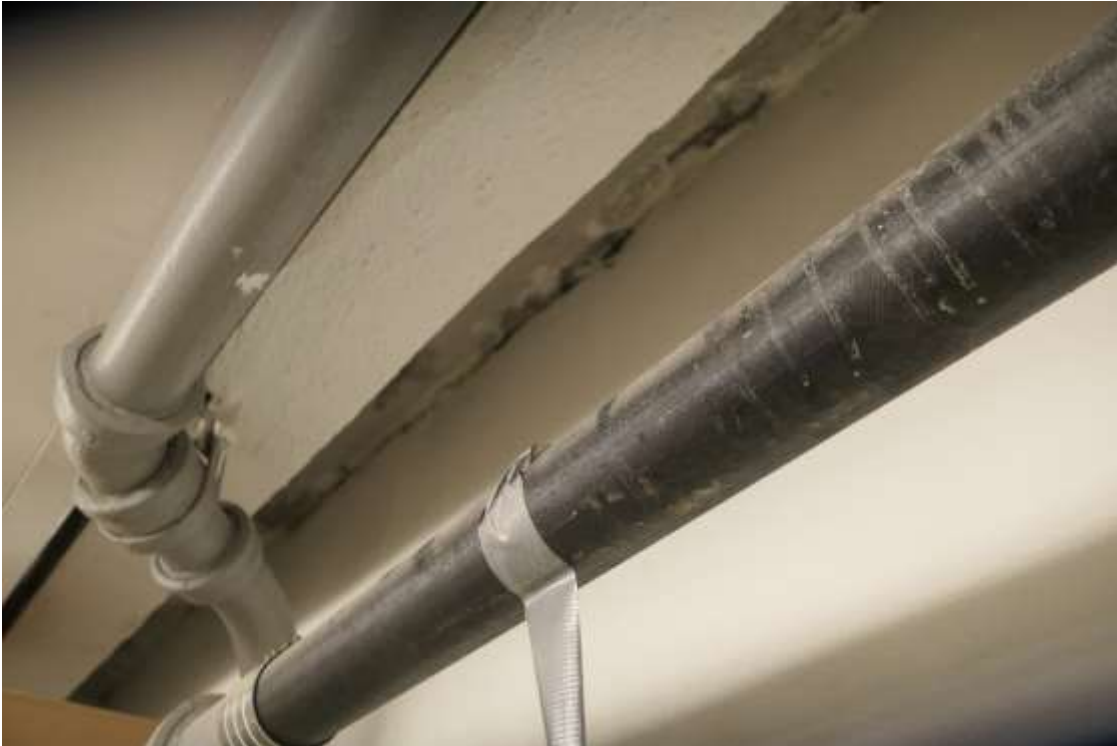
Photo A17 – Source of water infiltration is located at the ceiling line of Storage Room B4.

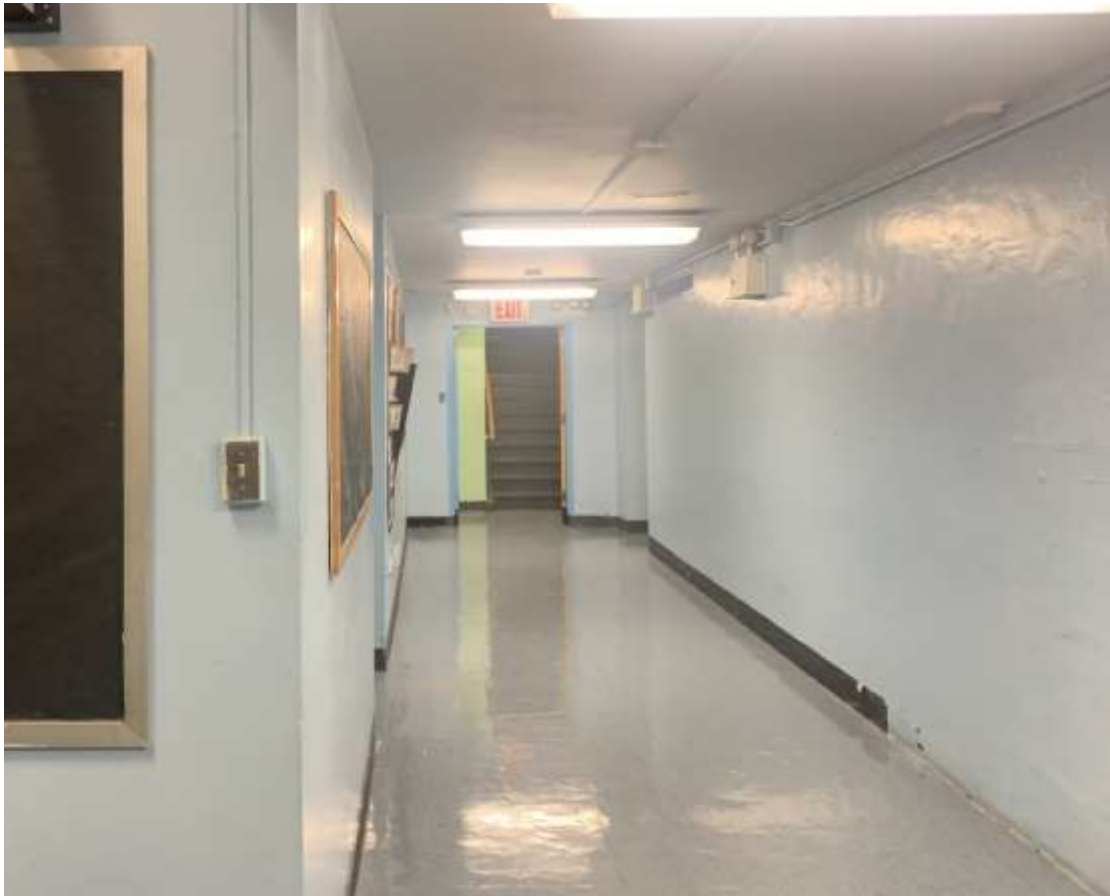
Photo A18 – View of hall towards Stair #3

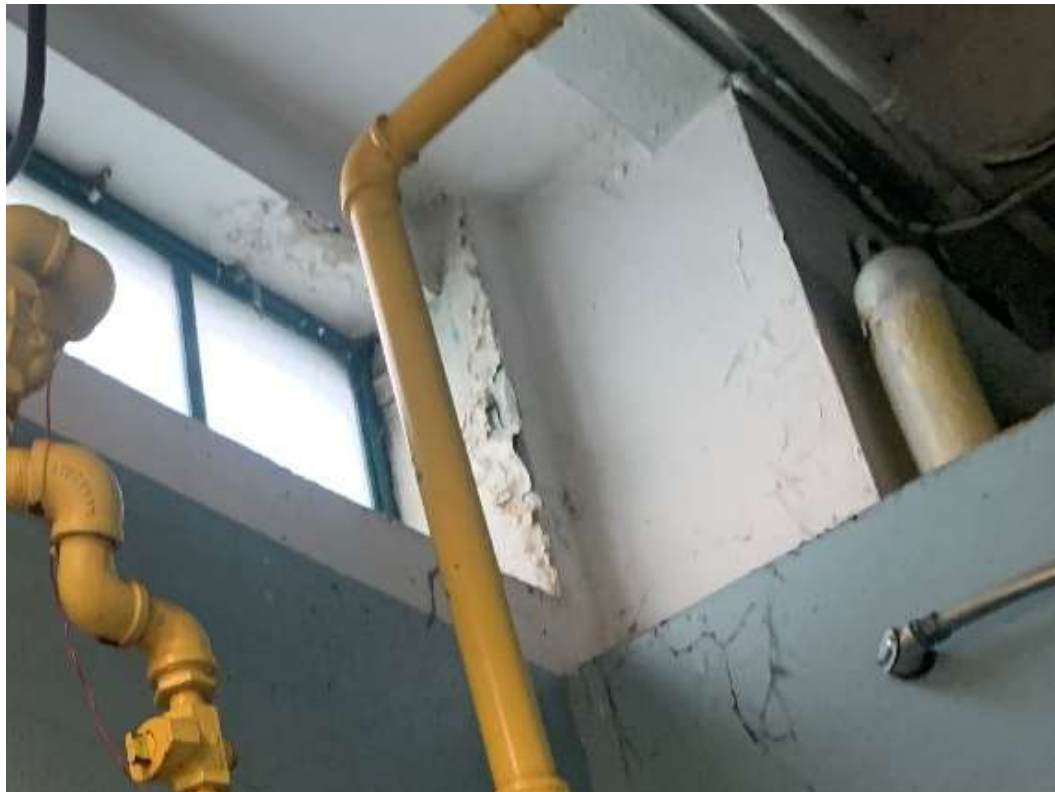
Photo A26 – Damage at plaster finish at Storage Room B3C

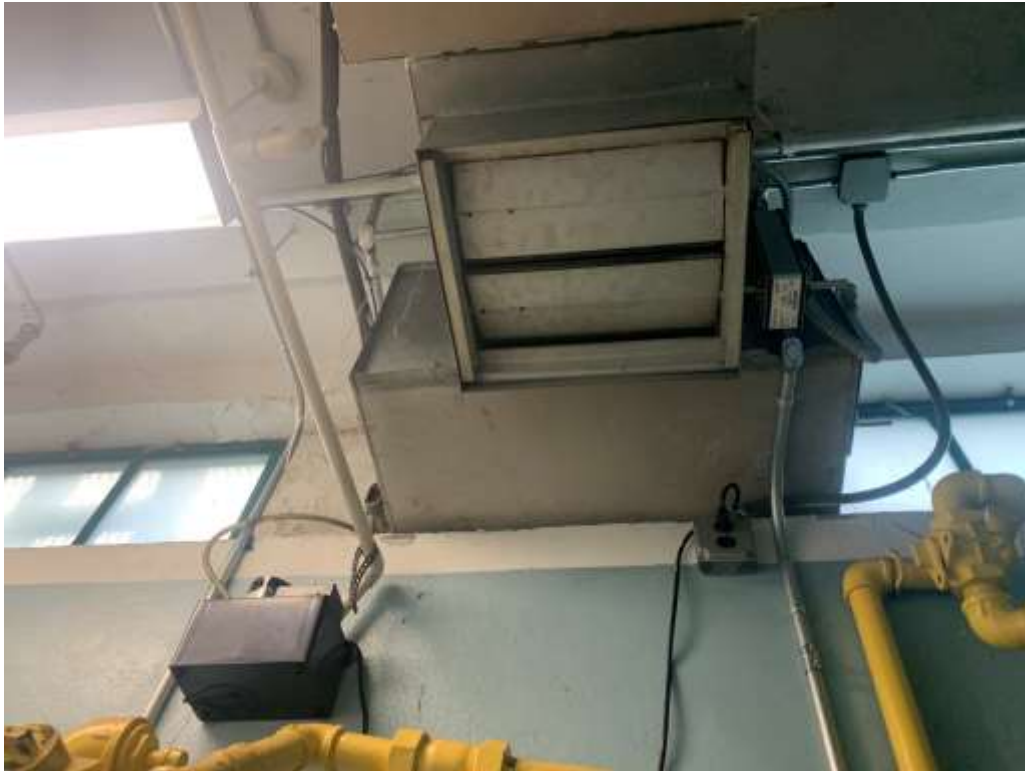
Photo A27 – View of Storage Room B3C.
