# Capital Improvement Program

Architecture & Engineering

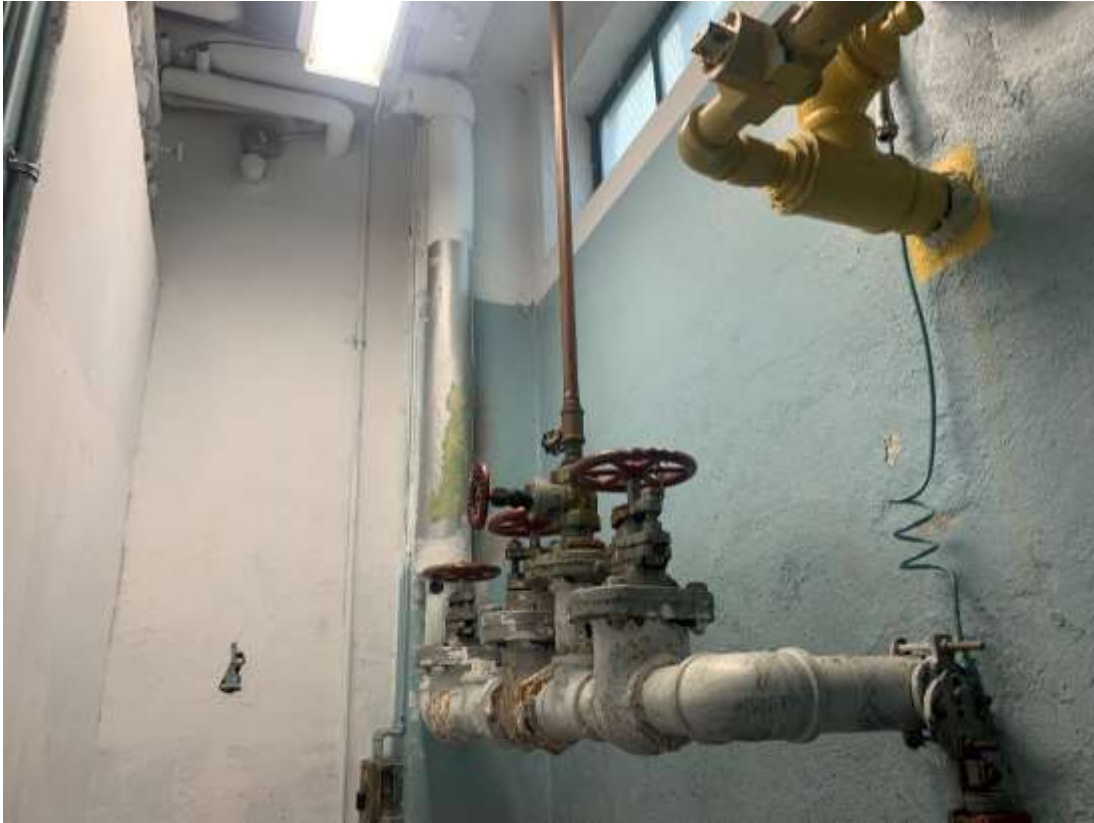
Photo A30 – View of damage at wall in Storage Room B3C.

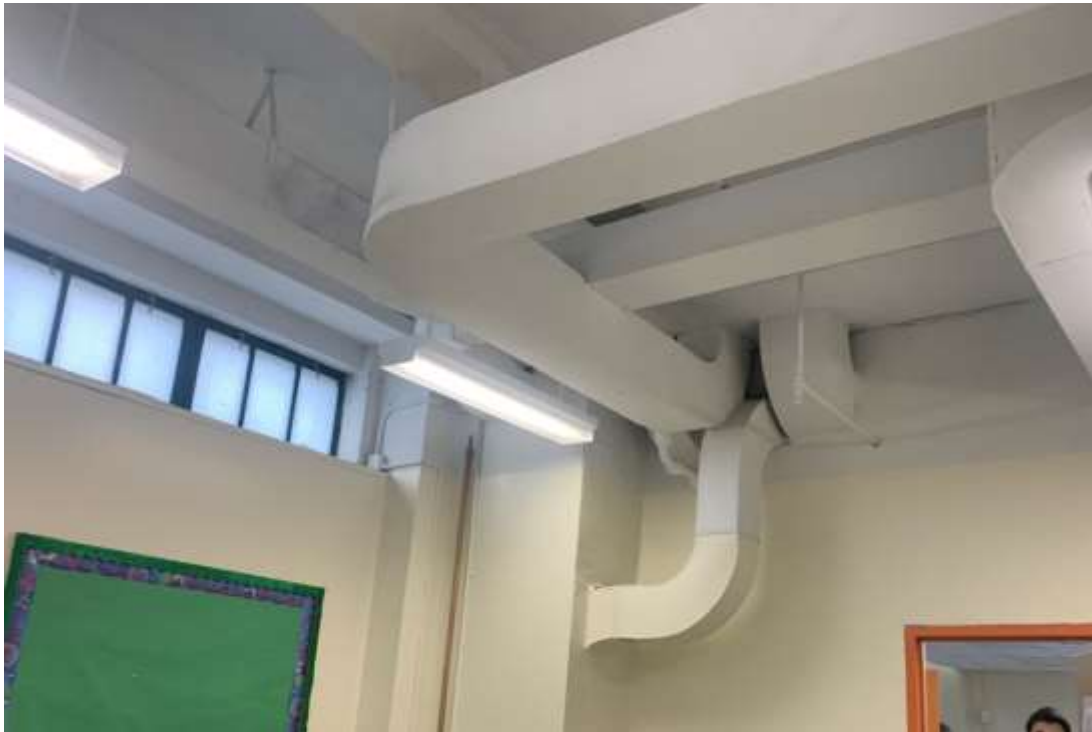
Photo A31 – View of Room B3B.

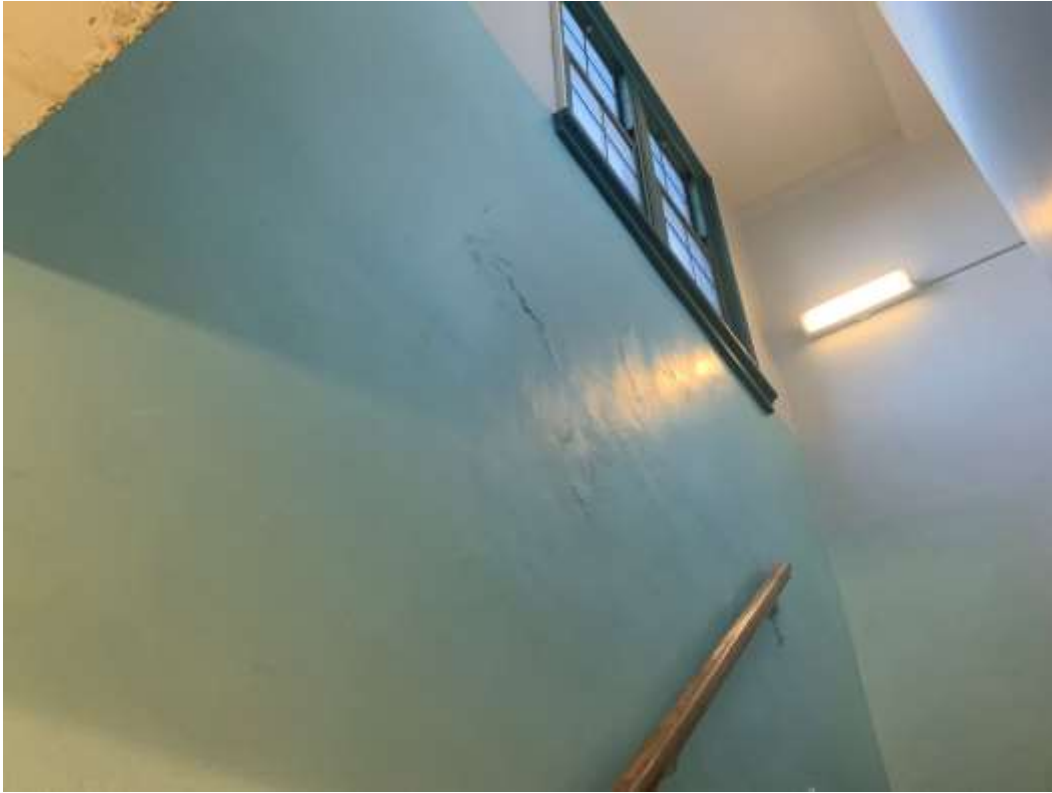
Photo A36 – Damaged interior plaster in bulkhead at wall in stair #2 area, indicates water infiltration.

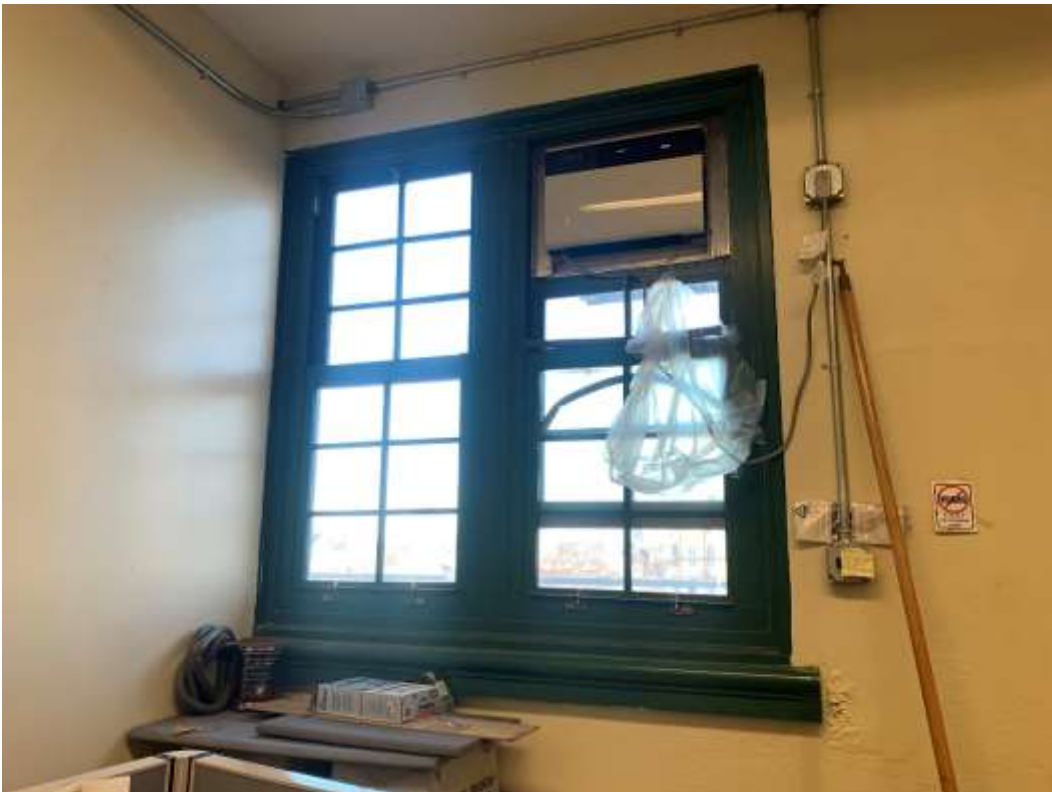
Photo A37 – Damaged interior plaster in bulkhead indicates water infiltration.

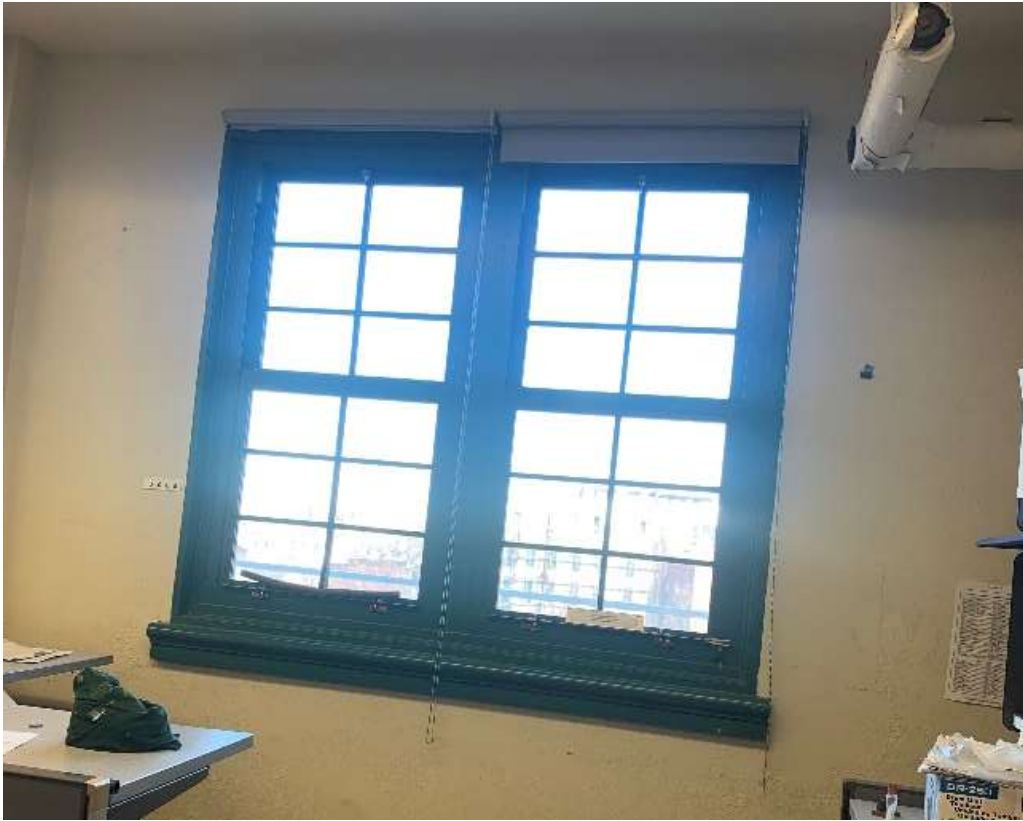
Photo A38 – Damaged interior plaster in bulkhead indicates water infiltration.

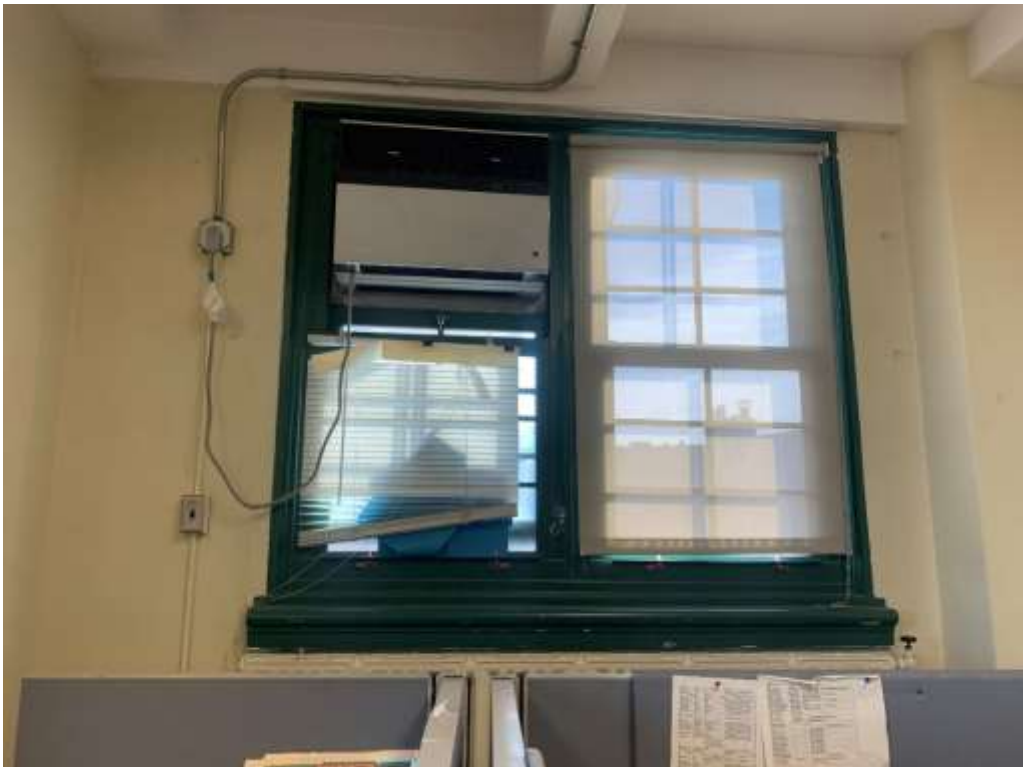
Photo A39 – Damaged interior plaster in bulkhead indicates water infiltration.

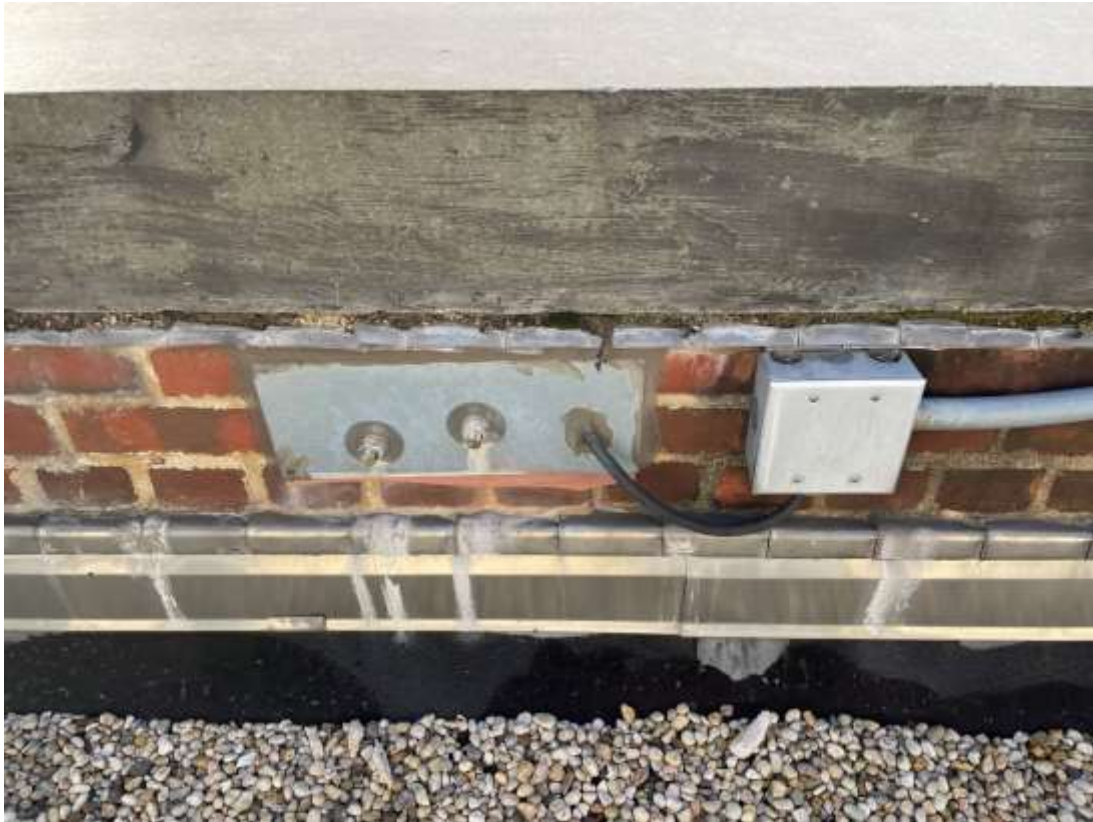
Photo P01 – Roof parapets are in overall good condition, there's some deteriorated brick joint mortar in some areas.

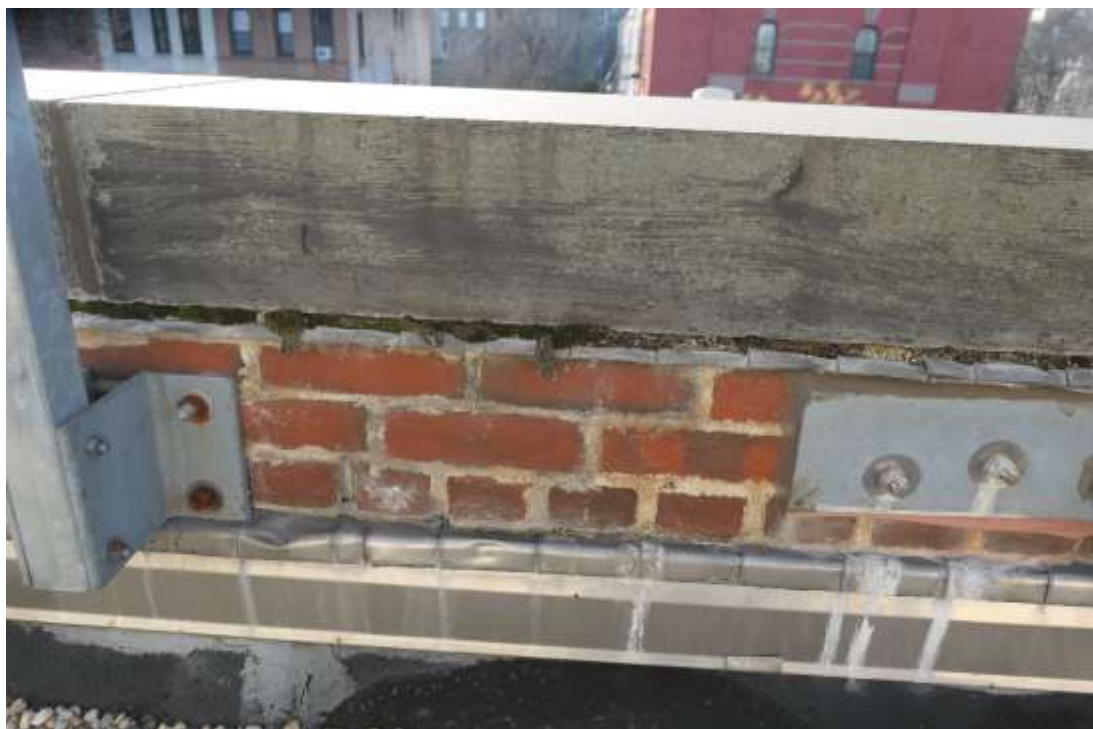
Photo P02 – Roof parapets are in overall good condition, there's some deteriorated brick joint mortar in some areas.

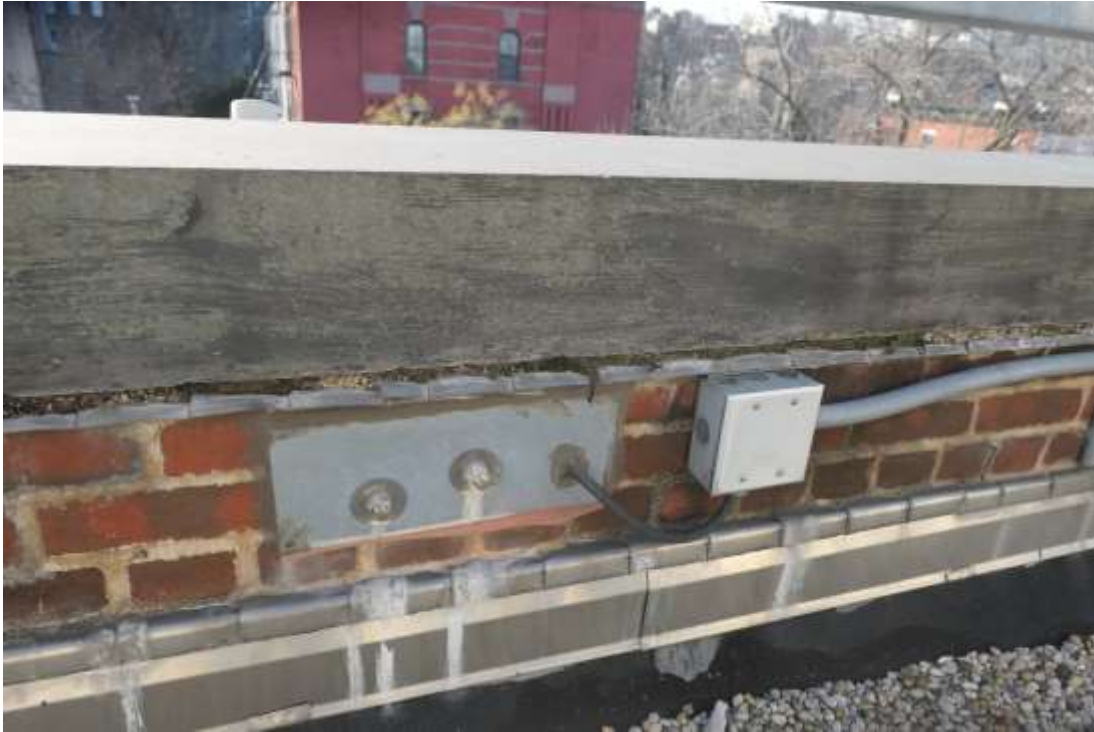
Photo P03 – Roof parapets are in overall good condition, there's some deteriorated brick joint mortar in some areas.

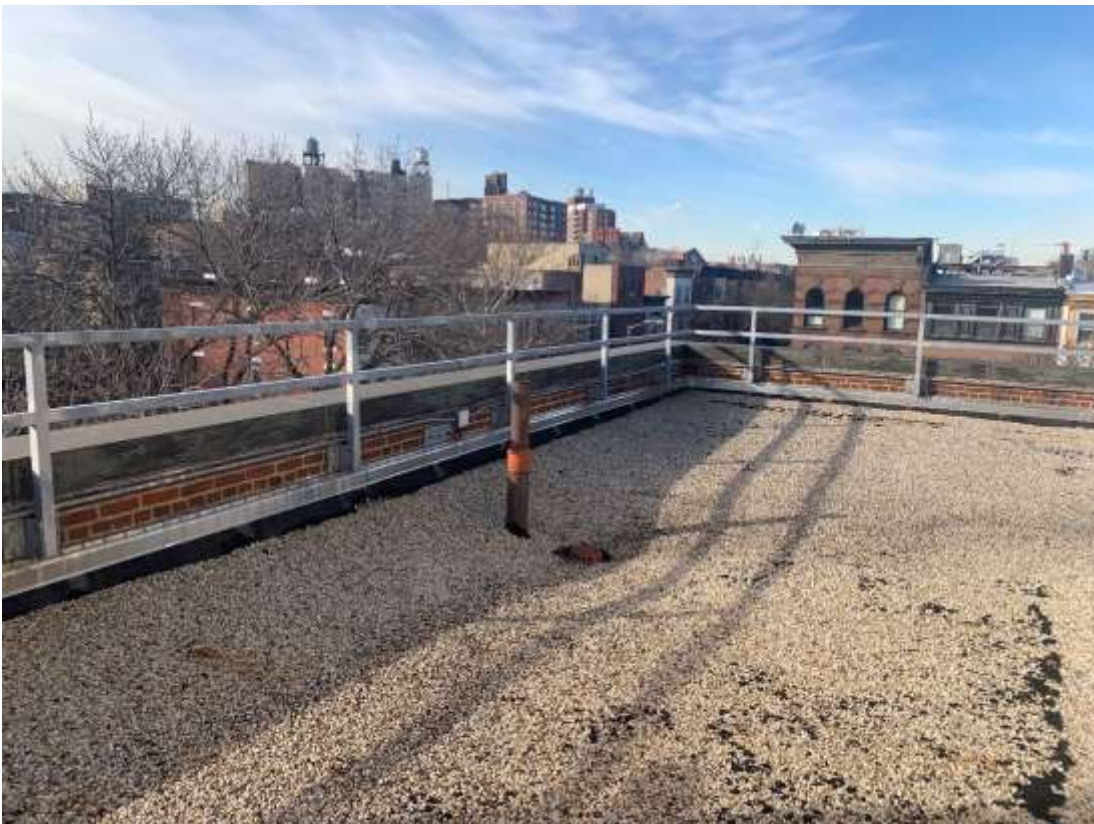
Photo P04 – Roof parapets are in overall good condition; roof is in good condition as well.

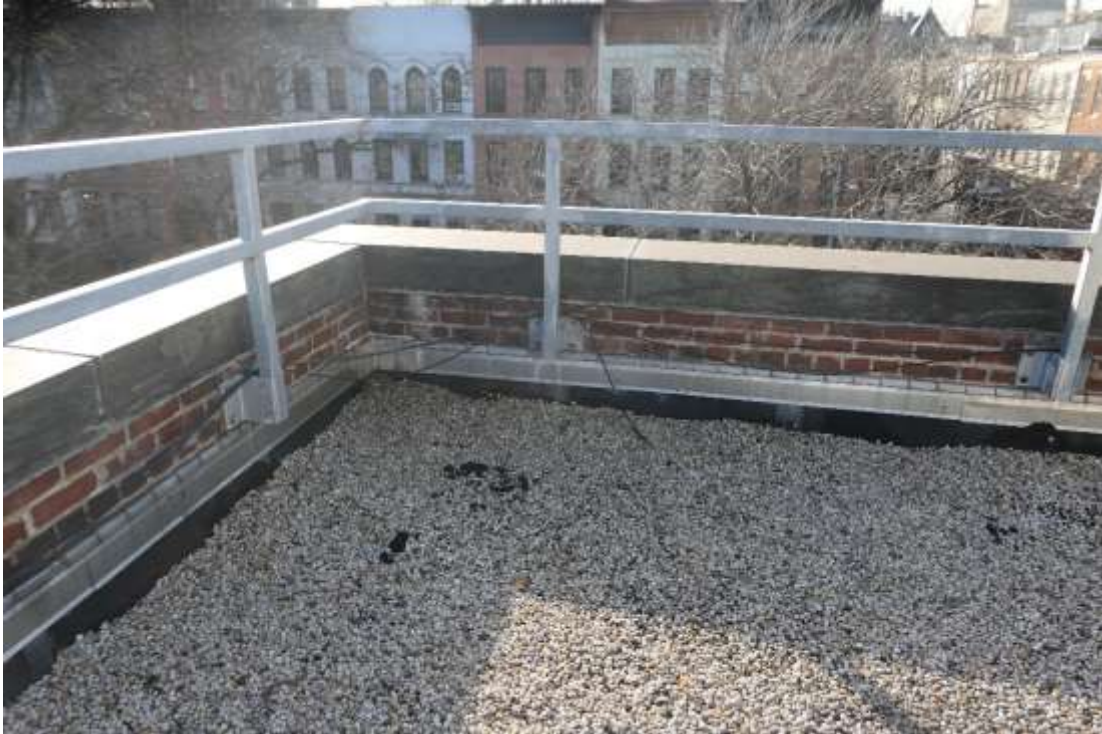
Photo P05 – Roof and roof barrier are in good condition, parapets shown some deteriorated brick joint mortar in some areas.

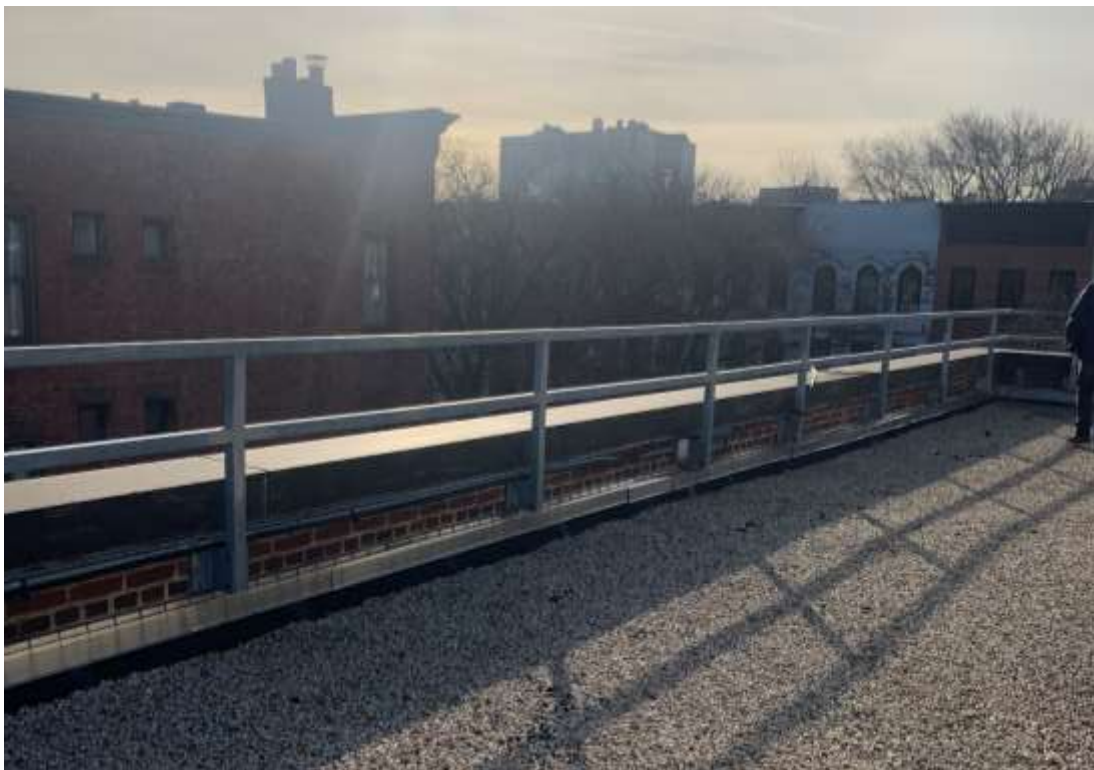
Photo P06 – Roof Barrier is in good condition.

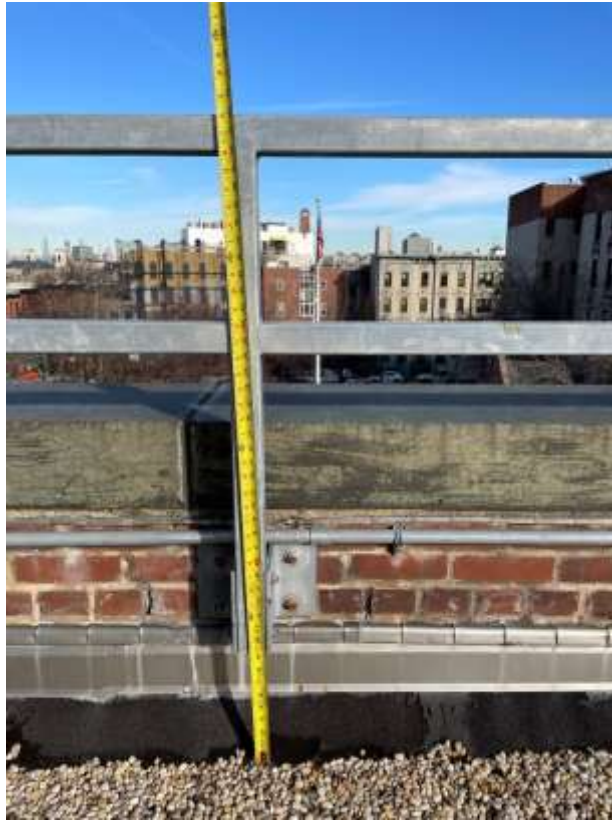
Photo P07 – Roof Barrier is up to code and in good condition.

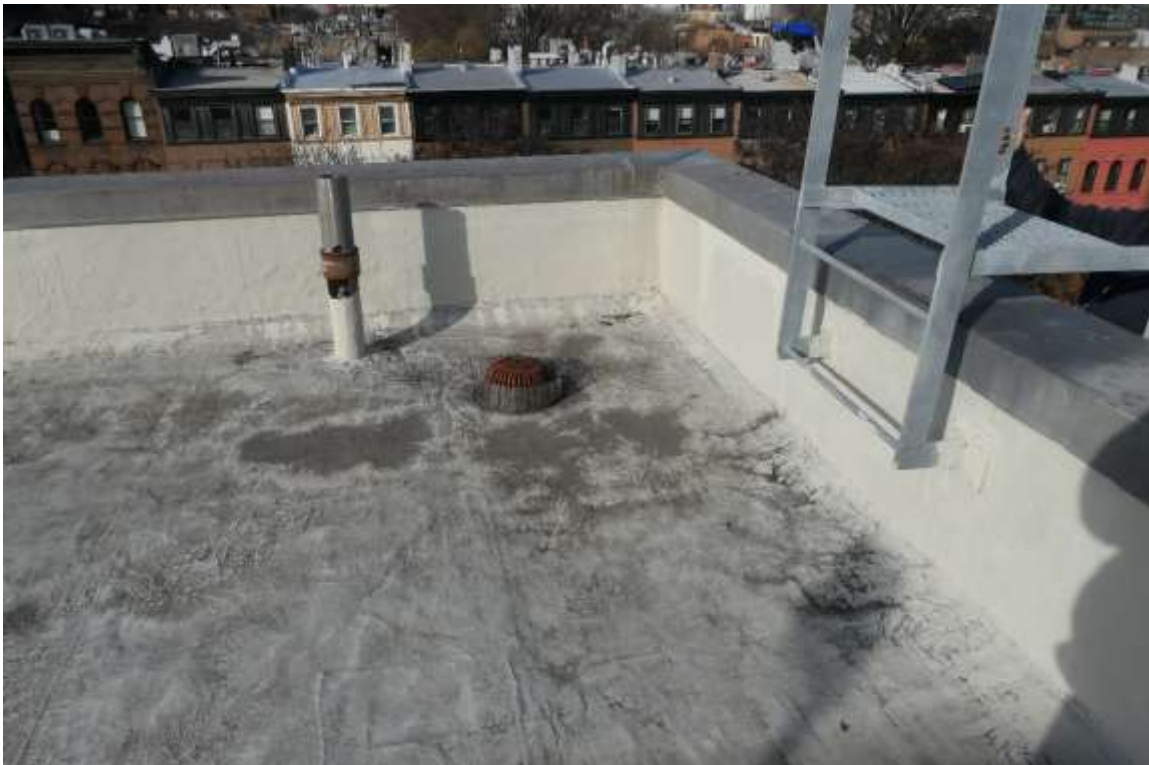
Photo P08 – Bulkhead parapet, roof drains and vents are in good condition.

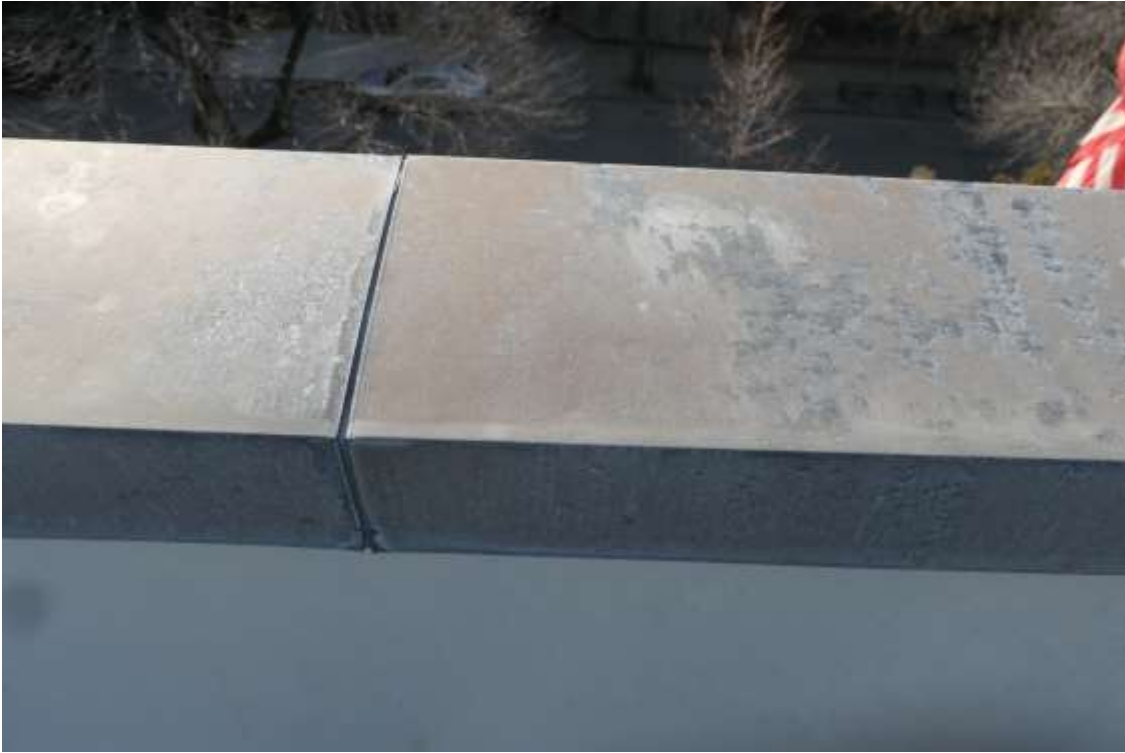
Photo P09 – Parapets at bulkhead roof are in good condition.

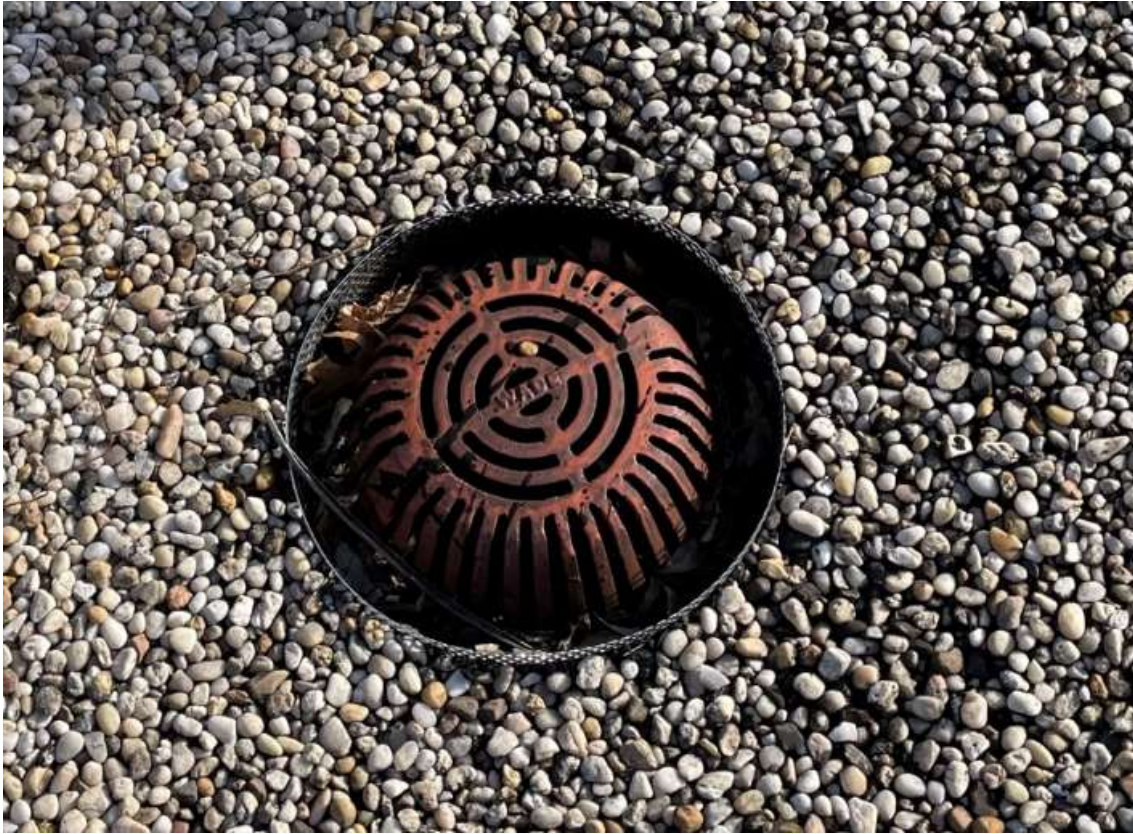
Photo R01 – All roof drains are in good condition.

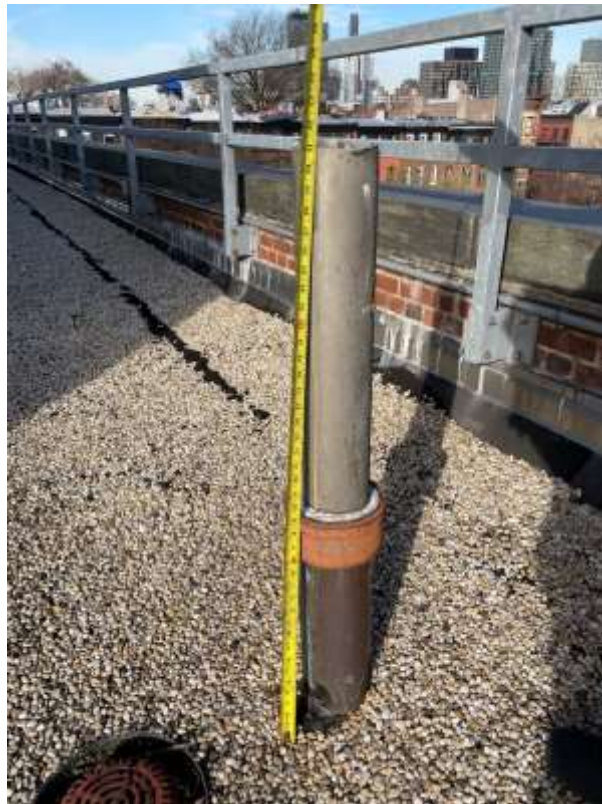
Photo R02 – All vents are in good condition.

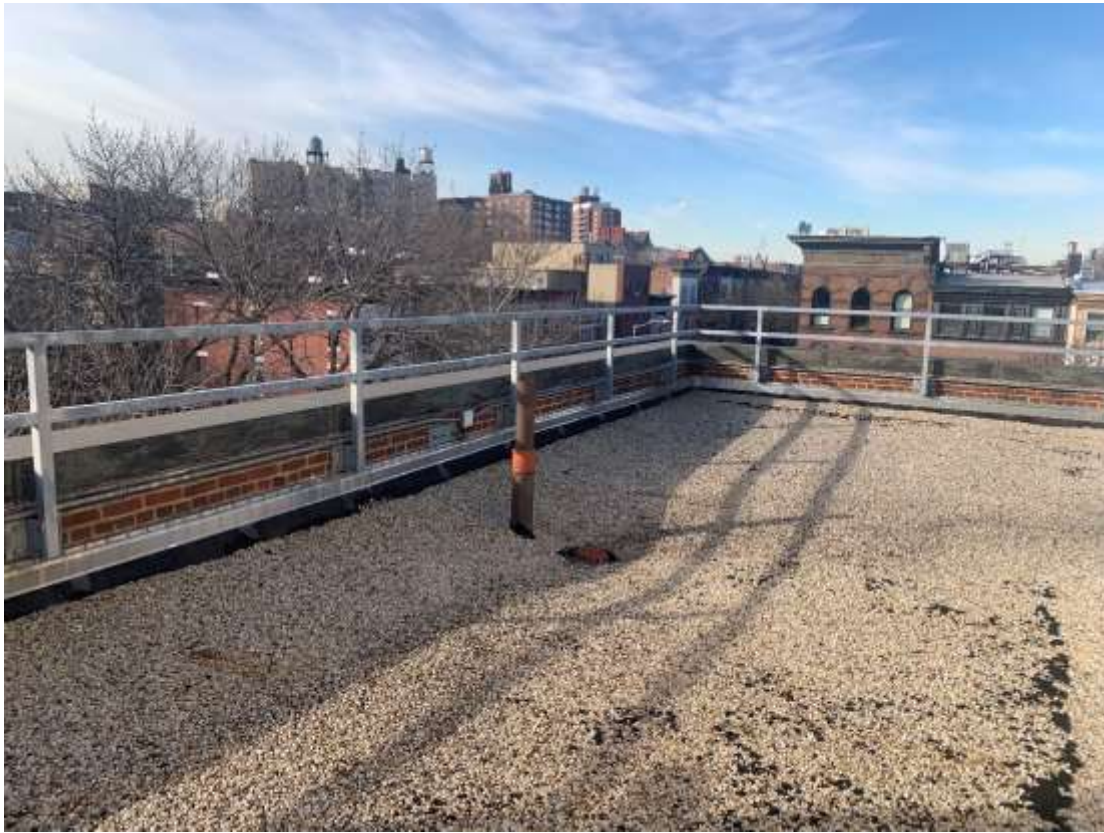
**Photo R03 – View of Roof, facing Southwest.**

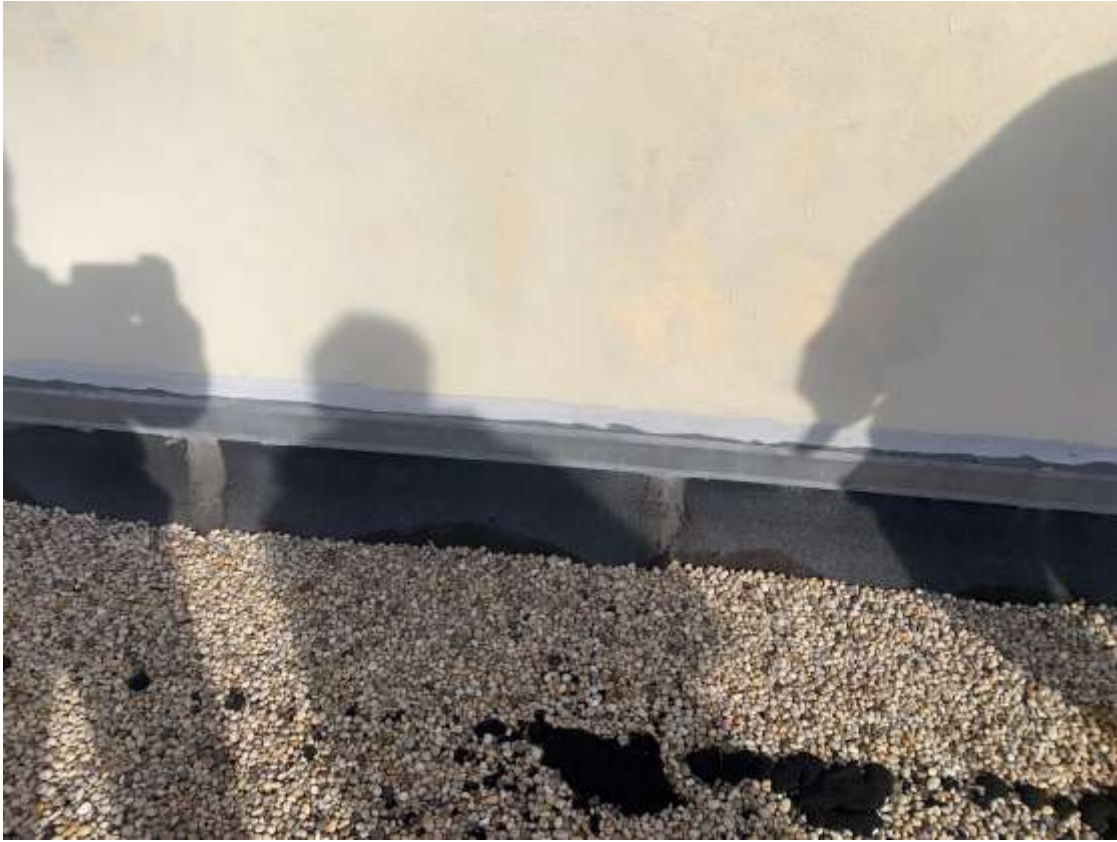
Photo R05 – Roof flashing is in good condition.

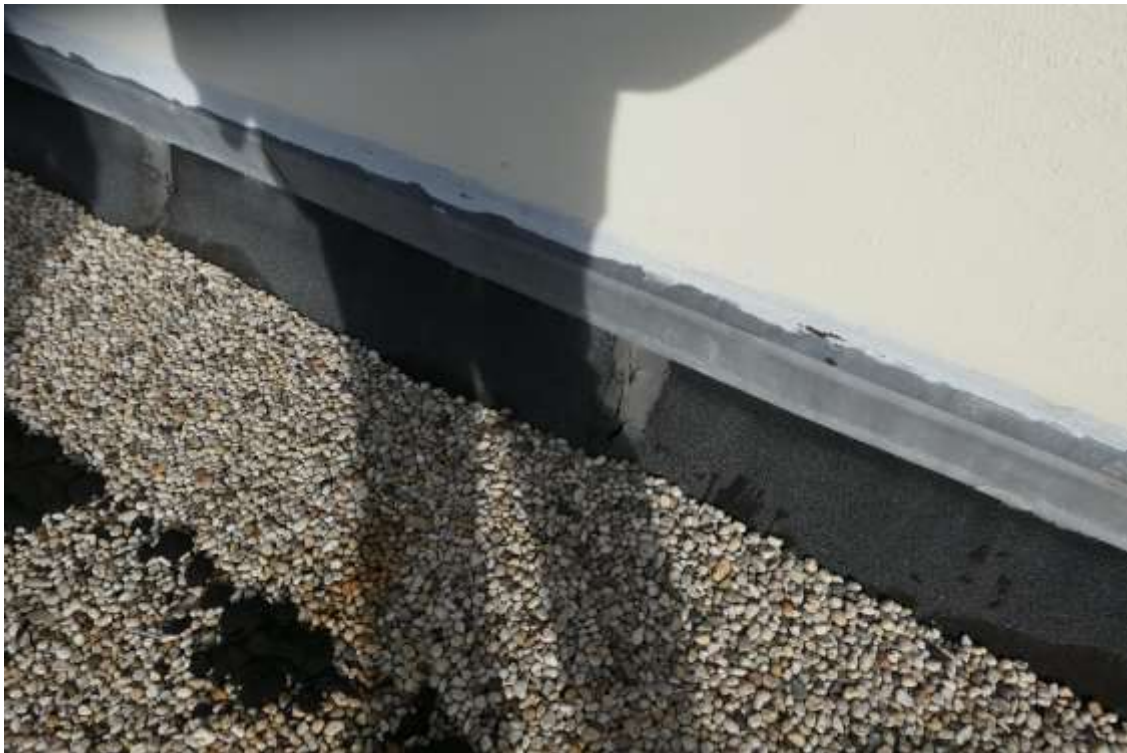
Photo R06 – Roof flashing is in good condition.

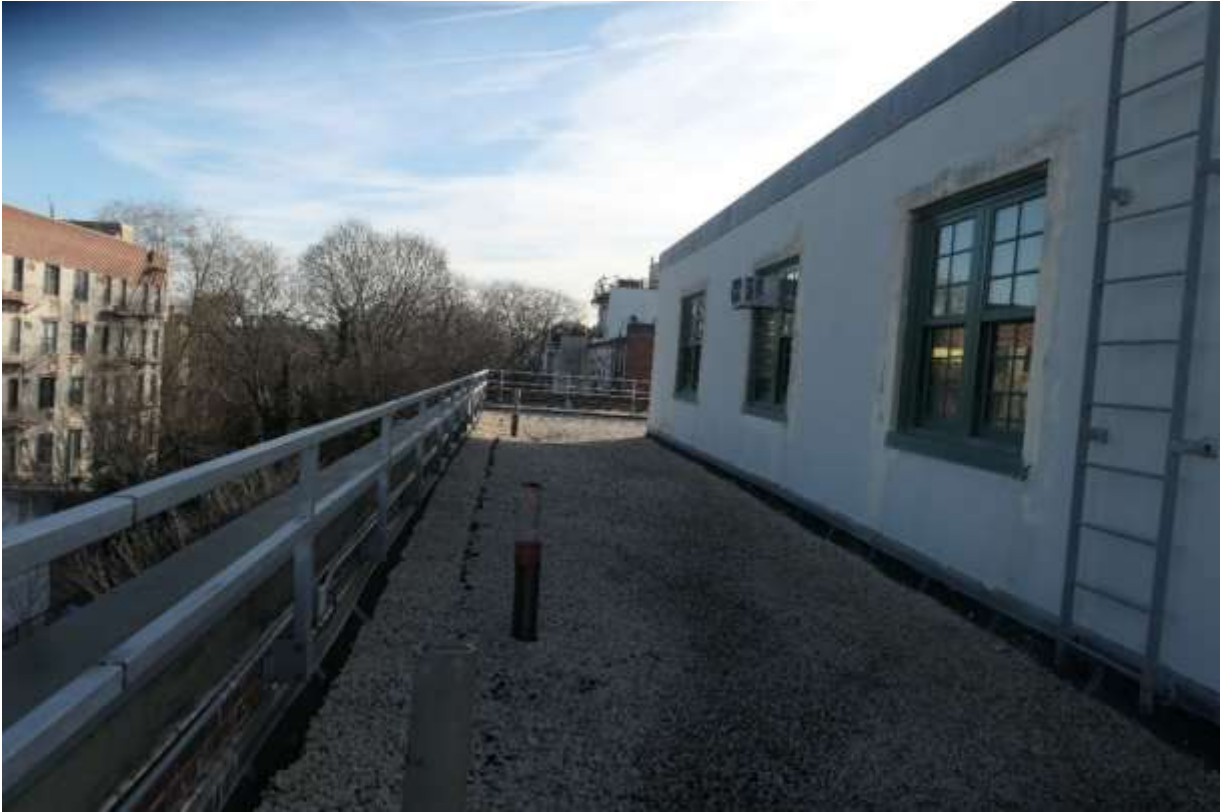
**Photo R07 – View of Roof and North Bulkhead façade, facing East.**

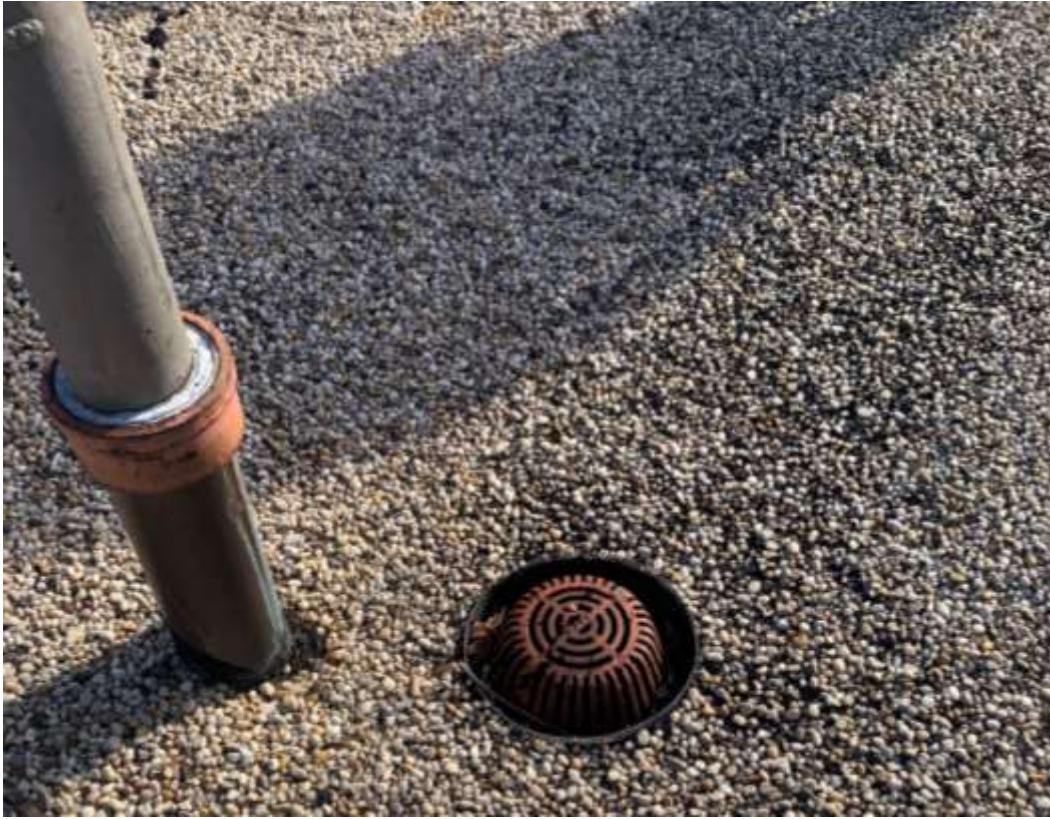
Photo R09 – Roof drains and vents are in good condition.

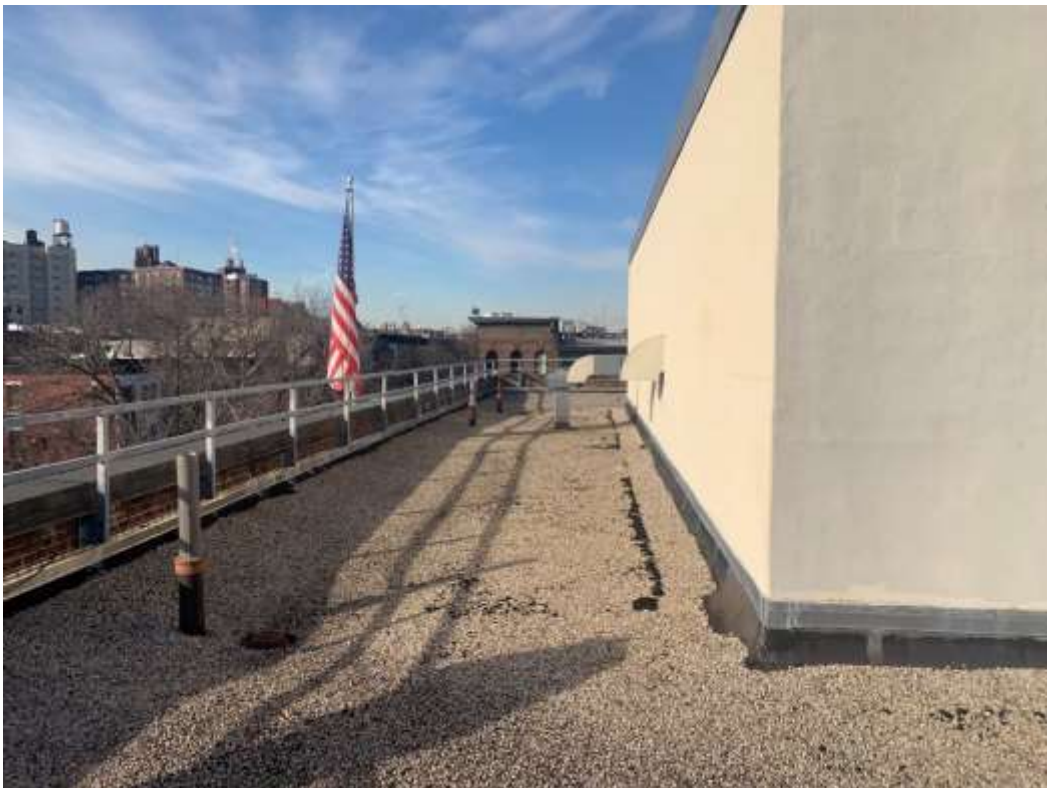
Photo R10 – View of Roof and Southwest Bulkhead, facing West.

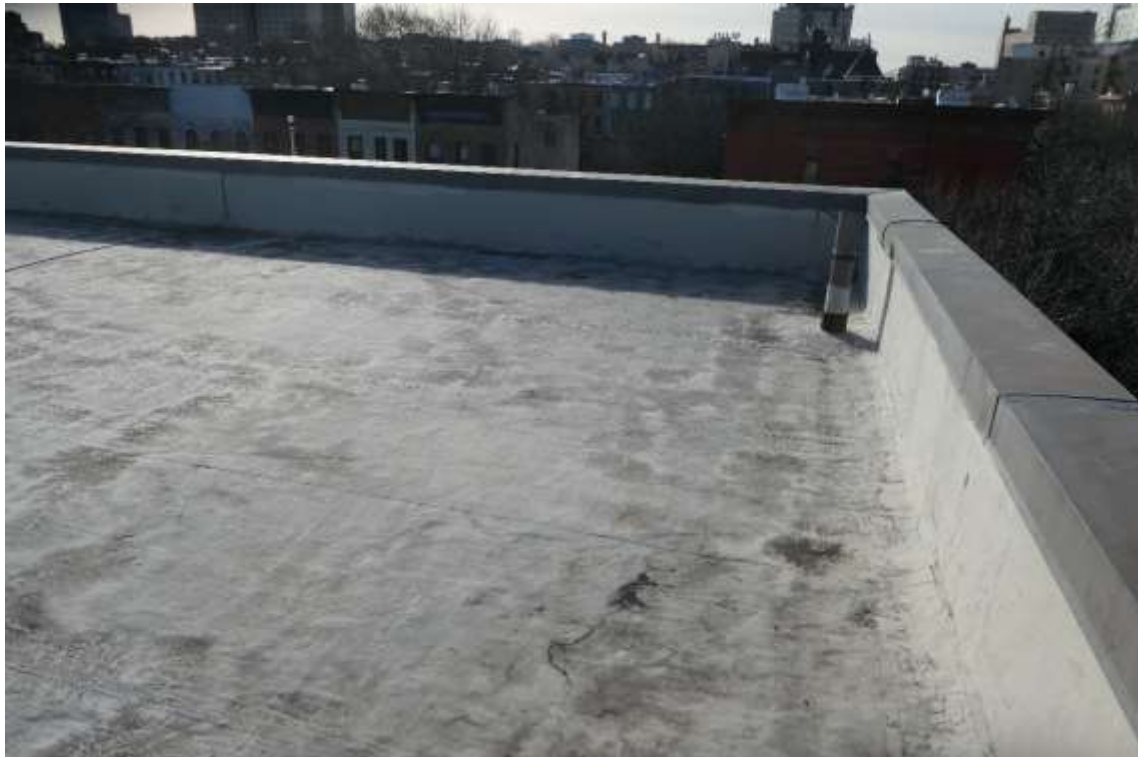
Photo R12 – Bulkhead parapets are in good condition.

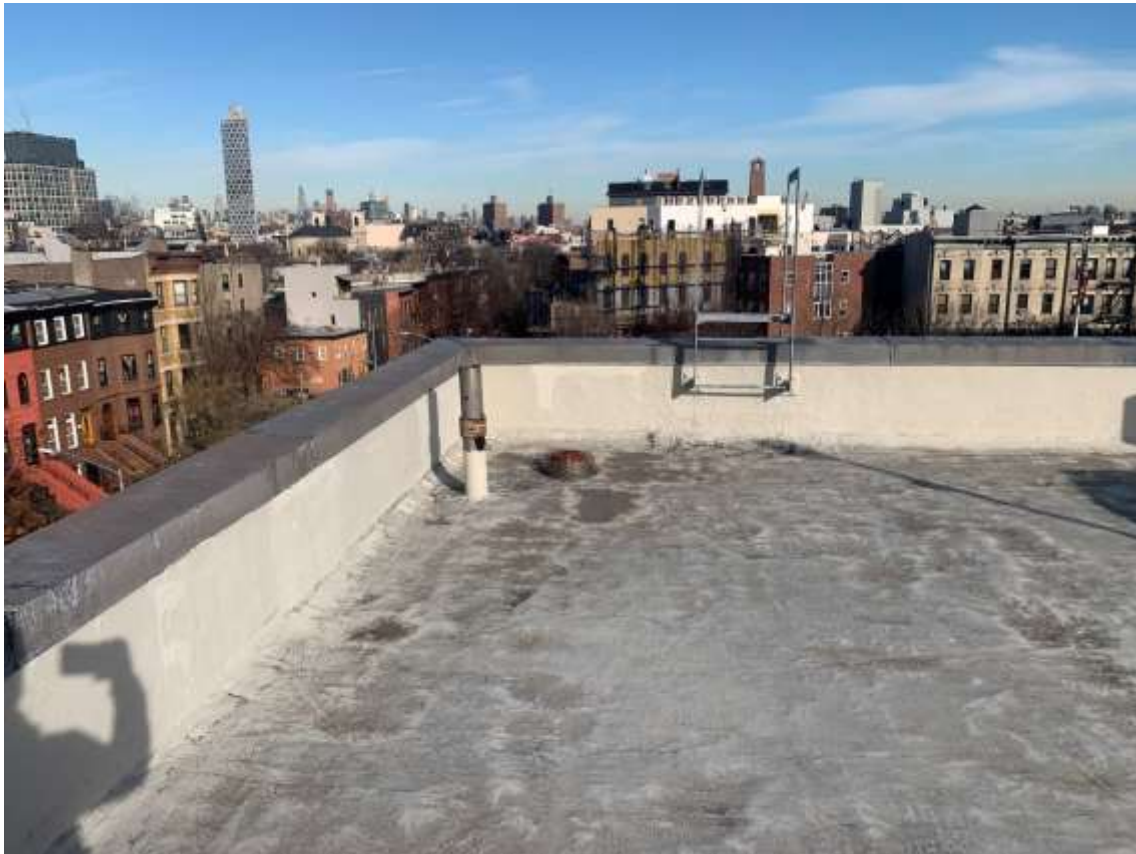
Photo R13 – View of bulkhead roof, roof ladder, vent and roof drain, facing North.

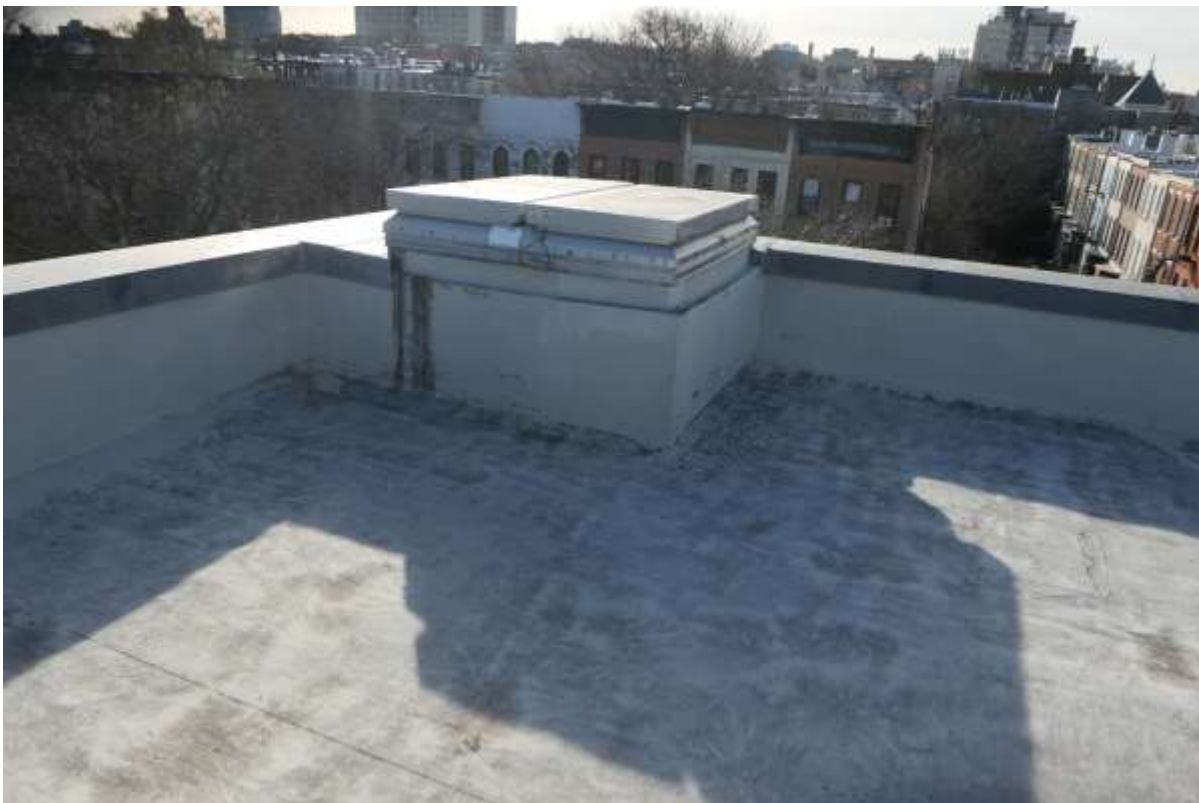
**Photo R18 – Roof hatch at Bulkhead roof is in good condition.**

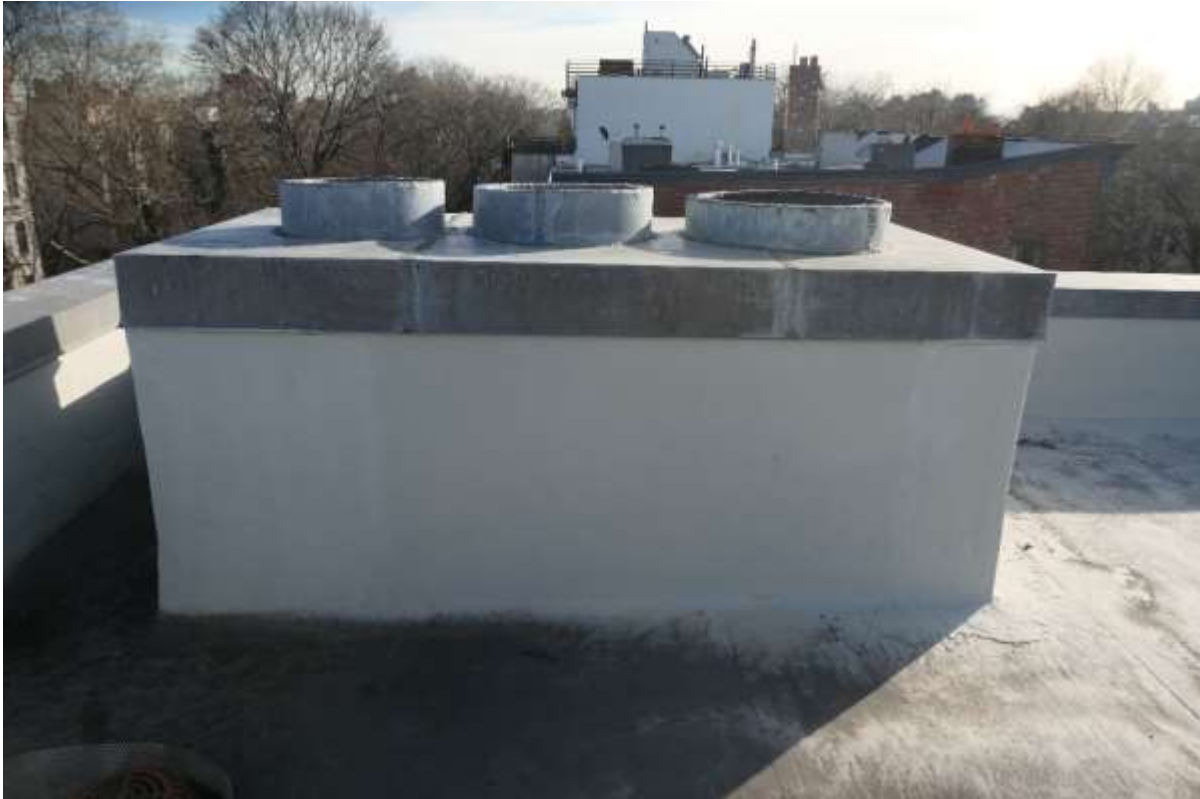
**Photo R19 – Chimney at bulkhead roof is in good condition.**
