# Capital Improvement Program

Architecture & Engineering

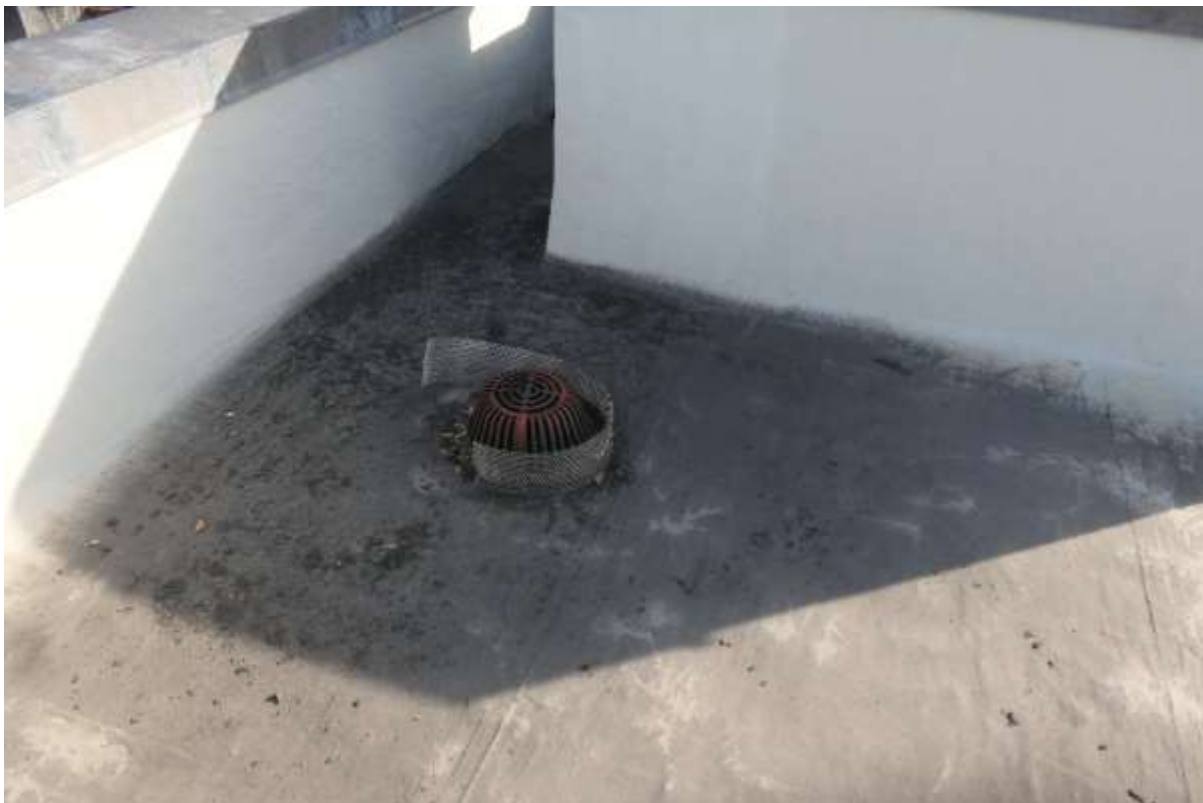
**Photo R20 – Roof drains at Bulkhead roof are in good condition.**

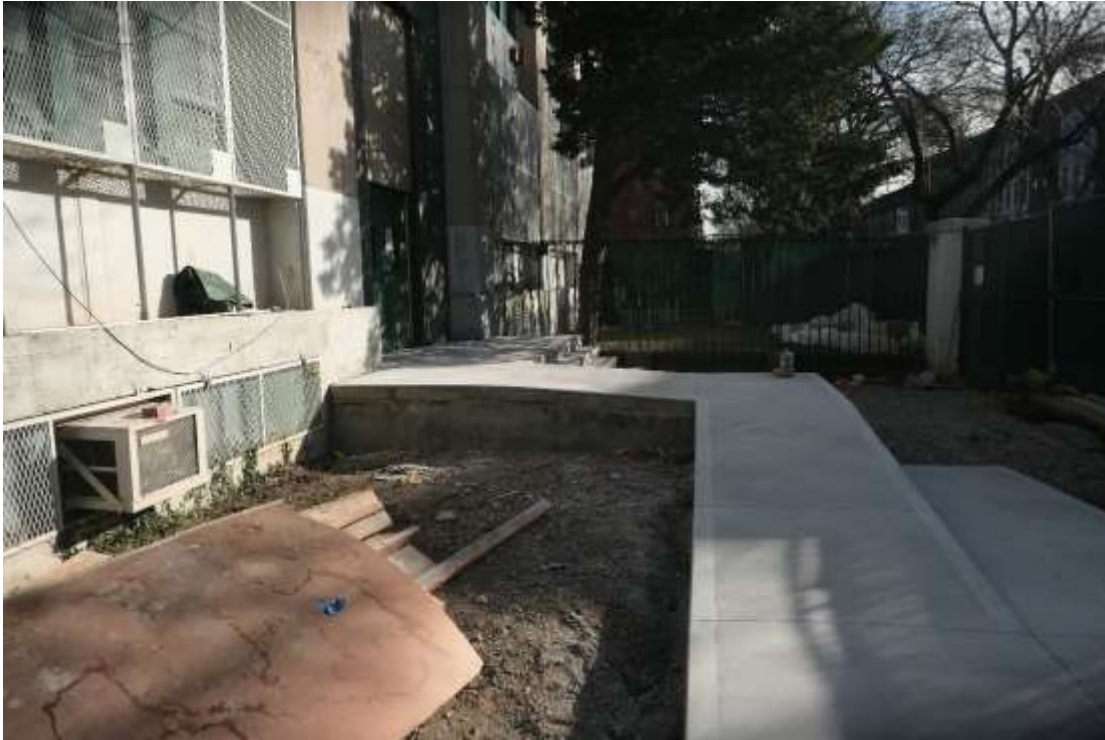
**Photo S01 – Existing ramp at main entrance.**

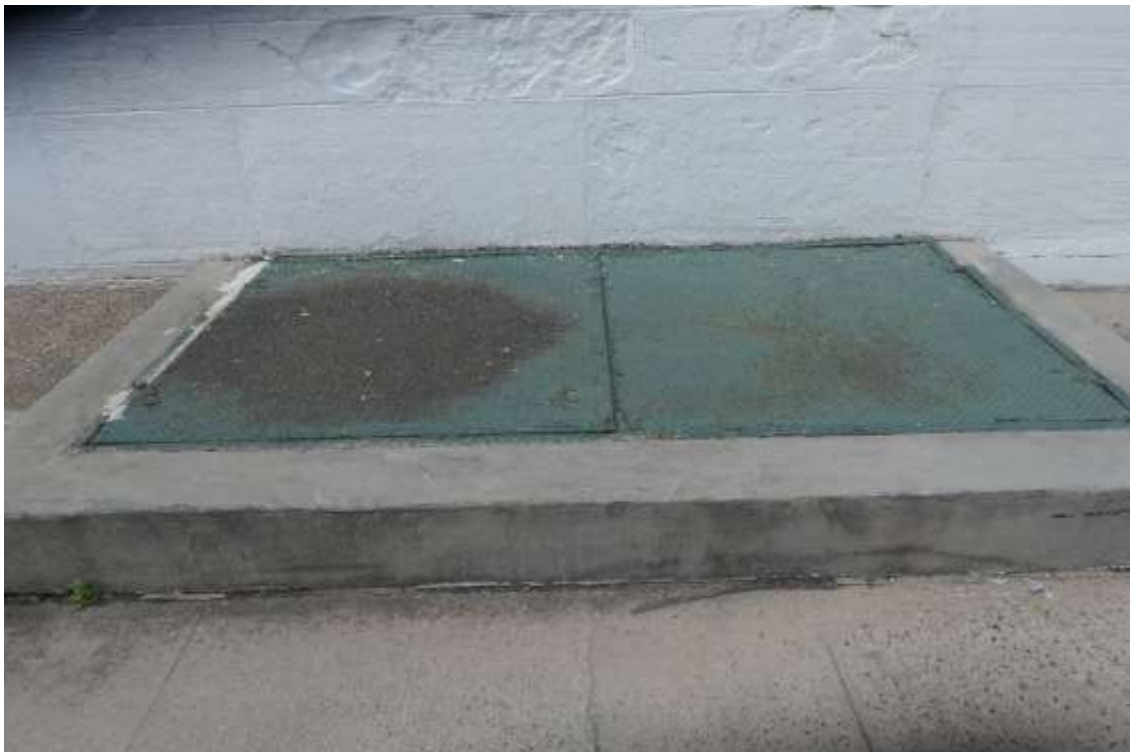
Photo S04 –Vault/Hoist Doors are in fair condition.

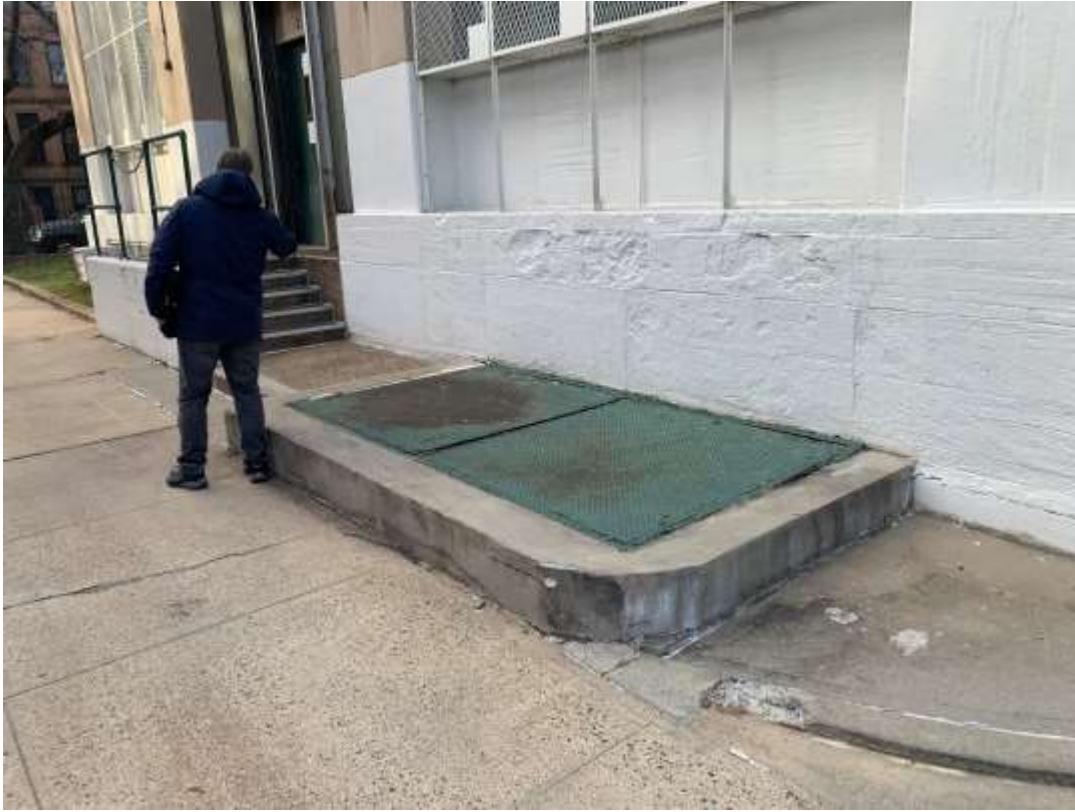
Photo S05 – View of Vault/Hoist doors at East Façade, next to access.

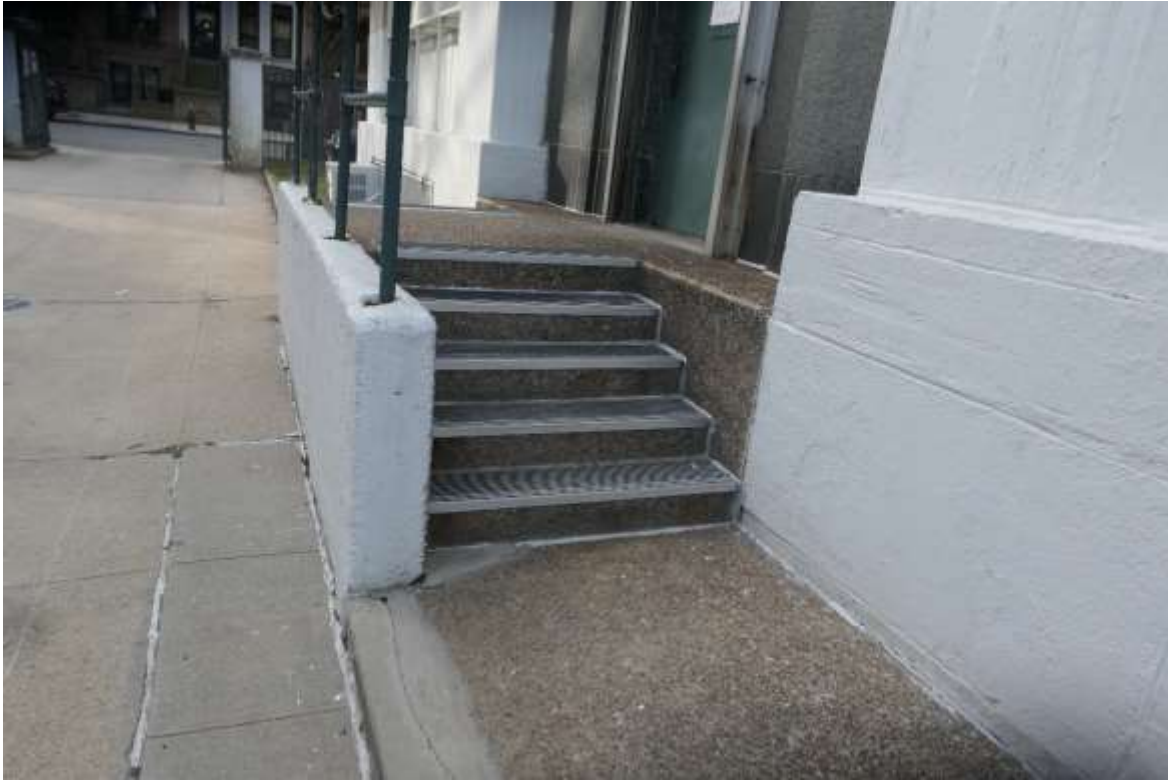
**Photo S07 – Stairs are in good condition.**

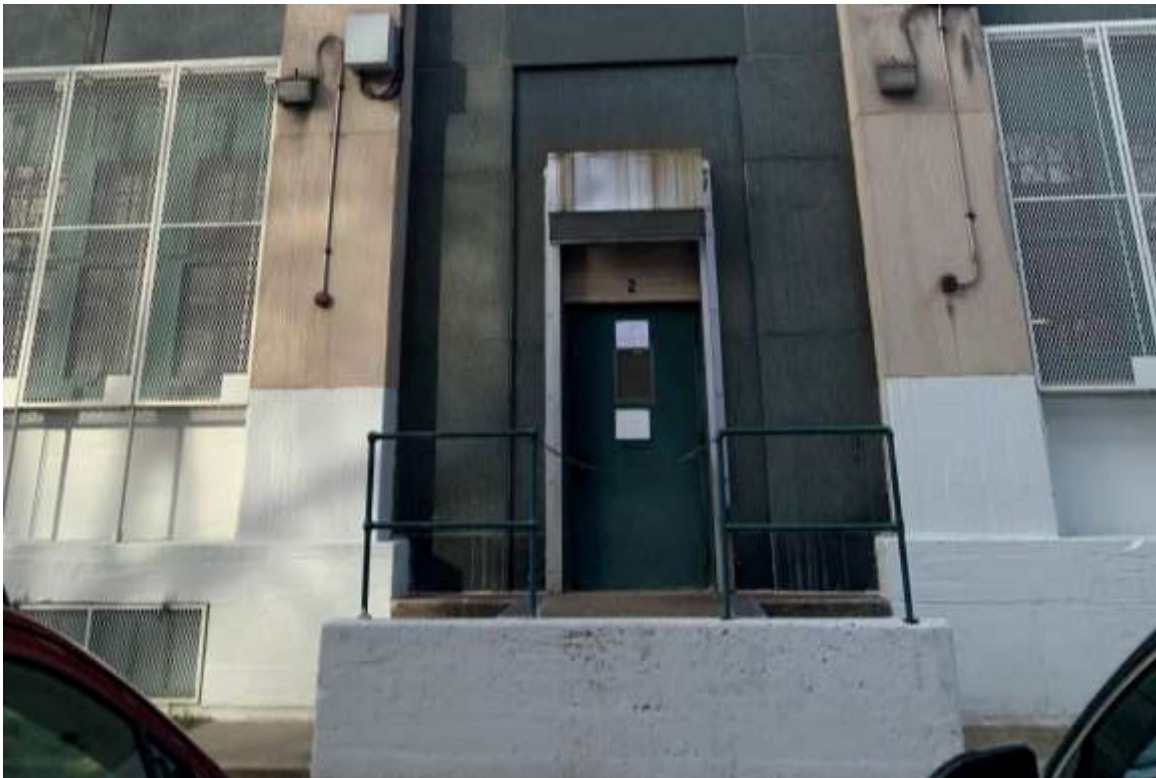
**Photo S08 – Check walls and railing at East entry are in good condition.**

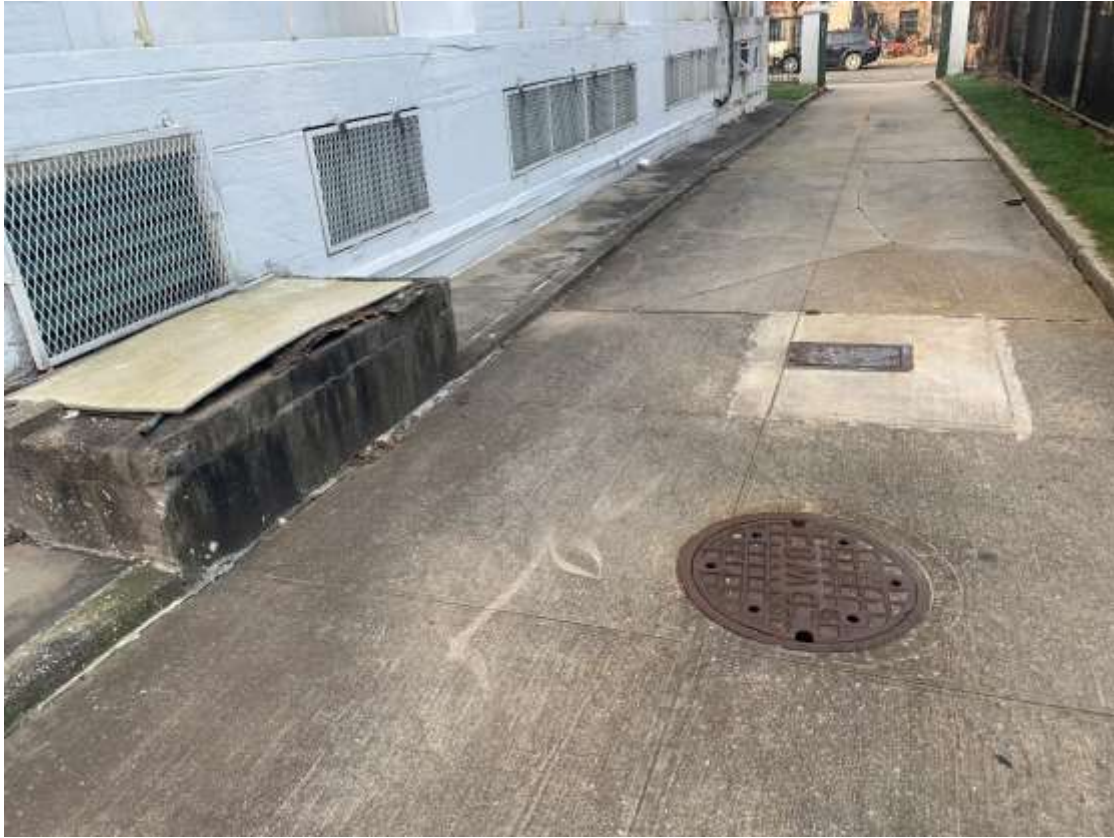
Photo S09 – Areaway located at the north of the building, next to driveway.

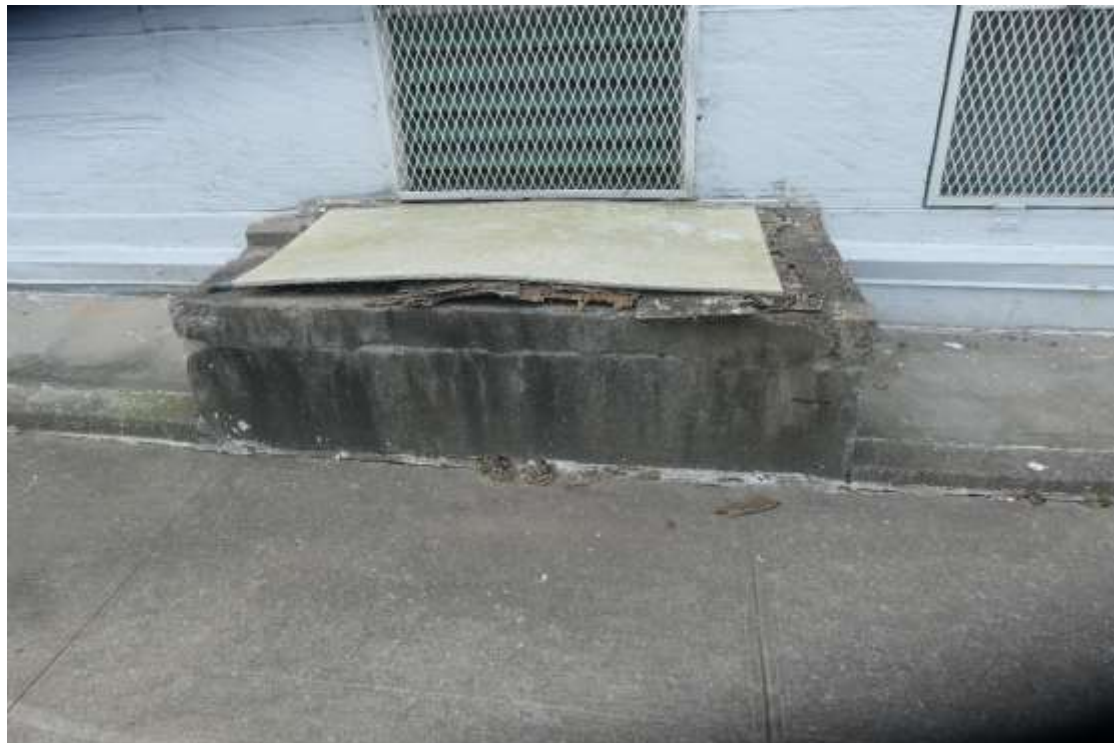
Photo S10 – Areaway is in fair condition.

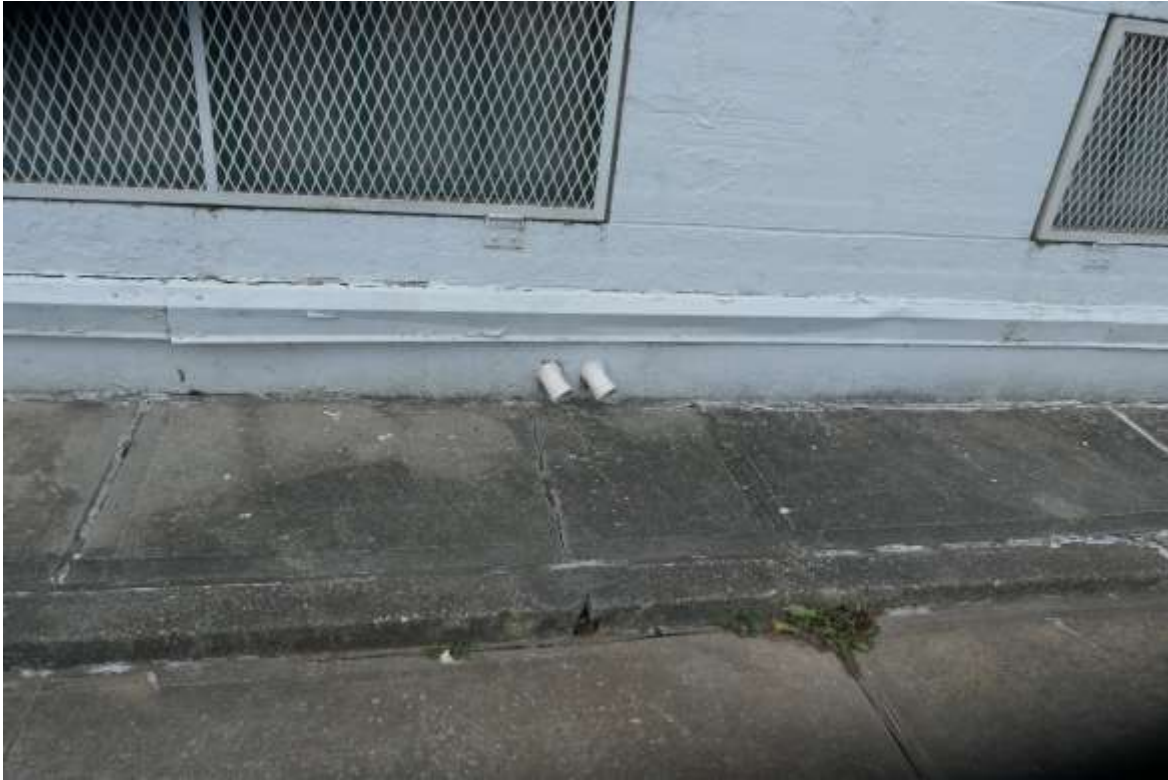
Photo S11 – Sidewalk at North façade next to parking driveway is in fair condition.

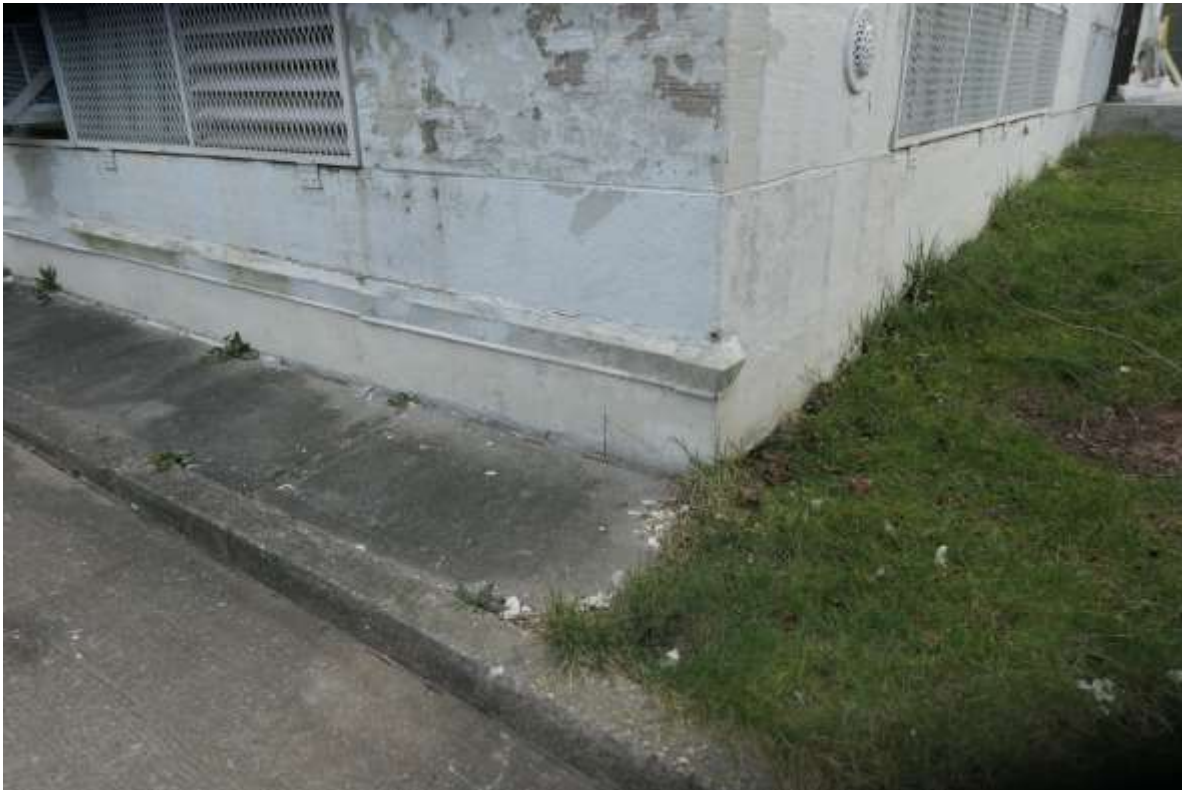
Photo S12 – Sidewalk next to parking driveway is in fair condition.
